# Agenda

# ELEMENTS of the MOYLE INTERCONNECTOR

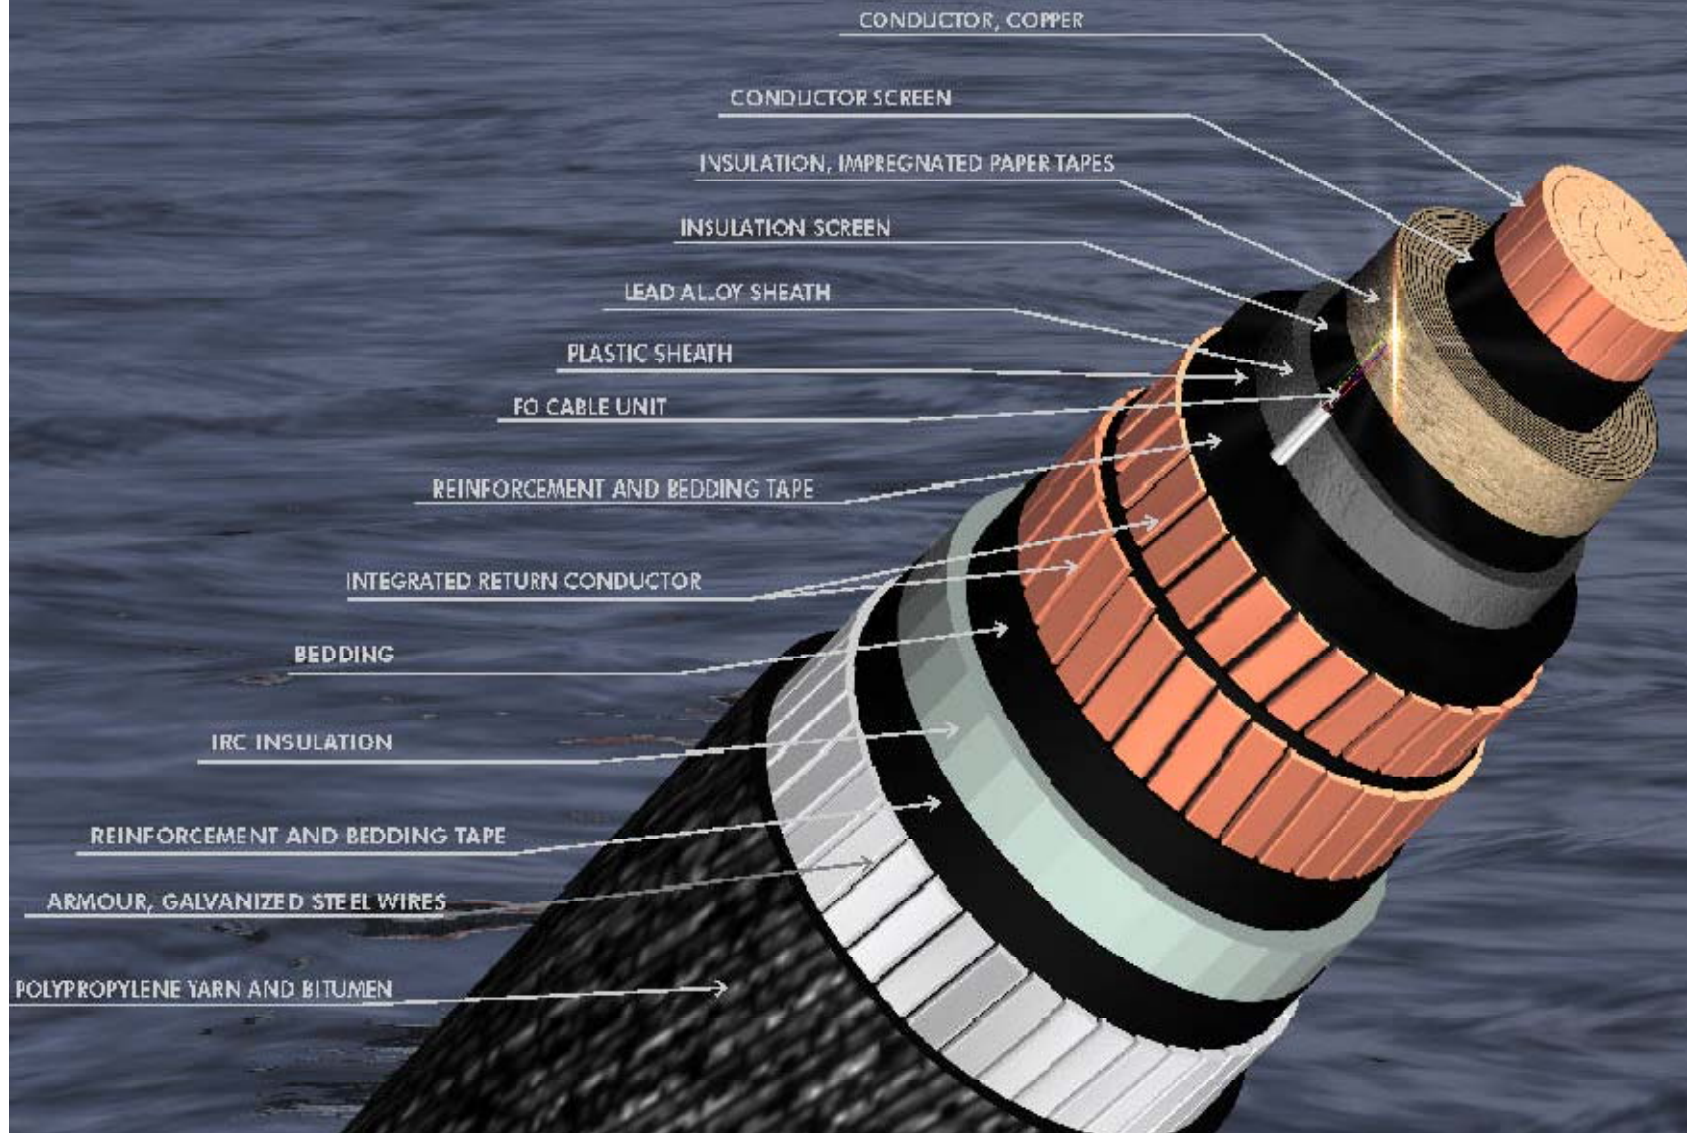
# Nature of Recent Faults – IRC Insulation

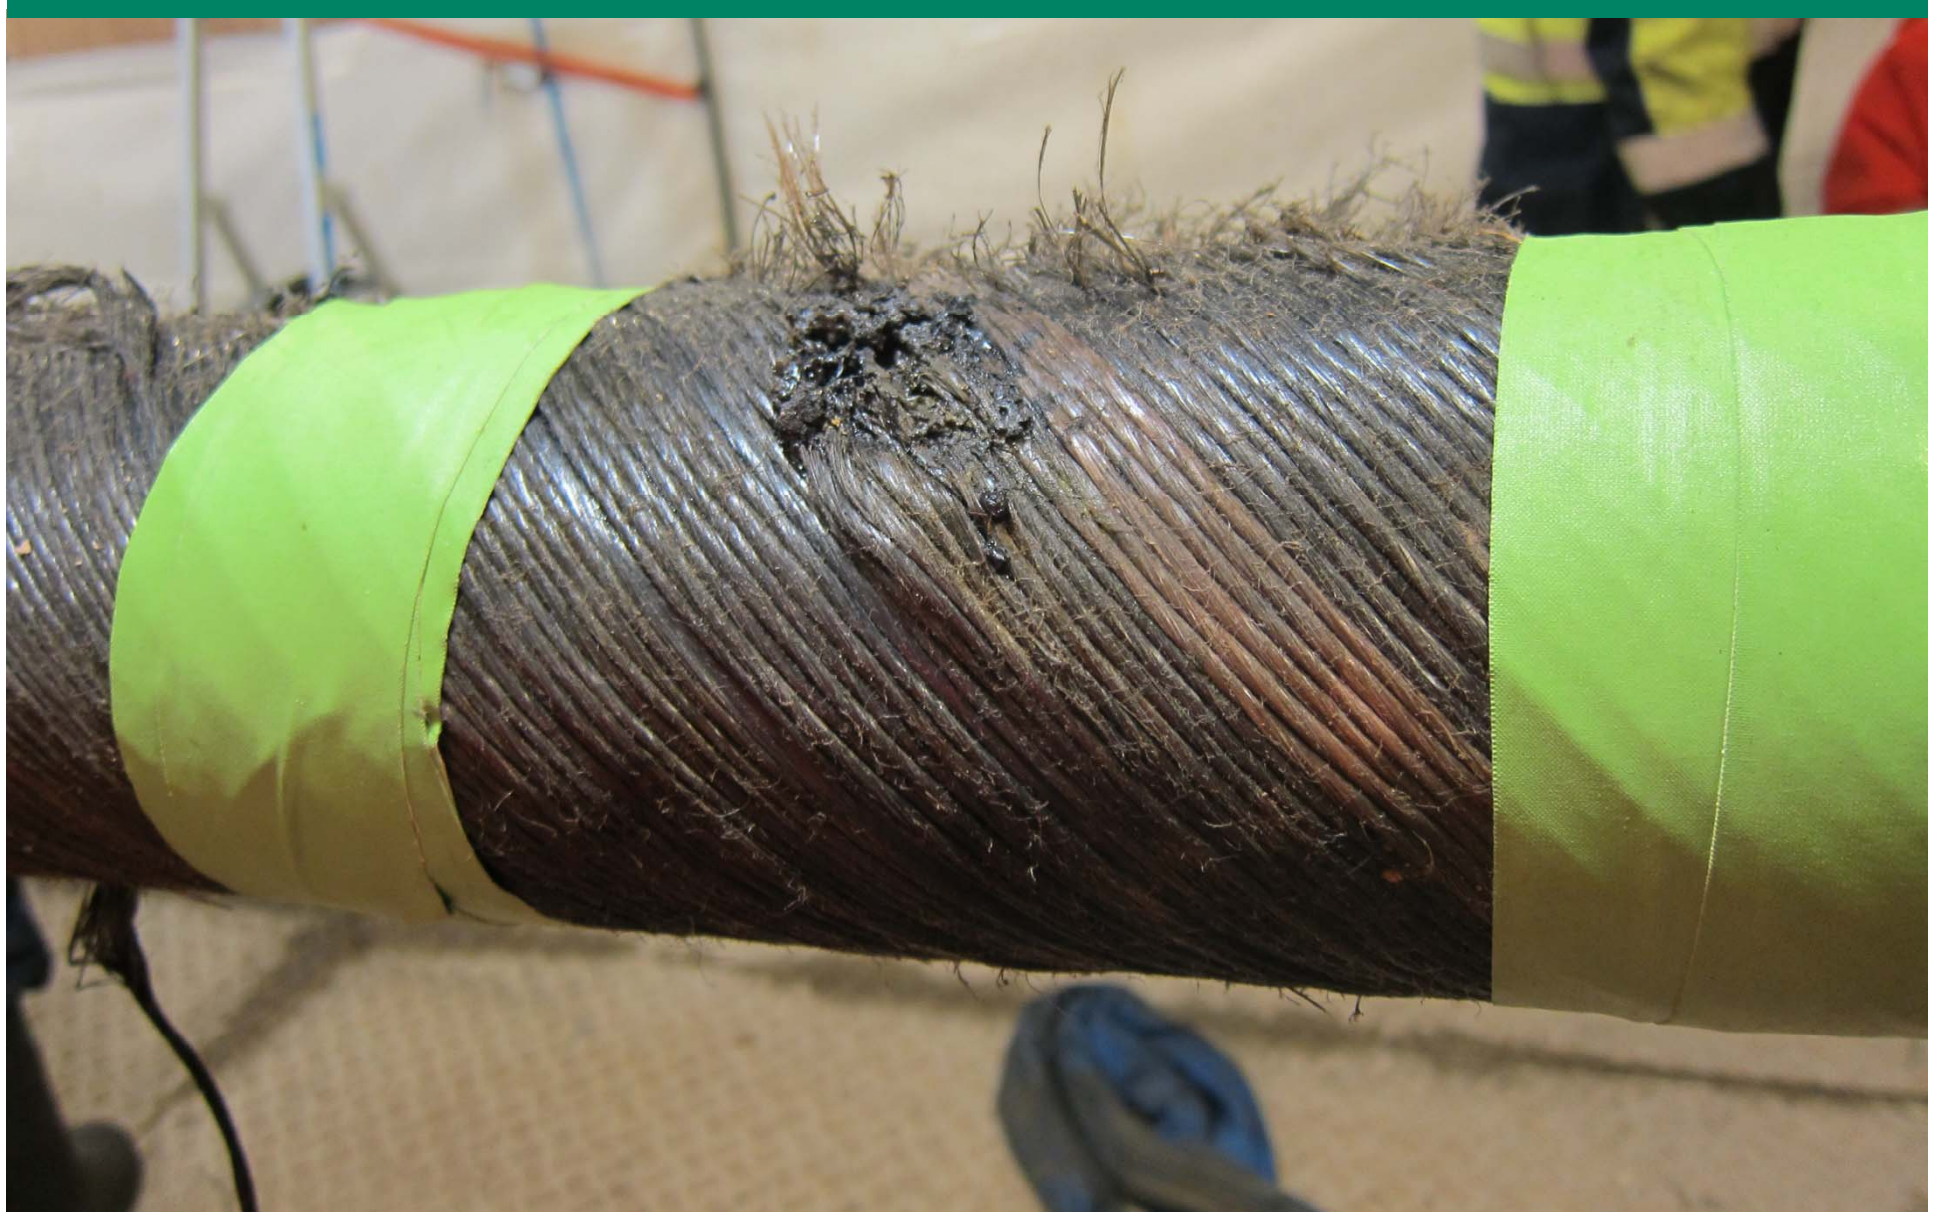
## Nature of Recent Faults – IRC Insulation

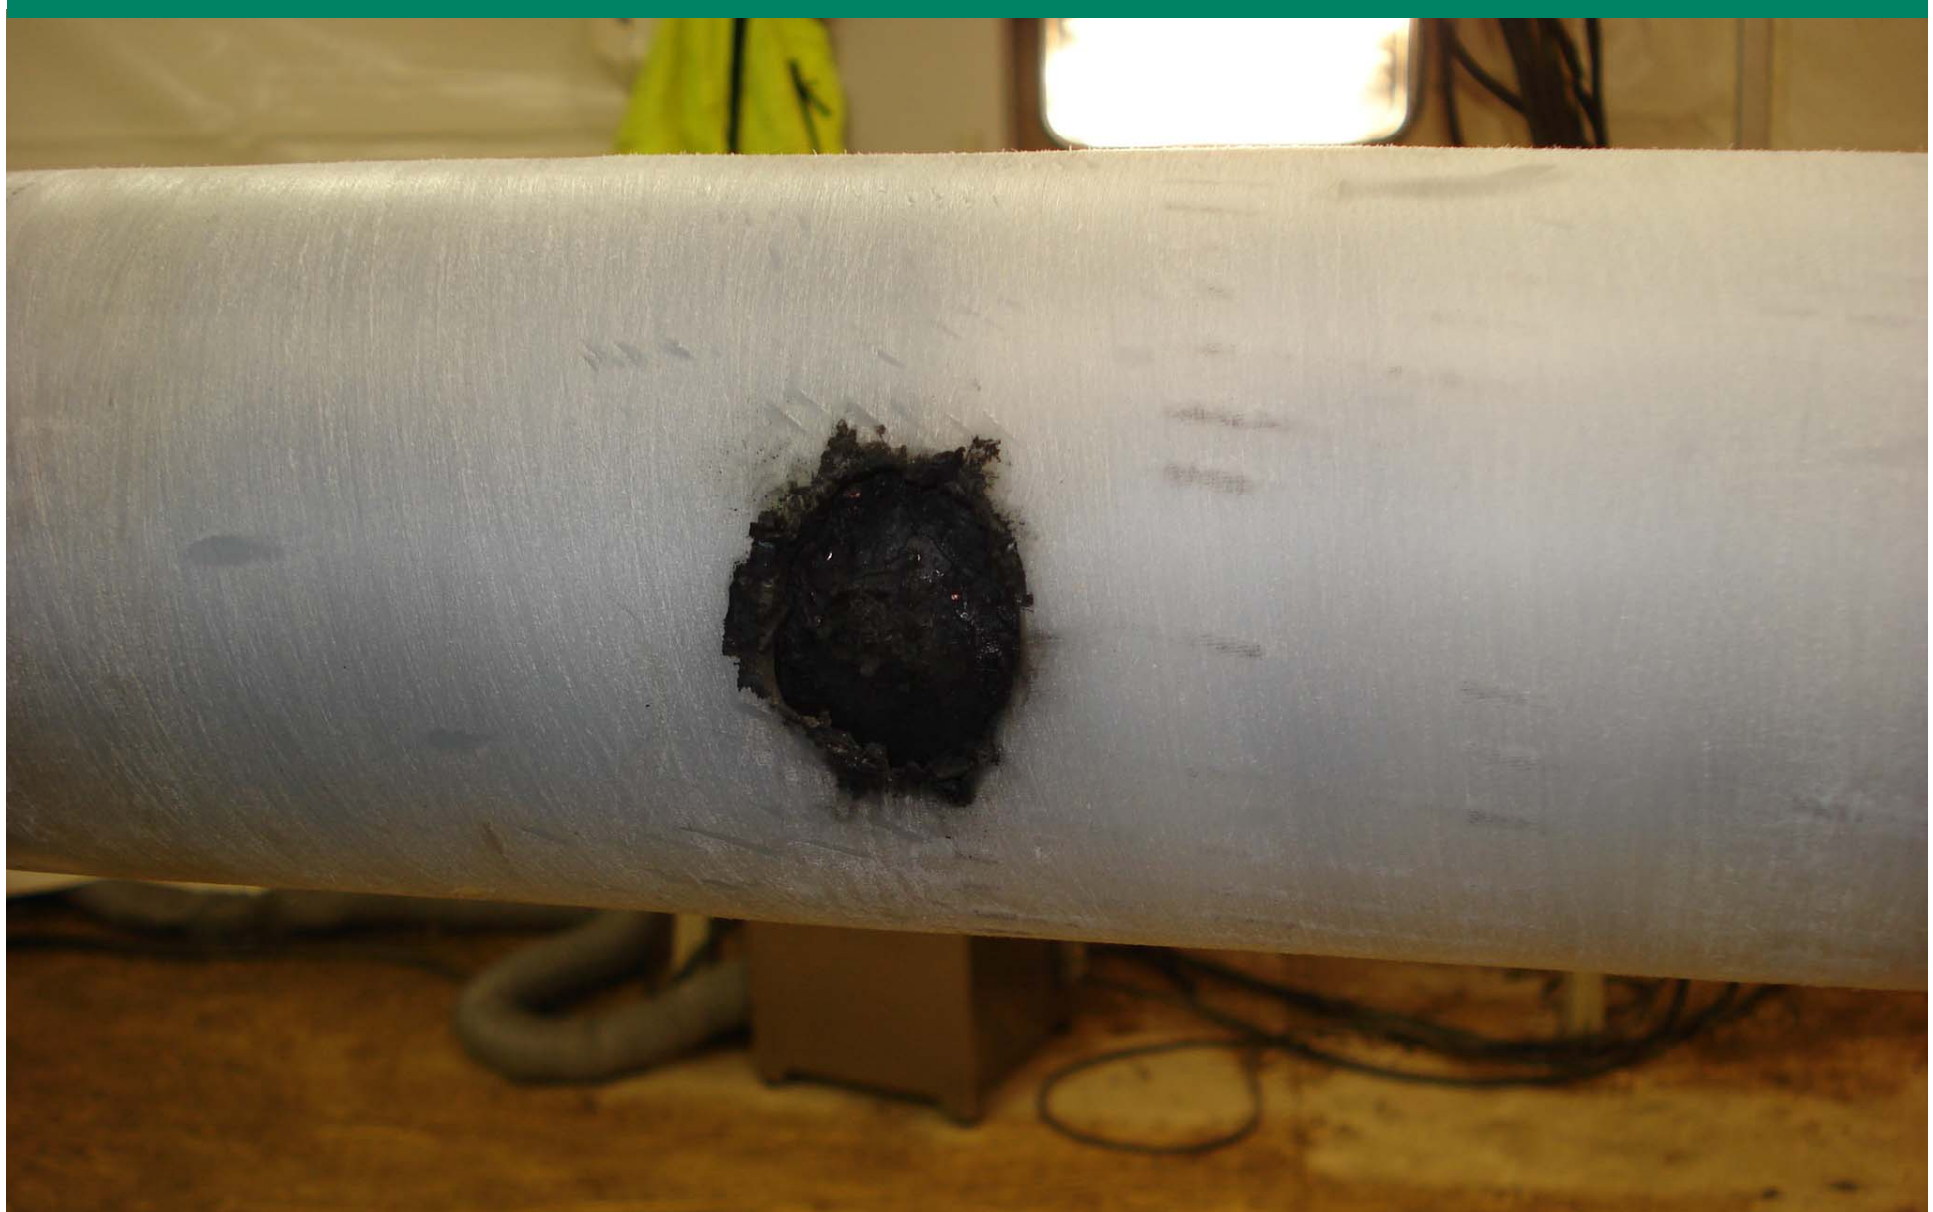
## Nature of Recent Faults – IRC Insulation

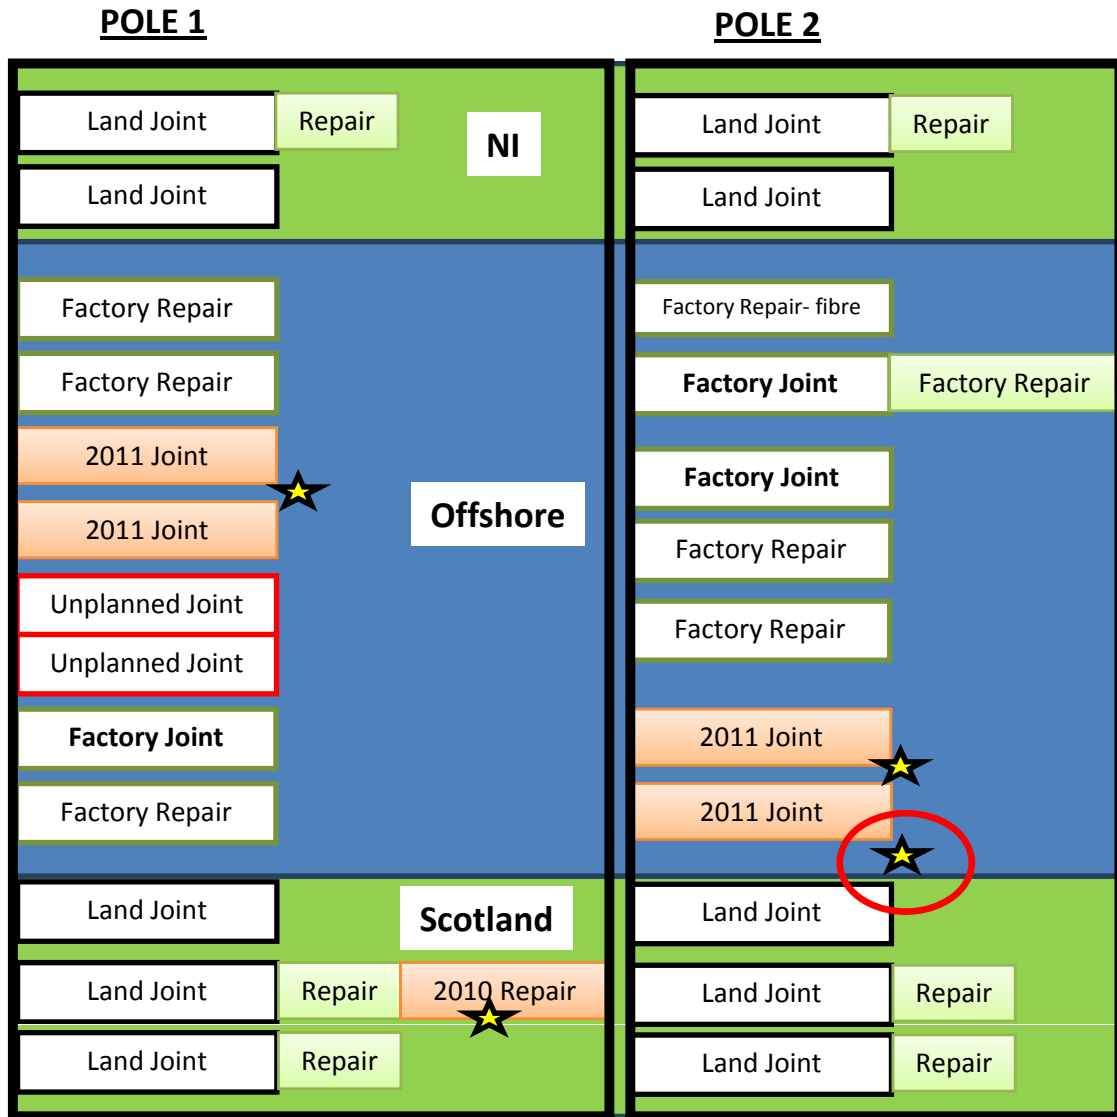
# Obvious Risk of further IRC insulation faults

IRC Insulation known at risk locations	Pole 1	Pole 2
Onshore	4	5
Offshore	6	4

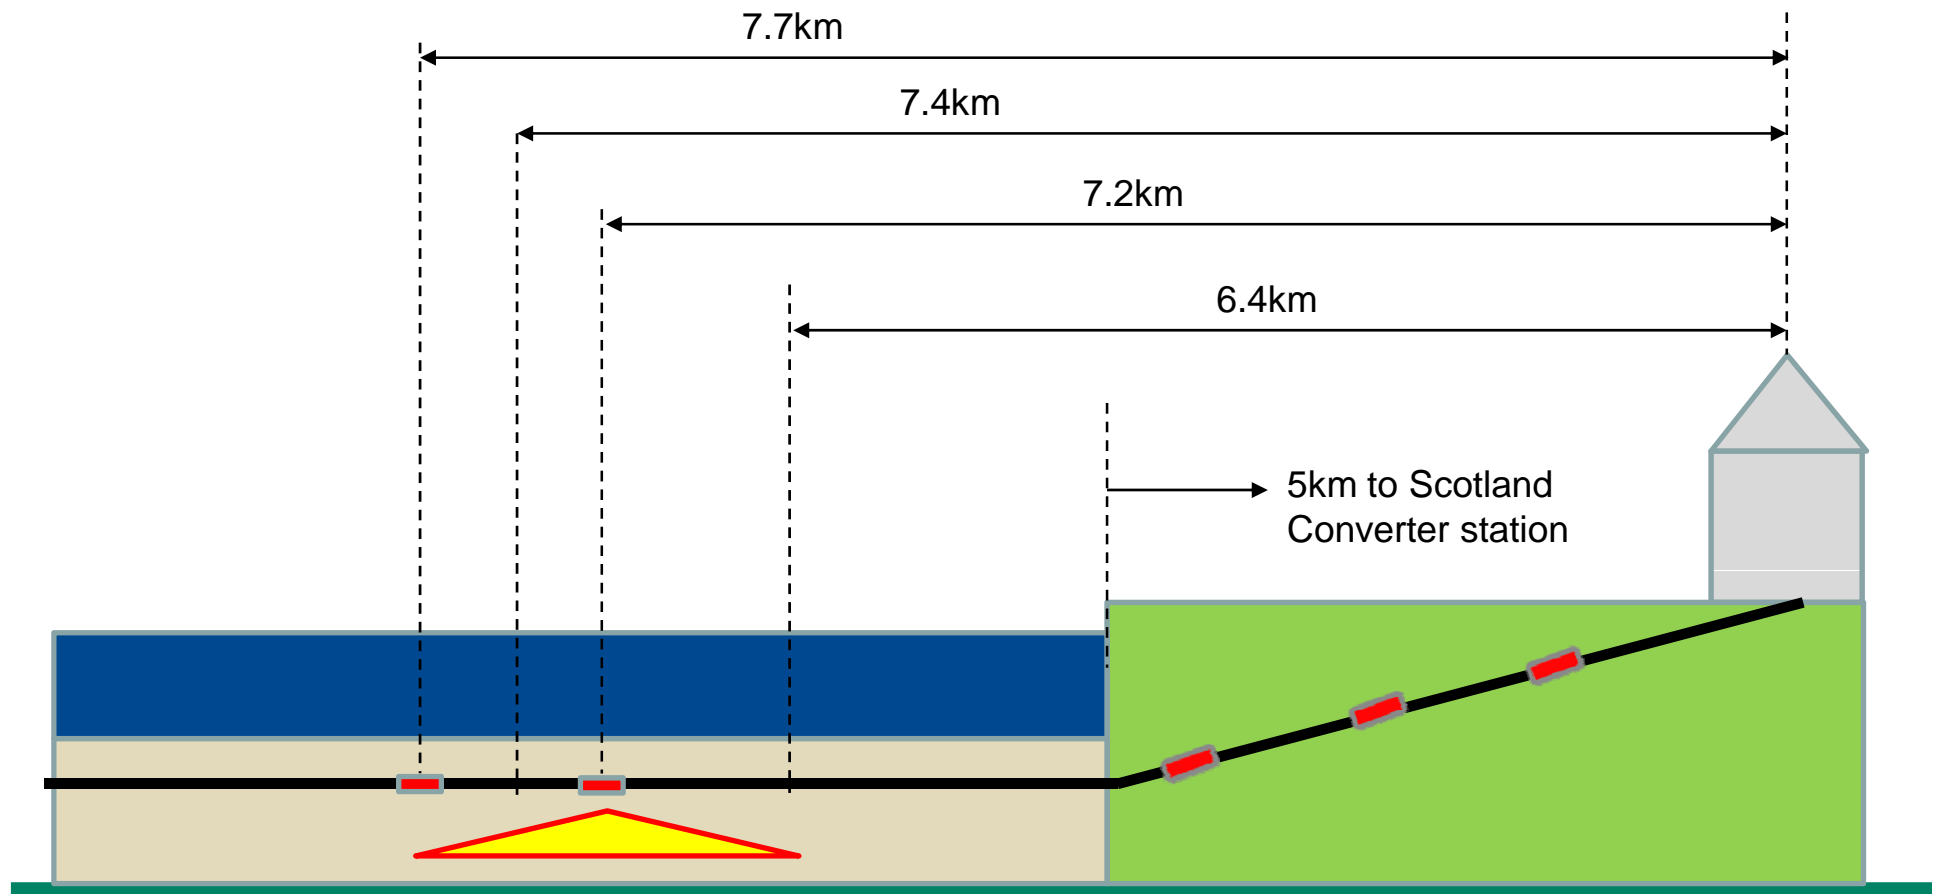
# Precise Location of Existing Fault

- Precisely pinpointing the current fault might enable a lower risk, lower cost repair to be engineered and considered

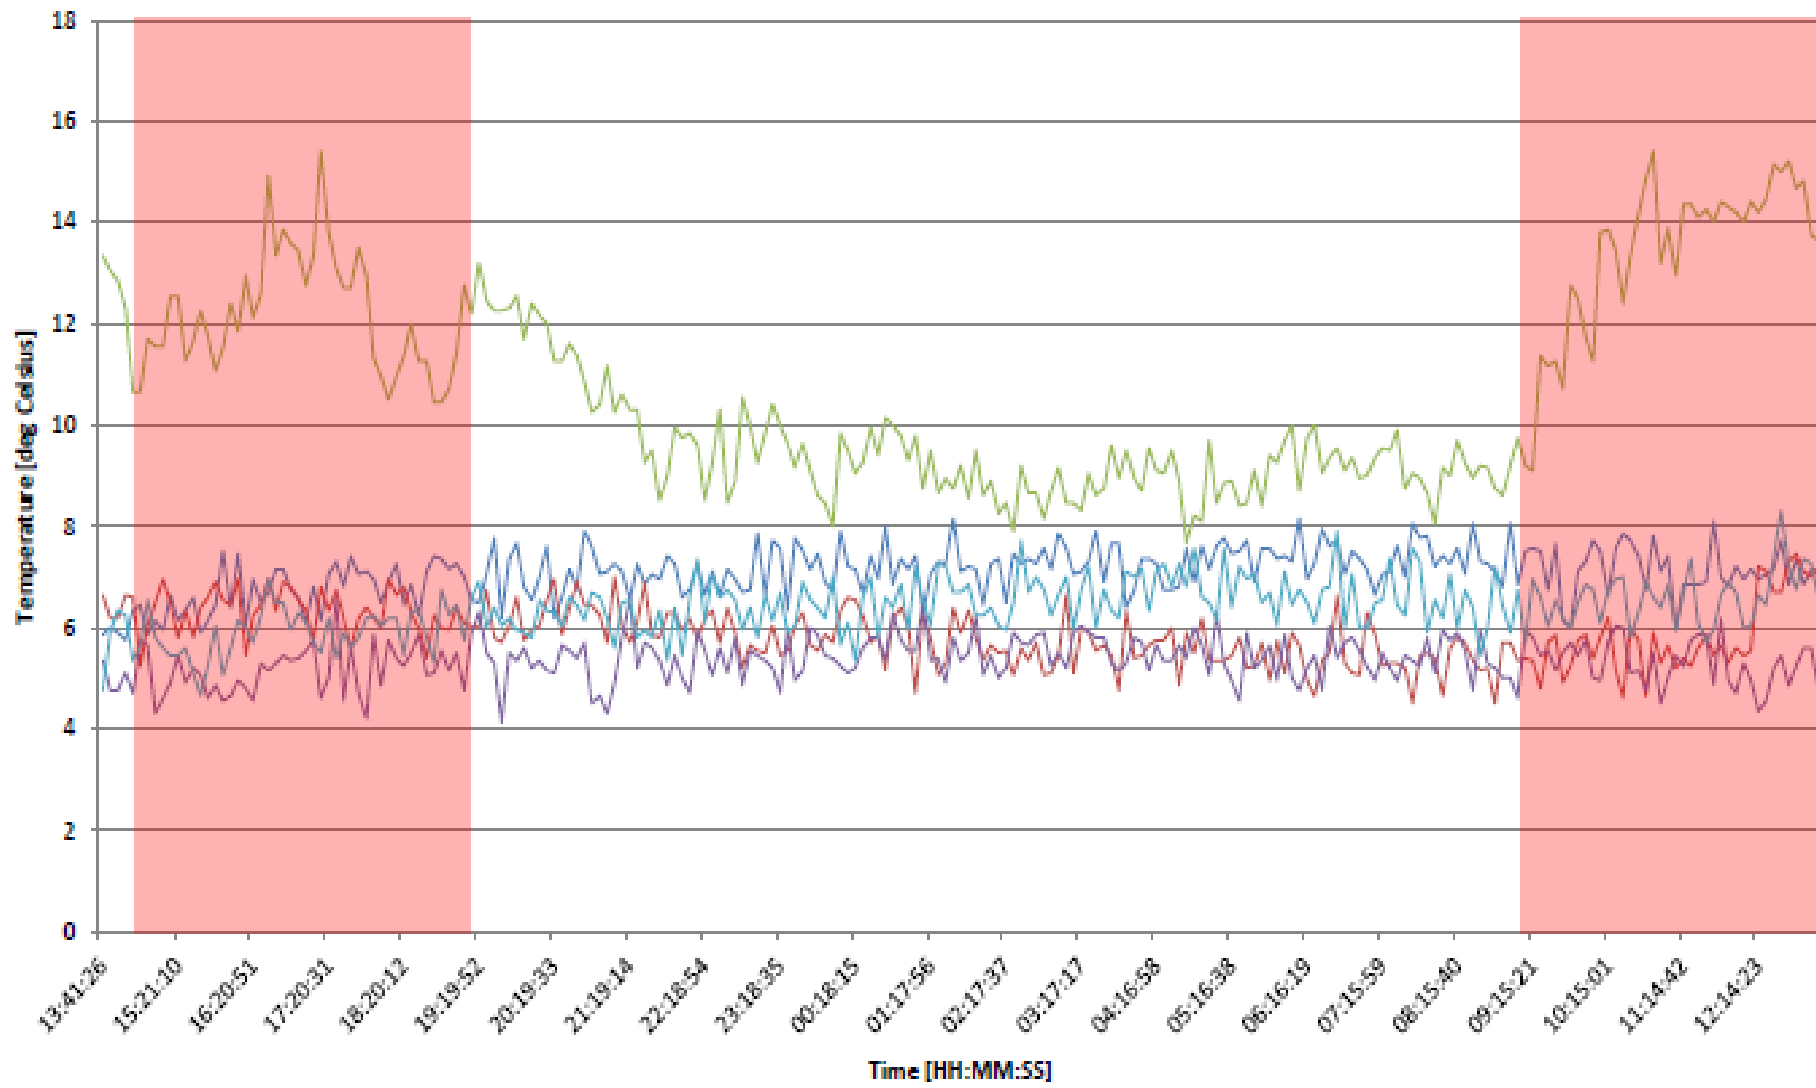
# Hotspot when current injected
