16010859-ETD/POL 11-1387A

**Study for the EirGrid East-West Interconnector
high voltage DC 200 kV land cables**

An independent assessment

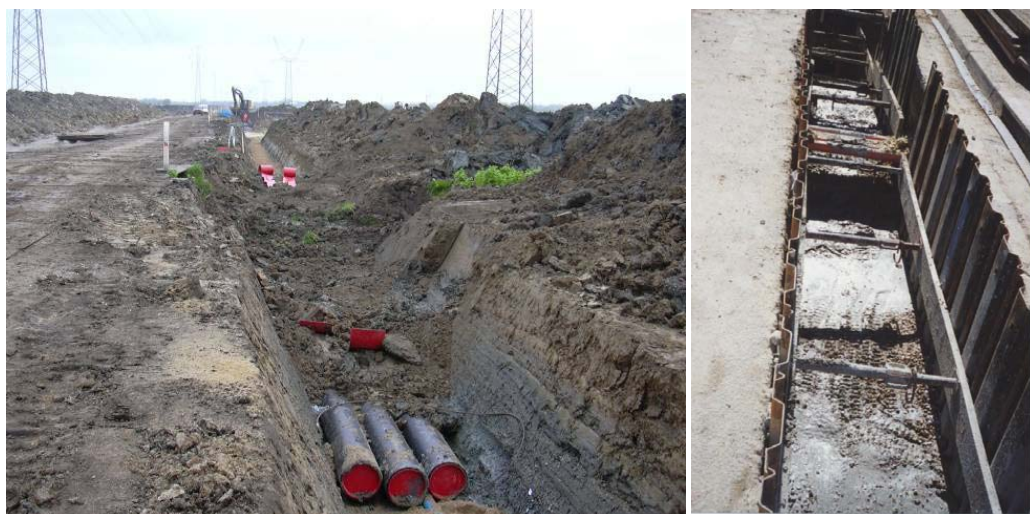
Figure 1: Cables in pipes (left) and cables in ducts (right), which are pipes cast in concrete. The pictures are examples given in Cigré TB 398.

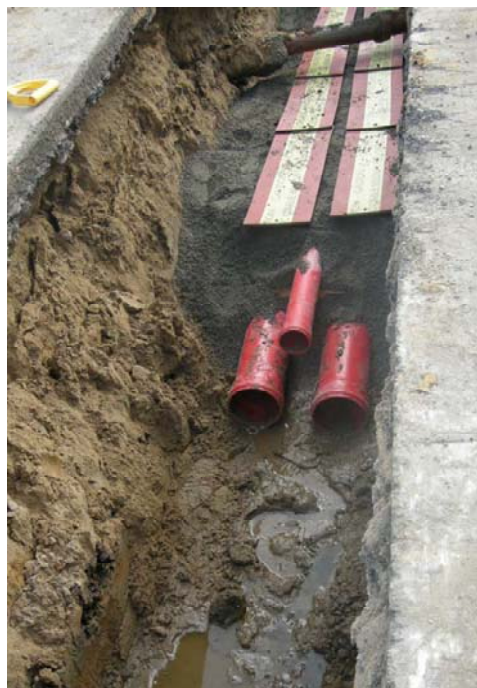
Within the cable route, the position of the duct for fibres is either in between the power cable ducts, or about 50 mm above these ducts as is shown in Figure 2.

Figure 2: Installation of DC cables.

In Figure 2 the distance between the warning tiles and the duct for fibres is about 80 mm. For the ducts in which the fibres are installed KEMA expects a little higher risk of third party damage, but given the tiles and the CBM this increase in risk is small. Furthermore, damage of the fibres does not form a safety hazard, and the position of the fibre ducts does not influence the safety of the DC cables. Increasing the number of fibres or increasing the traffic through the fibres will not influence the operation of the cable system.

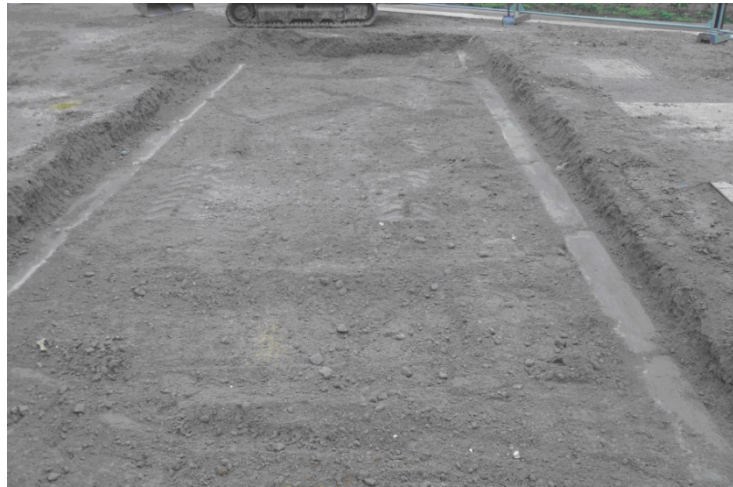
Figure 4 shows the soil on top of a 1 m deep installed 132 kV AC cable after a short circuit current of 15 kA during about 50 ms. This equals an energy dissipation of ~38 kJ, almost equal to the energy dissipation in the East-West interconnector when a failure happens. After removing top layers, no disturbance of the soil is found (see Figure 4). The effects of the short circuit were only visible within centimeters from the cable system.

Figure 4: Soil in uncovered joint pit after a failure of 15 kA during about 50 ms.

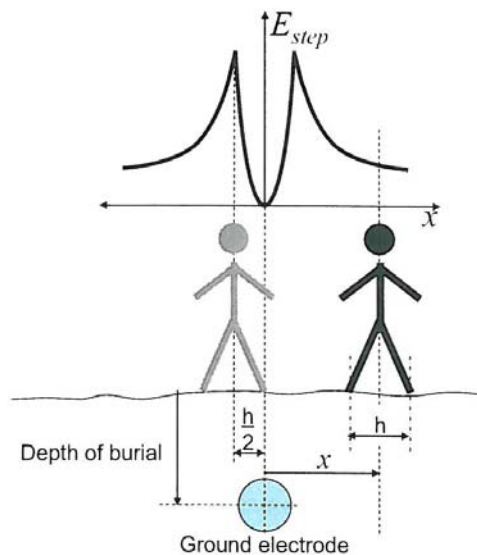
Figure 5: Step potential of a person approaching a buried electrode.

The voltage of an earth electrode is imposed on the surrounding soil, establishing potential gradients in the soil with the highest potentials (and potential gradients) occurring in the direct vicinity of the short circuit. A person or animal standing or walking in this area, with his feet some distance apart, may be exposed to a so-called step voltage which is the difference in potential between the locations where the feet are placed. A typical step potential profile for a simple buried electrode is shown in Figure 5. In this figure, the separation of the person's feet is a distance "h" and his position relative to the centre of the electrode is "x". The highest step potential occurs when the person has a position so that one foot is directly above the electrode and the other is at distance "h", i.e. $x=h/2$. The step potential is also a function of the distance between the person's two feet. An increase in the distance "h" results in an increased step potential. However, a common approach taken for human beings is to standardize this distance at one meter.

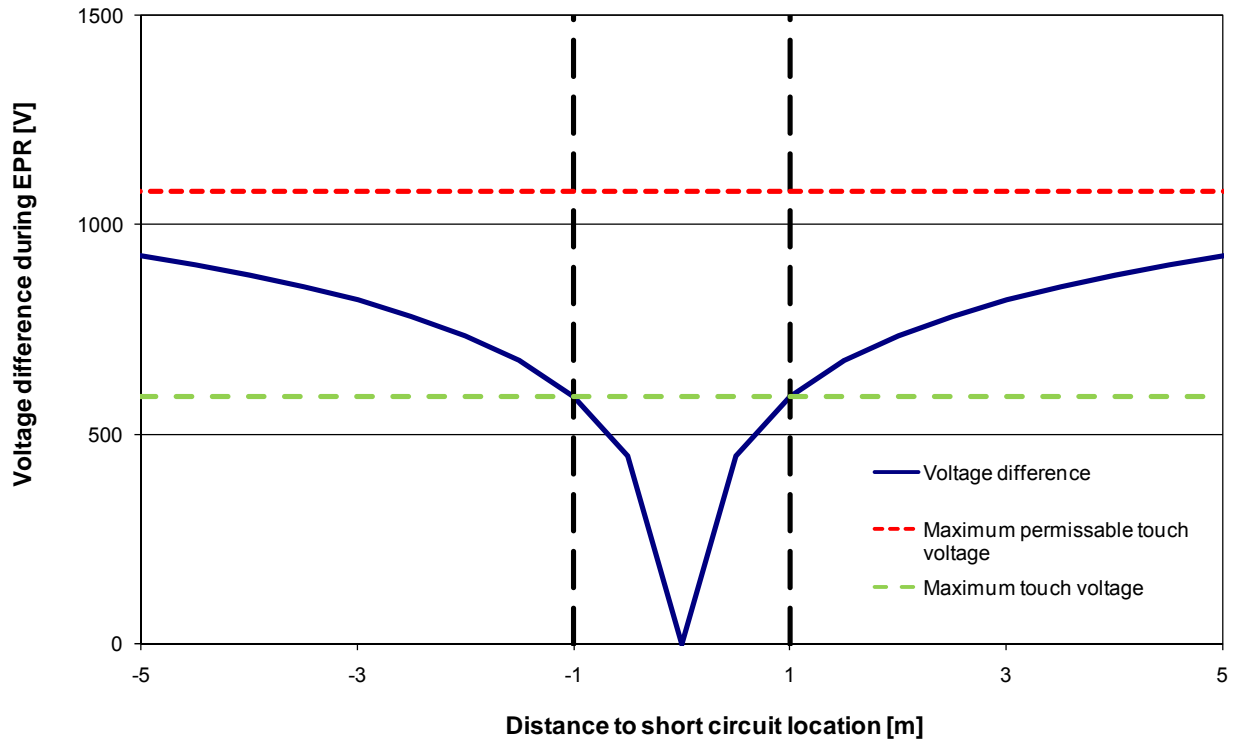
The maximum allowed touch voltage is calculated to be 1080 V. As this voltage is lower than the earth potential rise of 1350 V, the potential as a function of the distance from the point where the short circuit occurs is calculated. The result is shown in Figure 7.

Figure 7: Touch voltage difference as a function of the distance to the location of the short circuit.

Figure 7 shows that the touch voltage, which is highest at 1 meter from the location of the short circuit (refer to section 5.1), is maximal 590 V. This touch voltage is lower than the maximum permissible touch voltage of 1080 V. Therefore, also the touch voltage meets the requirements stated in the governing NEN-EN 50522, IEEE 80-2000 and IEC 60479-1 standards.

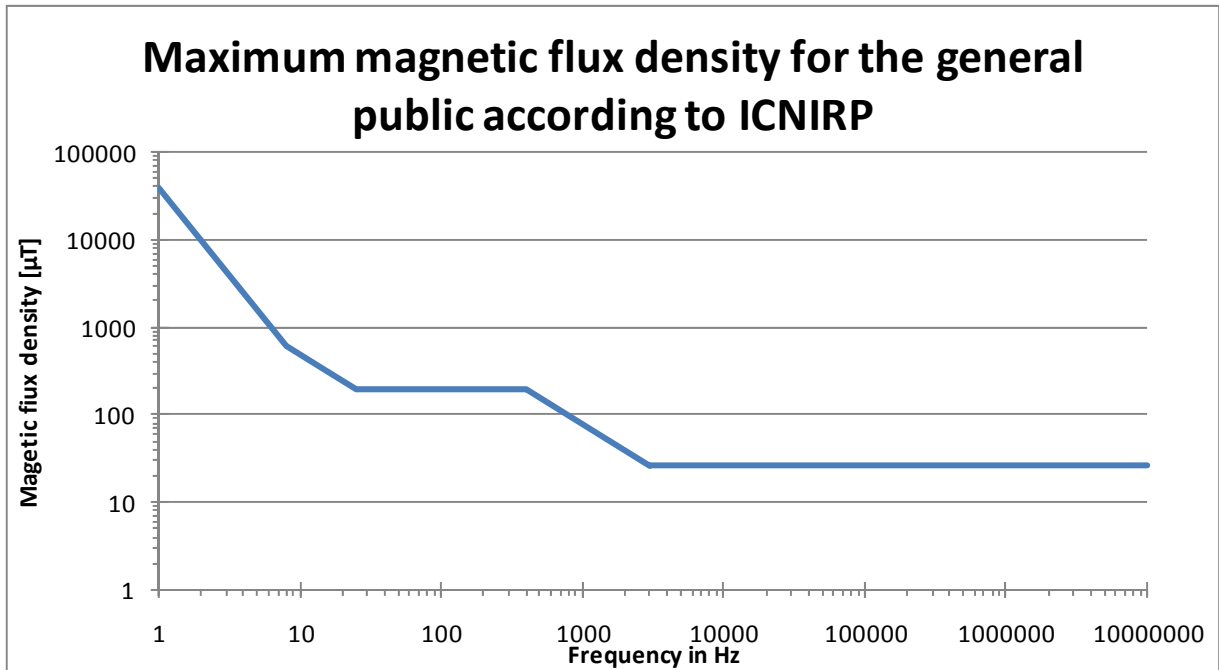
For time varying fields, the maximum magnetic flux density for the general public according to ICNIRP is given as a function of the frequency of the magnetic field in Figure 8. The maximum magnetic flux density at 1 Hz is 40.000 μT .

Figure 8: The maximum magnetic flux density of time varying fields for the general public according to ICNIRP.

The limitation for time varying magnetic fields is given by ICNIRP (section 6.1). For convenience, Figure 8 has been translated to a limitation on the current at a certain frequency through the power cable circuit, anticipating a minimum burial depth of 900 mm, and a spacing of 250 mm. The result is presented in Figure 11.

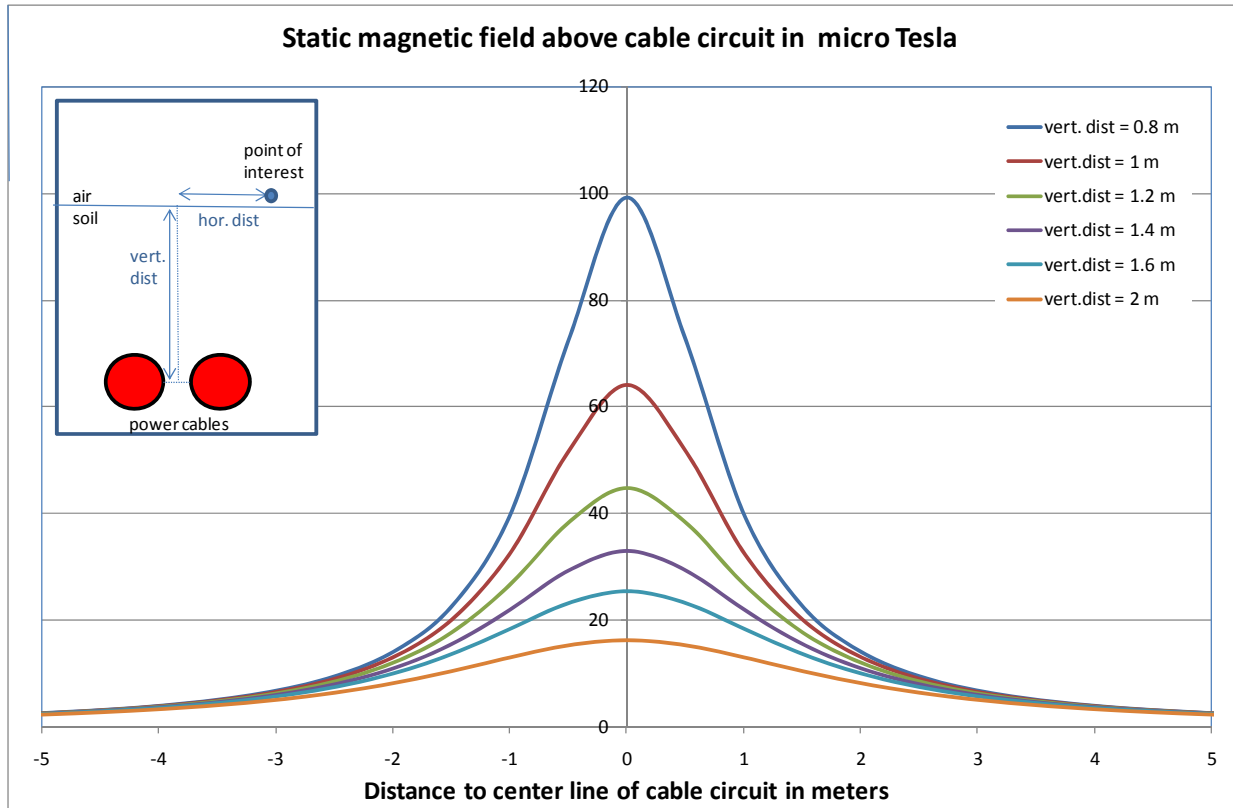
In Figure 9, the magnetic field above the power cable circuit is given as a function of the distance to the power cable. The flux density is given in micro Tesla [μT]. Both the vertical distance (cable depth) and the horizontal distance are given in the figure. Different cable depths are represented by the different lines in the graphs. The vertical distance given is the distance between the road surface and the heart of the power cable. Different horizontal positions with respect to the cables are presented via the x-axis. This axis gives the horizontal distance between the center of the cable circuit, and a certain location of interest.

Figure 9: The magnetic field above the HVDC bipole cable circuit in micro Tesla, as a function of the cable depth (vertical distance) and horizontal position.

Typically, the burial depth of the cables in the town of Rush is more than 1 meter, the shallowest burial is ~0.9 meters. Houses and other buildings are typically a few meters away. The closest house has a distance of ~1.5 meters from the center of the cable circuit.

magnitude as the magnetic field curve shown in Figure 9, KEMA expects the total increase of the magnetic fields due to the bends will be small. The top values will remain as stated in Figure 9, while one of the slow decaying ‘shoulders’ of the curve will be lifted with a value of maximally a few micro Tesla.

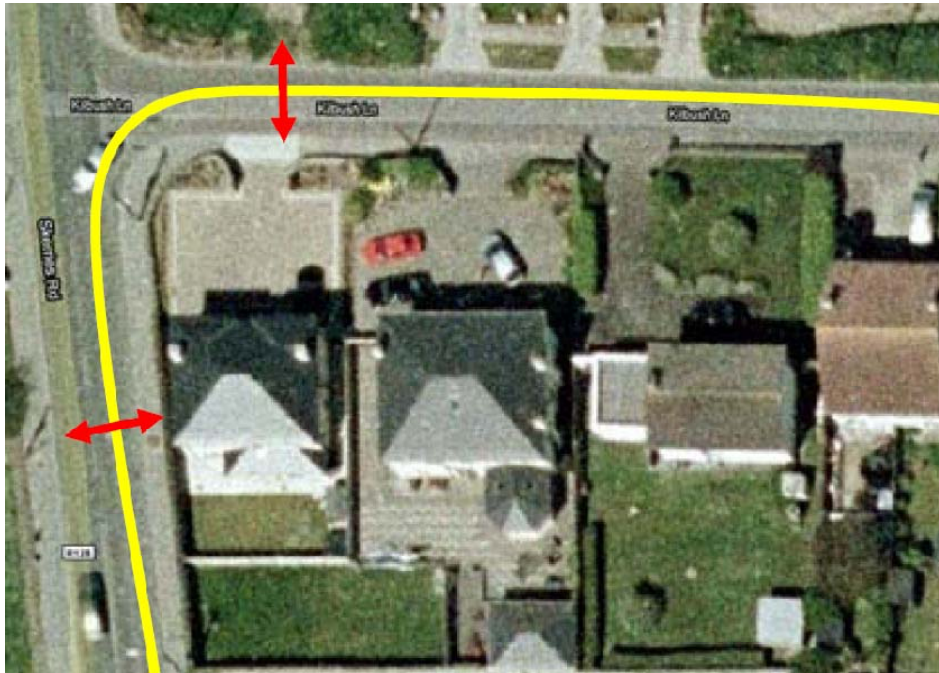
In the case of a bend in the cable route, the magnetic flux density might be increased due to superposition of different magnetic field contributions. In the town of Rush, the situation shown in Figure 10 is present showing a near 90 degree bend in the cable. At a certain point near the cable, there will be a magnetic field contribution due to both the horizontal and the vertical sections of the cable route. However, as the bending radius of the cable has the same order of

Figure 10: 90 degree bend in the cable at Skerries road en Kilbush lane.
