EirGrid Evidence Based Environmental Studies Study 7: Soils & Geology

Literature review and evidence based field study on the
effects of high voltage transmission development on soils
and geology

May 2016

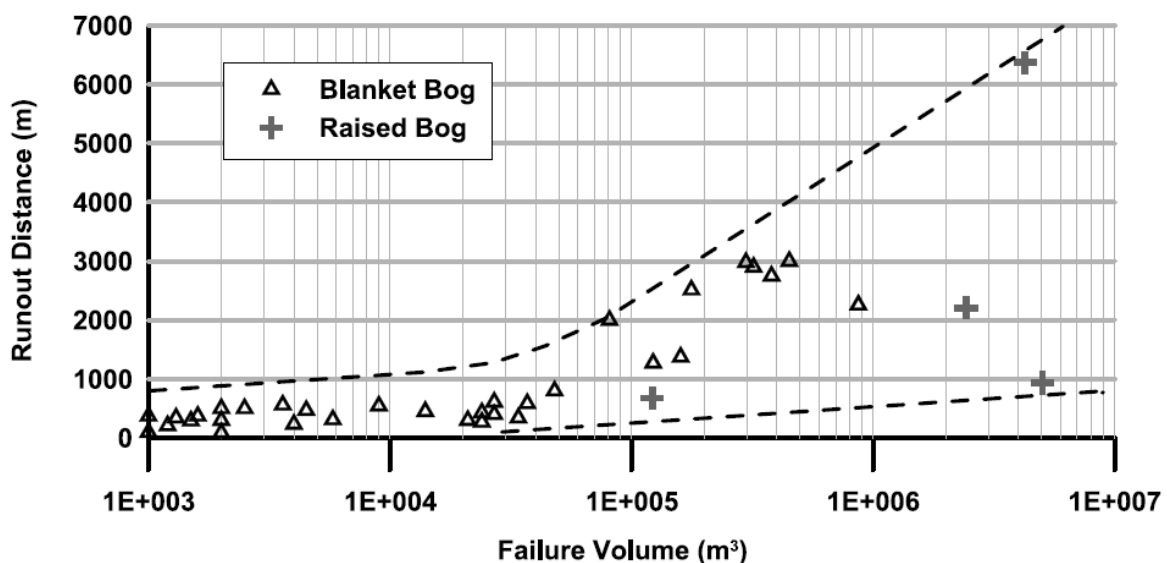
However the distance to which a peat failure may run depends on a large number of factors such as available water, proximity to drainage lines, slope gradient and length, peat thickness and failure volume. Little has been studied with regard to peat failure distances, however Boylan *et al* (2008) has presented the following relationship between peat volume versus run-out distance in Figure 2.2. This is not a definitive assessment but may provide an indicative trend.

Figure 2.2 Relationship between peat run-out distance vs. failure volume for landslide events. (Boylan *et al*, 2008)

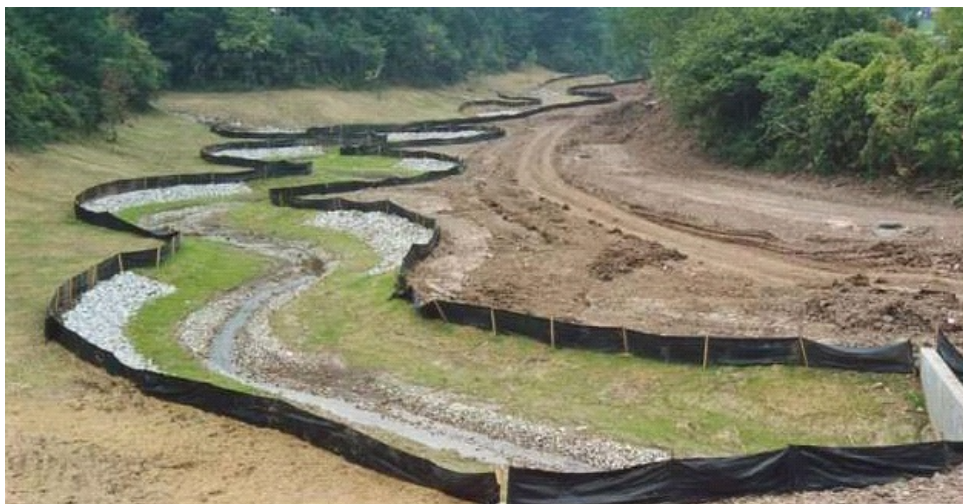
Figure 2.4 Example of a silt fence preventing sediment release into ditch/channel

- Silt fences to trap sediment and prevent it leaving the slope. (Figure 2.4)
- Burlap rolls and straw bales, however these are not considered to be the most effective due to being easily destroyed by cattle or degradation. (Figure 2.5)
- Sedimentation ponds to trap suspended particles contained in runoff and prevent them from leaving site. (Figure 2.6)

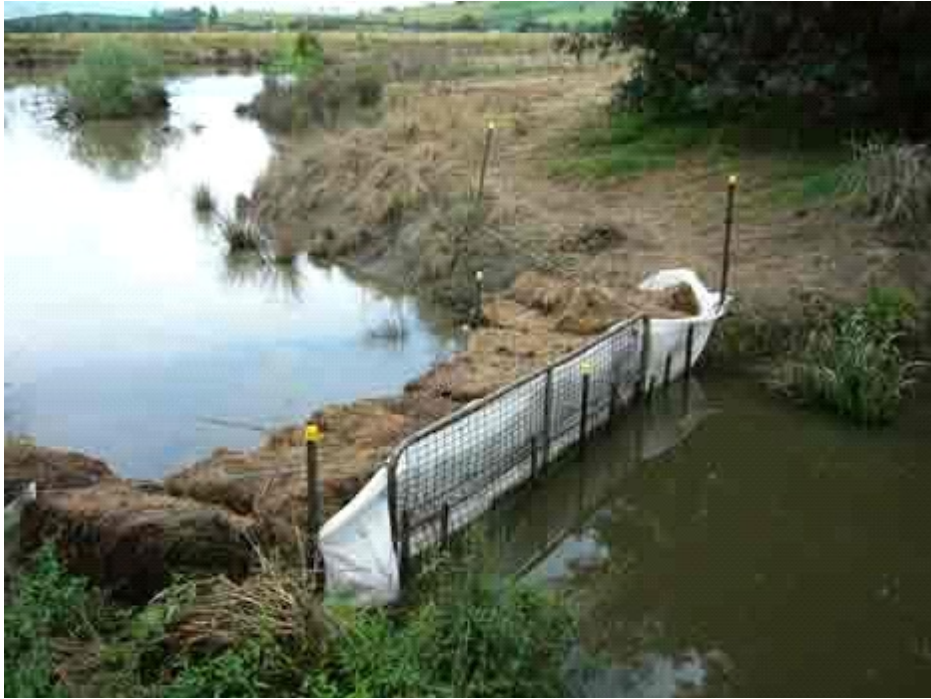
Figure 2.5 Example of straw bales and burlap rolls being used to prevent siltation of river

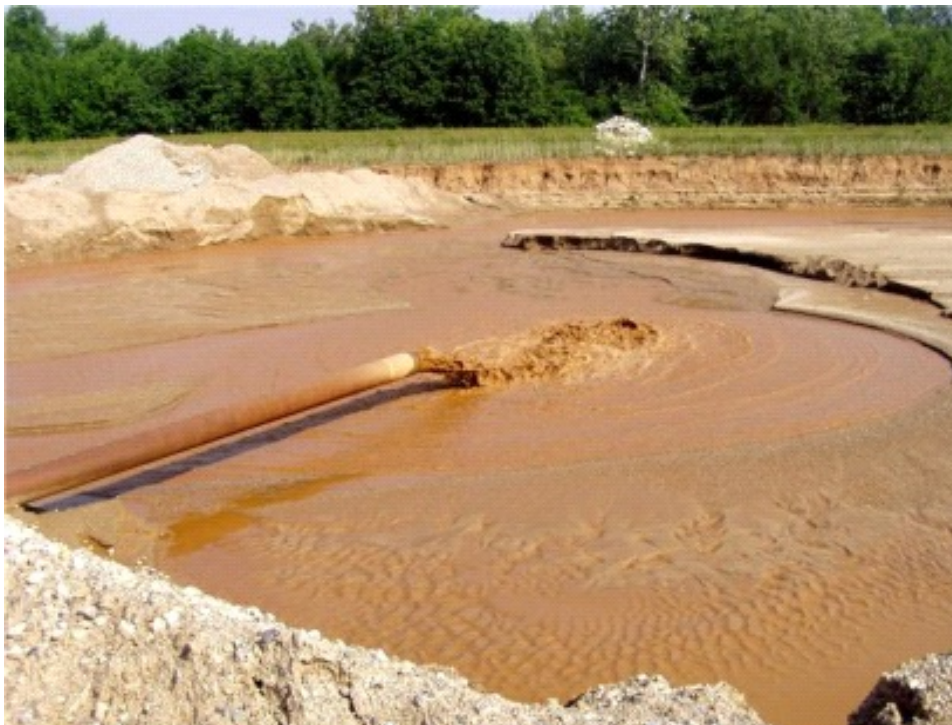
Figure 2.6 Sedimentation pond being used to allow settlement of suspended particles as part of the surface water management of a construction site

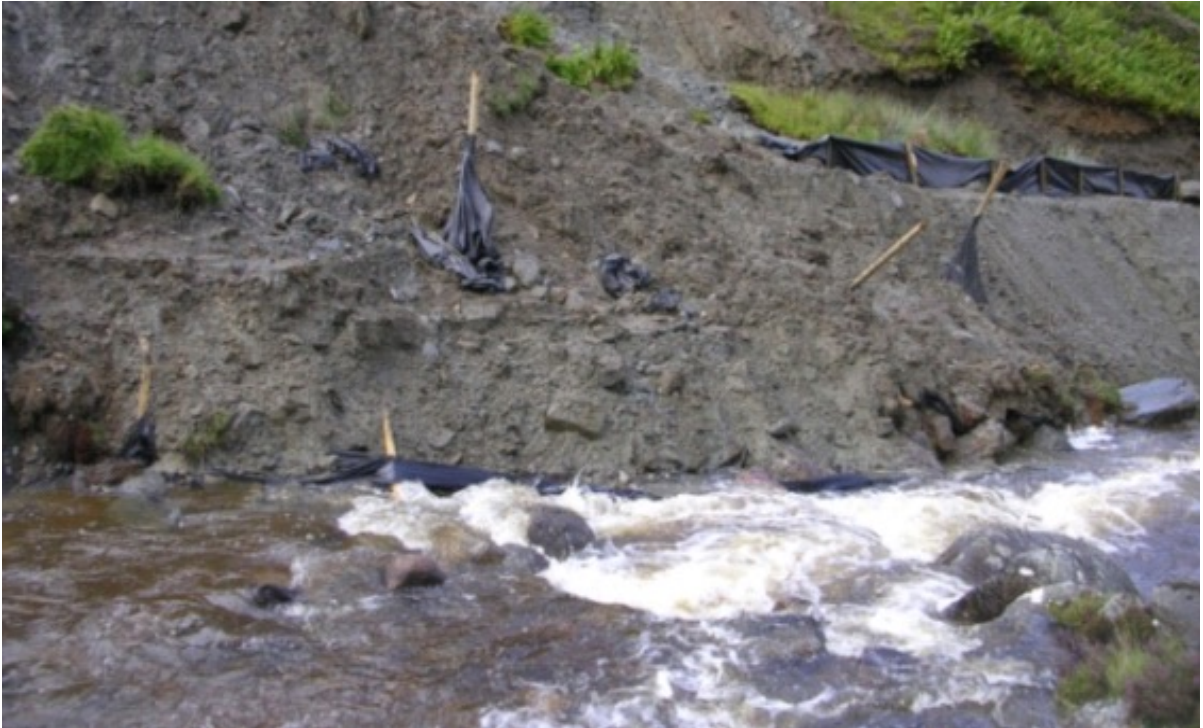
Figure 3.5 Inadequate erosion control measures leading to detrimental damage to adjacent stream

- loading of the ground, which may cause bearing failure in weaker soils (Figure 3.4)
- excavation for foundations, causing the ground upslope to become unstable (Figure 3.4)
- compaction of in-situ soils, particularly along temporary access routes, making it less permeable and causing increased water run-off, increasing the level of soil release and siltation/sedimentation
- exposure of fine soils during the excavation process
- stockpiling of materials without adequate erosion control measures (Figure 3.5)

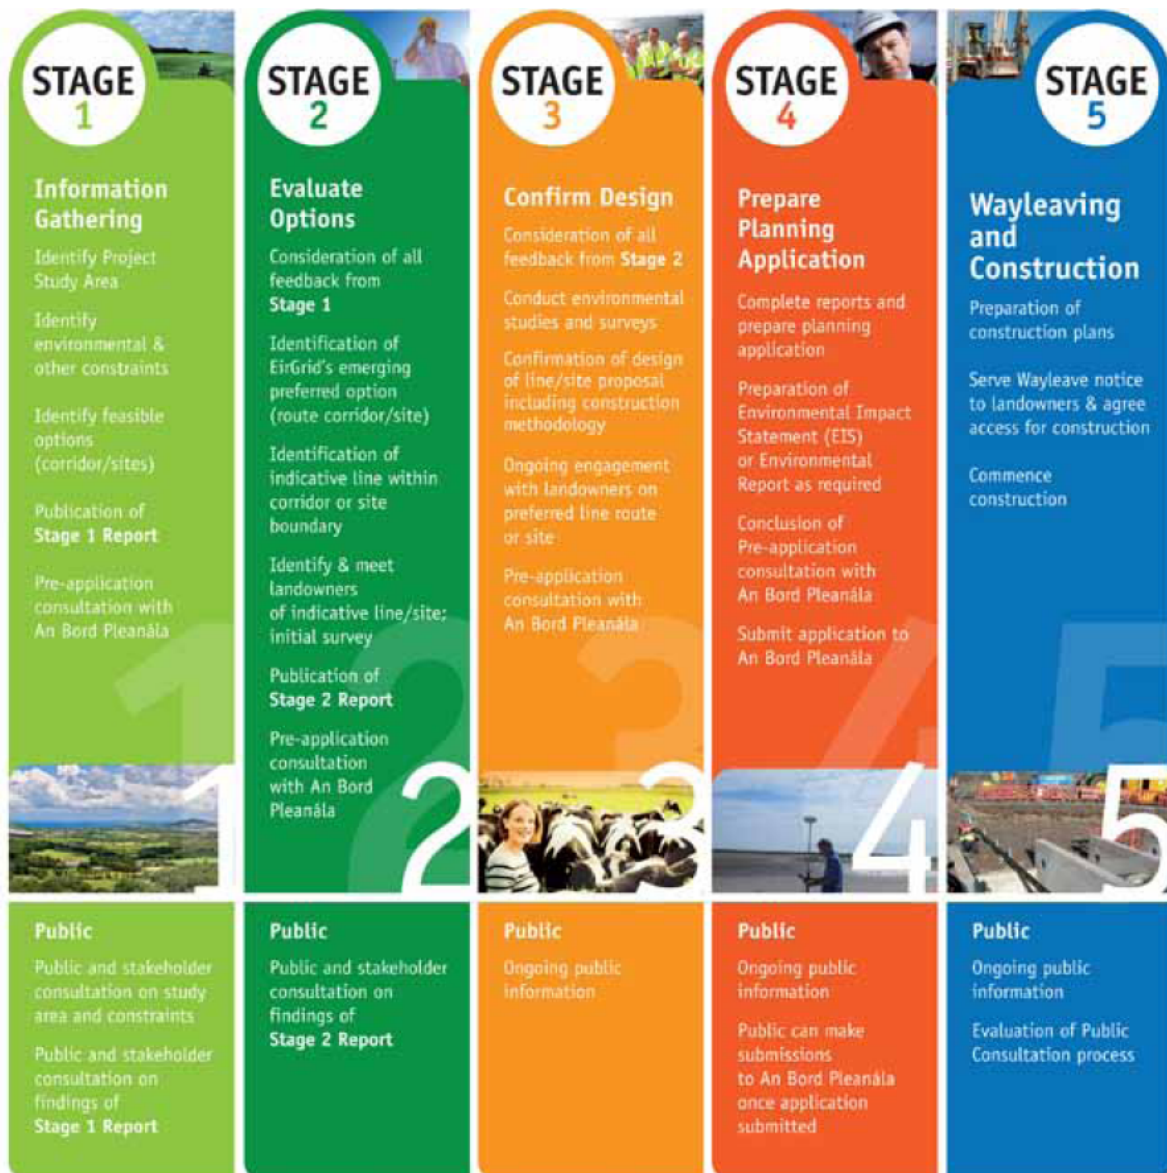
Figure 4.1 EirGrid's Project Development and Consultation Roadmap

Environmental considerations form part of the EirGrid strategy for Grid Development from the earliest stages of a Project. This is evident in EirGrid's Project Development and Consultation Roadmap (Figure 4.1) which illustrates that environmental and other constraints are identified in Stage 1, the Information Gathering Stage.

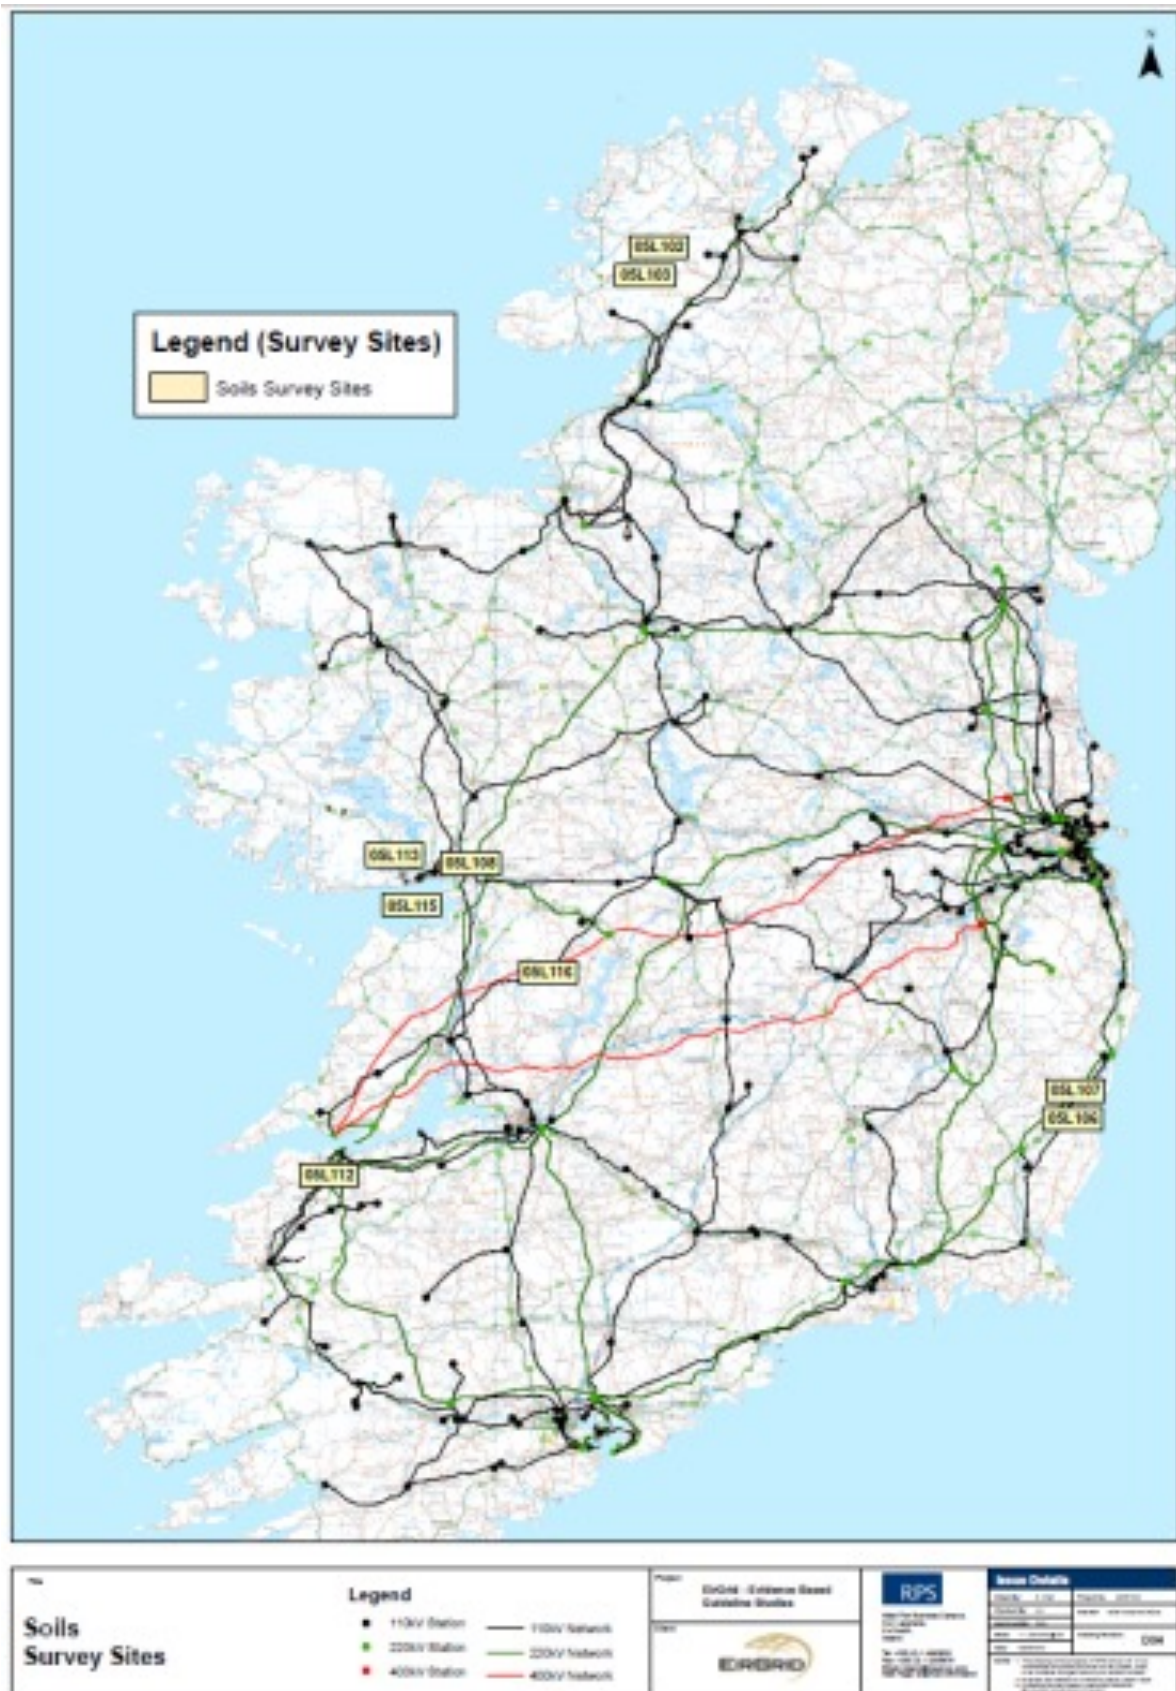
Figure 5.1 Soil and Geology Study Sites

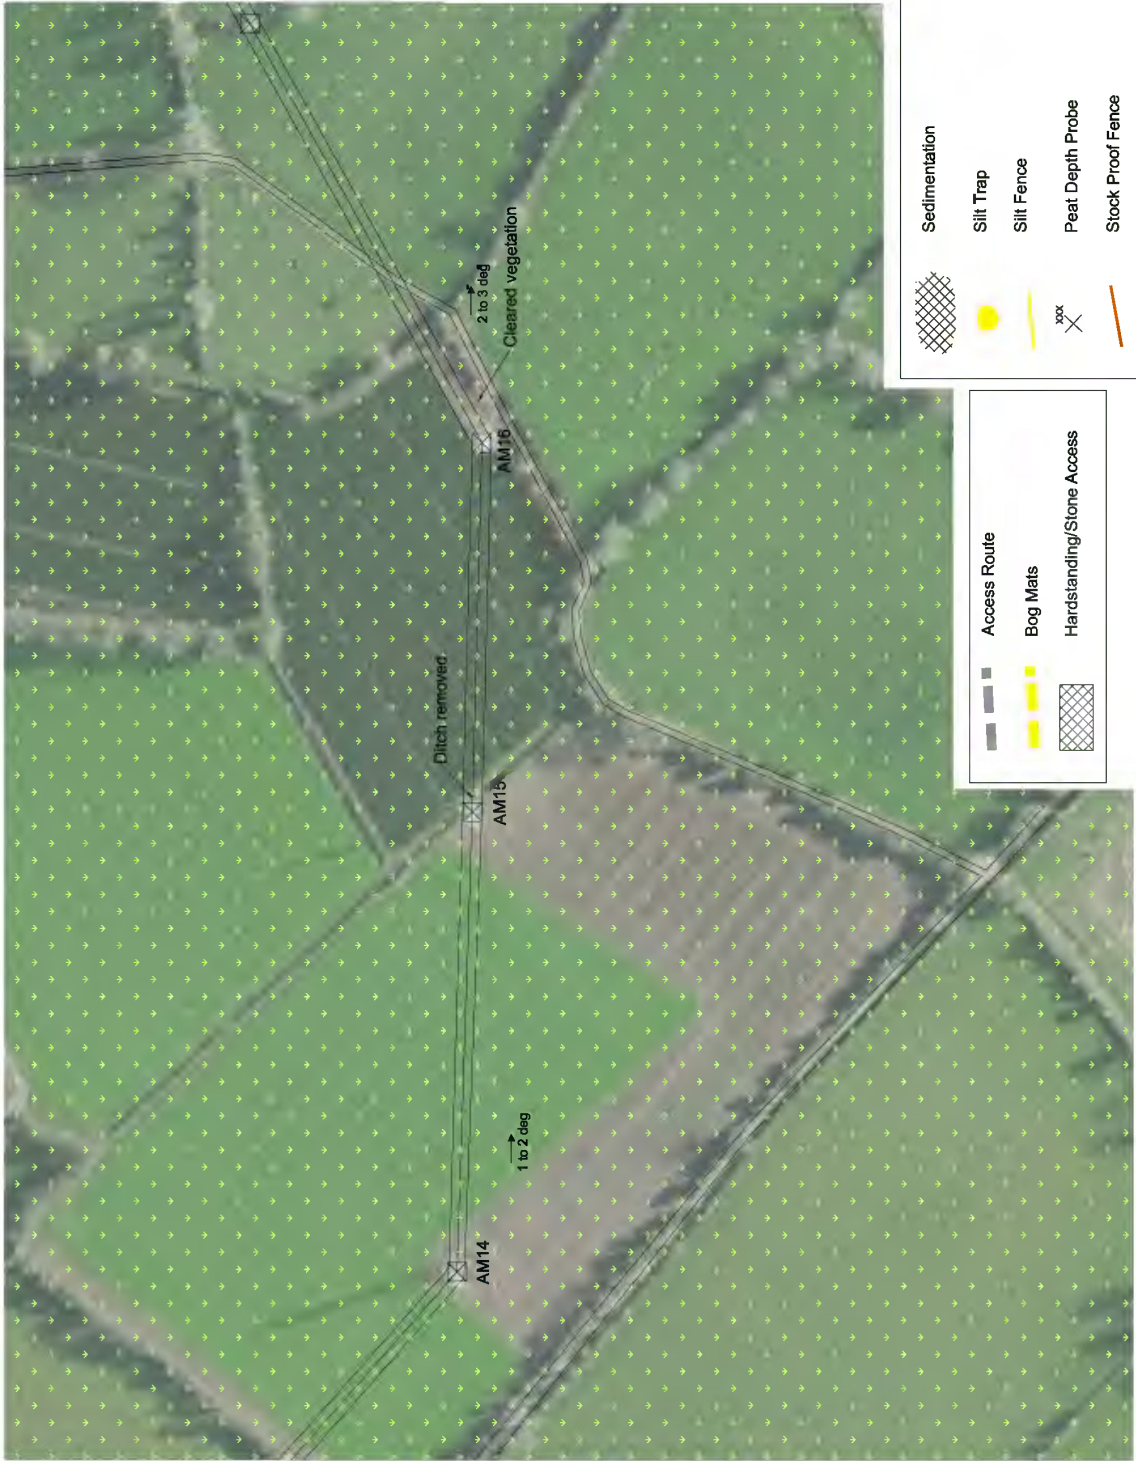
Project: Evidence Based Studies - Soils and Geology	Issue Details		Office Use Only	
	Title: Standard Site - During Construction - Connemara 110kV IMP5 and 7	Drawn: GMcl Checked: WO Approved: GMcl Scale: NTS Date: 01/05/13	Job No. MDE1020 File Ref. MDE1020DG0002 Fig No. DG0002	Rev. D01

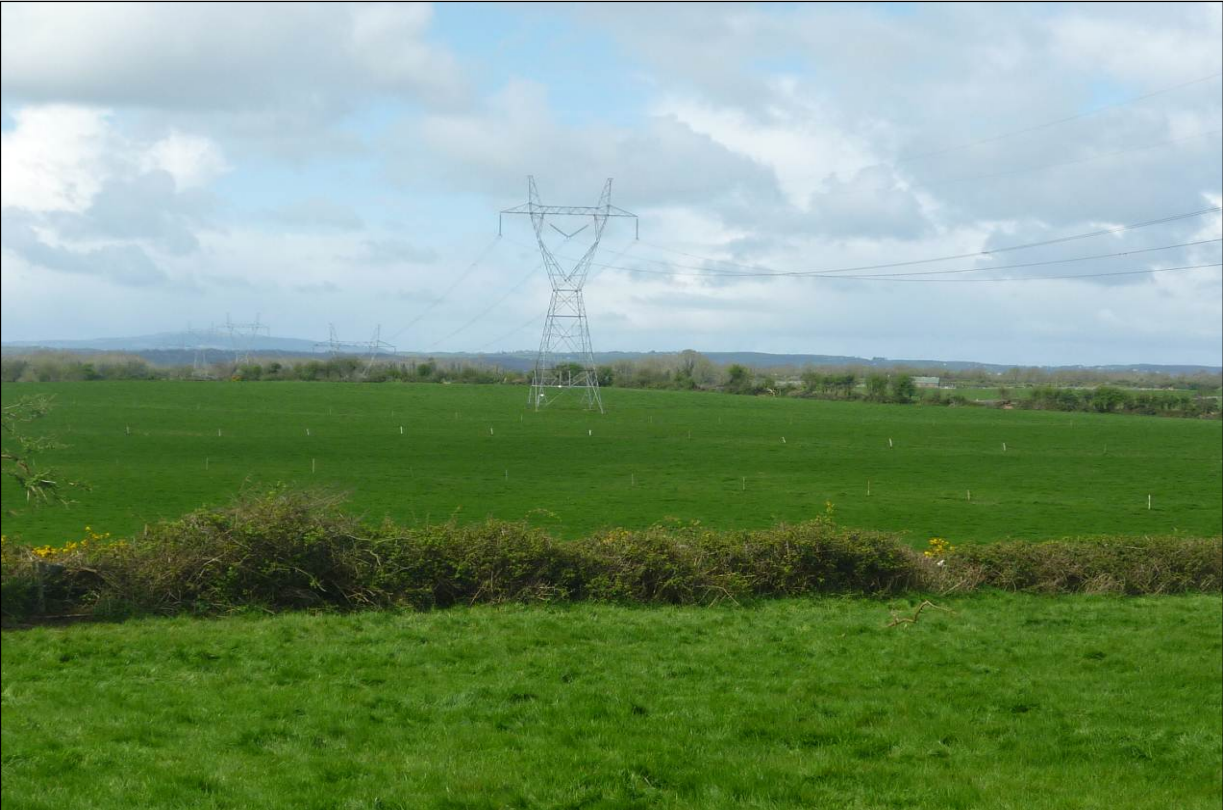
Example of a 400 kV intermediate tower design along the Dunstown-Moneypoint overhead line, Co Clare

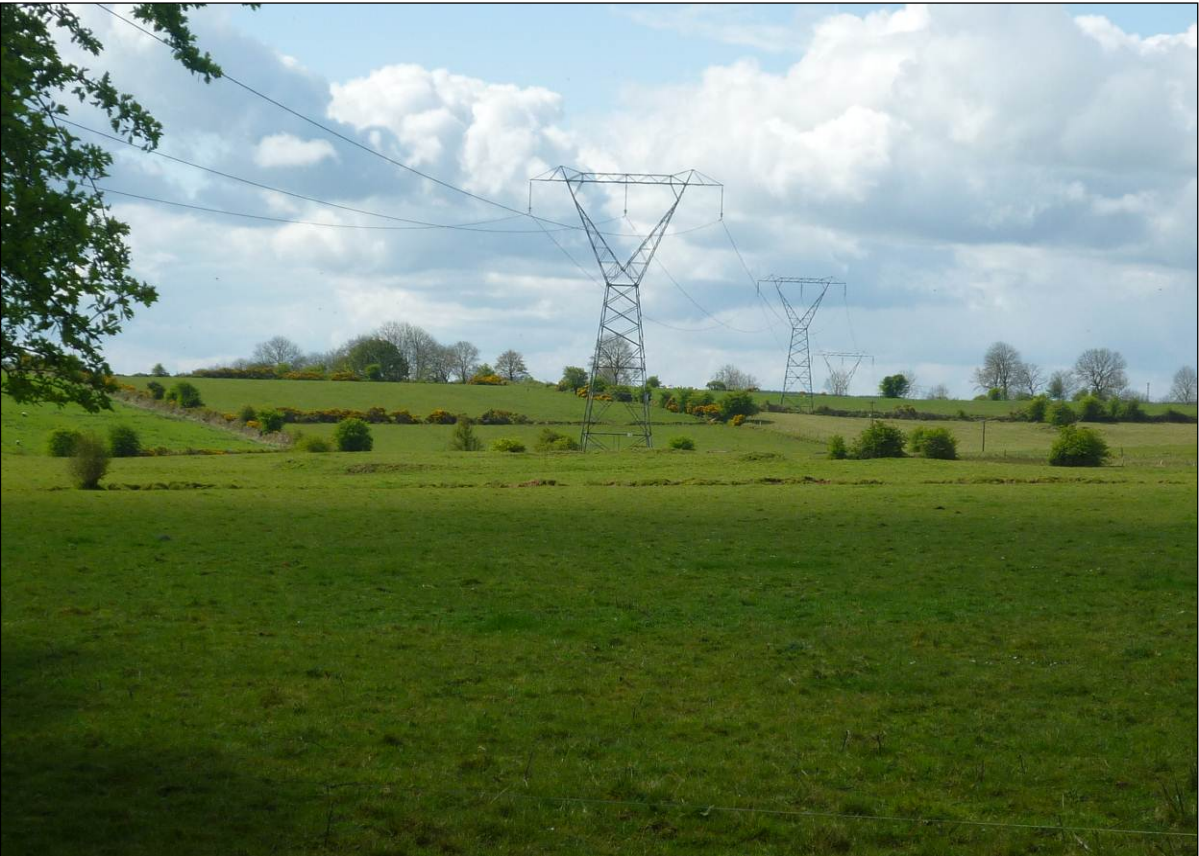
Example of a 220 kV intermediate tower design along the Cashla – Flagford overhead line, Co Roscommon

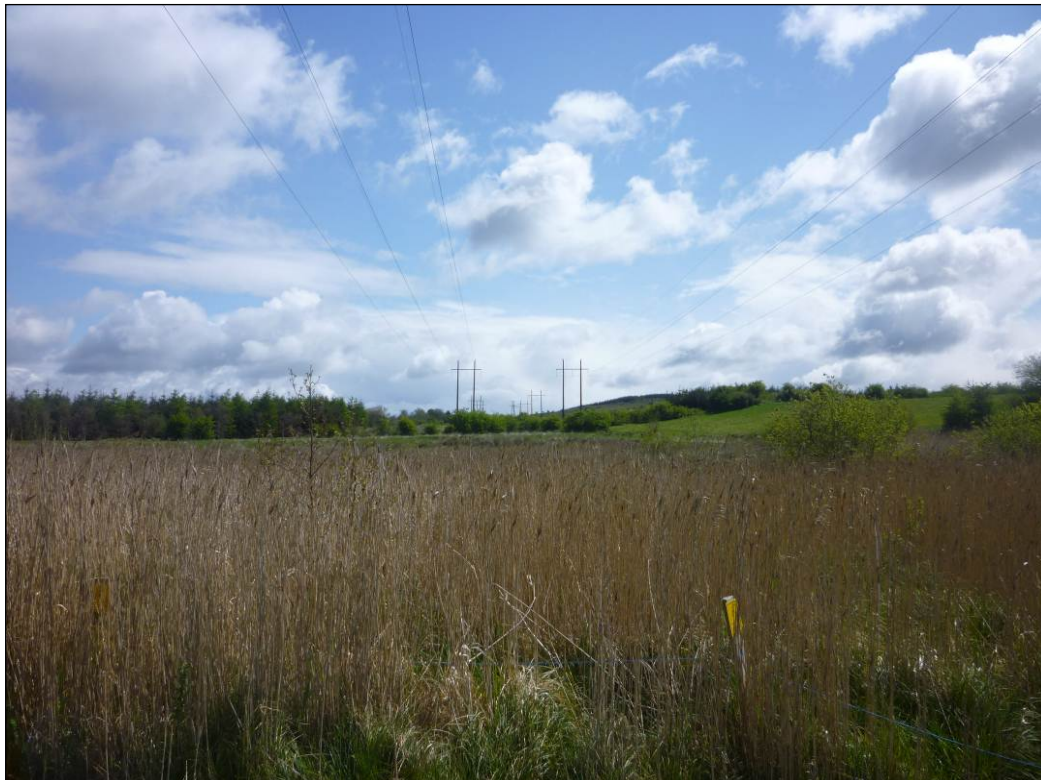
Example of a typical 110kV single-circuit double wood polesets with earthwire (Co Sligo)

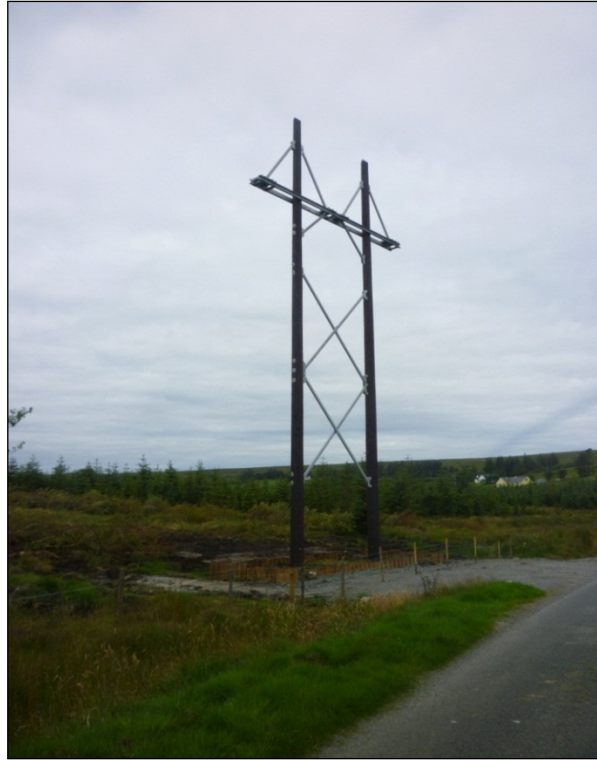
Braced double wood poleset

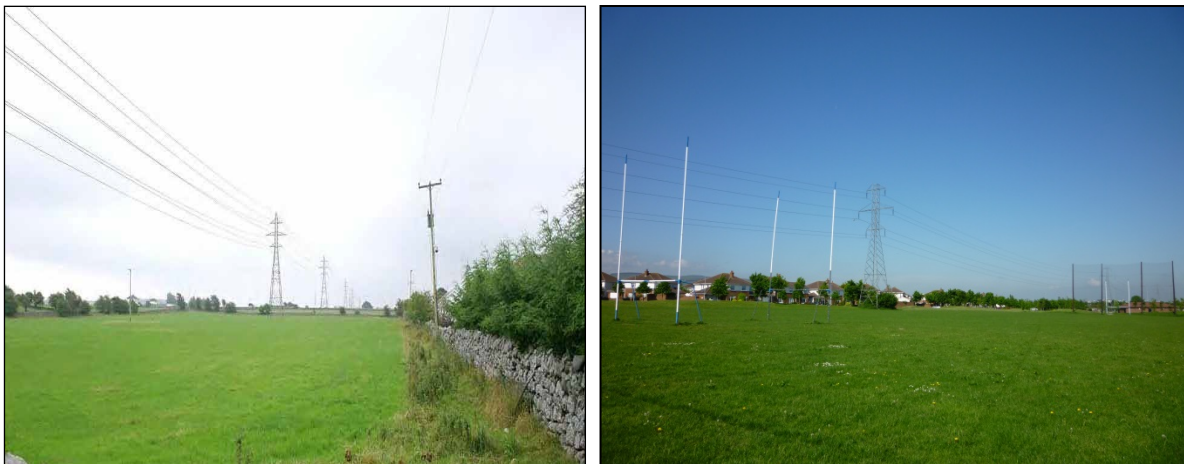
Double circuit alignments, including 110 kV overhead lines, always require to be supported by lattice steel towers. The average number of structures on a line is 3-4 per km depending on topography. In addition, the structures are higher, as each circuit must be carried in a vertical plane.

Typical 110 kV double circuit structures

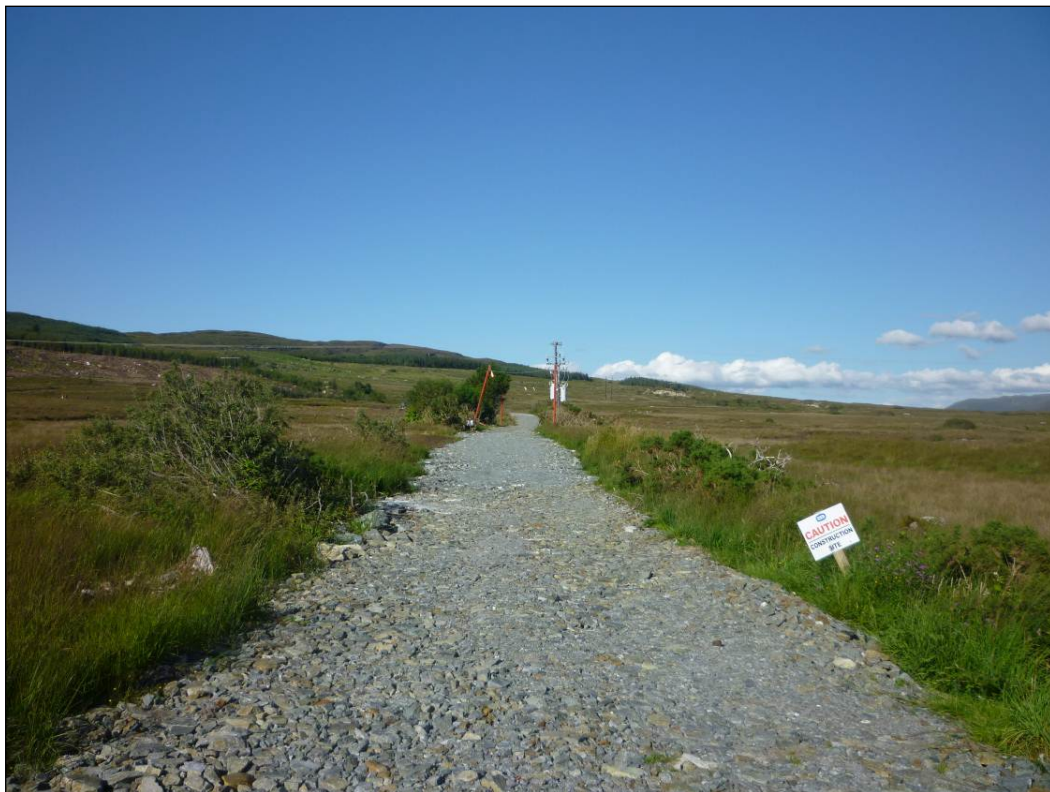
Example of a newly built access route for a transmission project, Co. Donegal

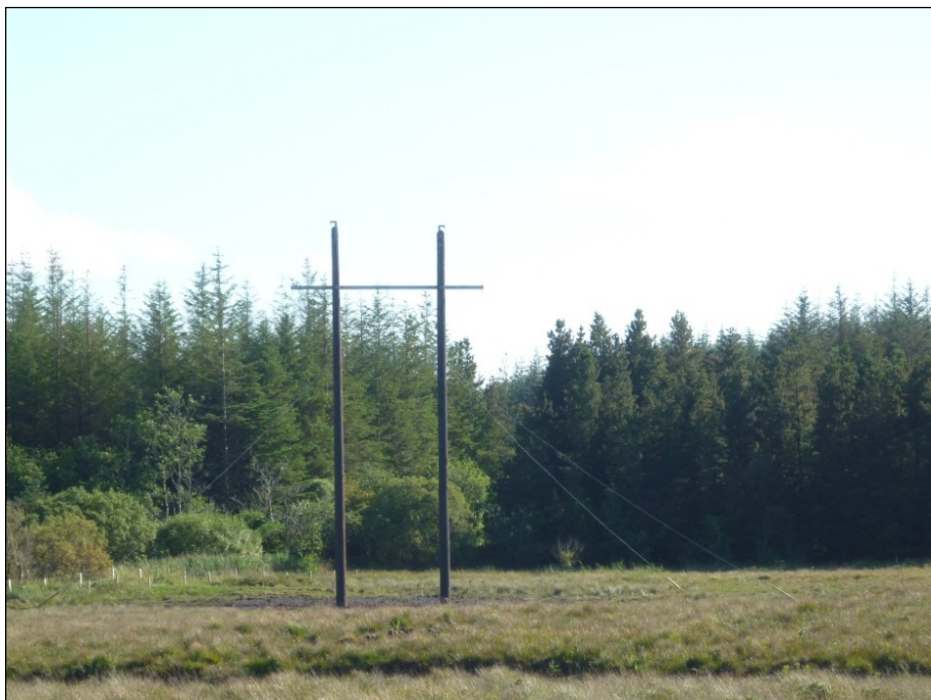
In addition to the excavation required for the poleset itself, where ground conditions dictate, stay lines may be required. This generally involves excavation of four trenches (approximately 2m x 2m x 1.8–2m deep) at a distance from the poleset. The installation of stay wires expands the area of disturbance associated with the erecting a poleset.

Stay lines in place, Donegal 110 kV Project

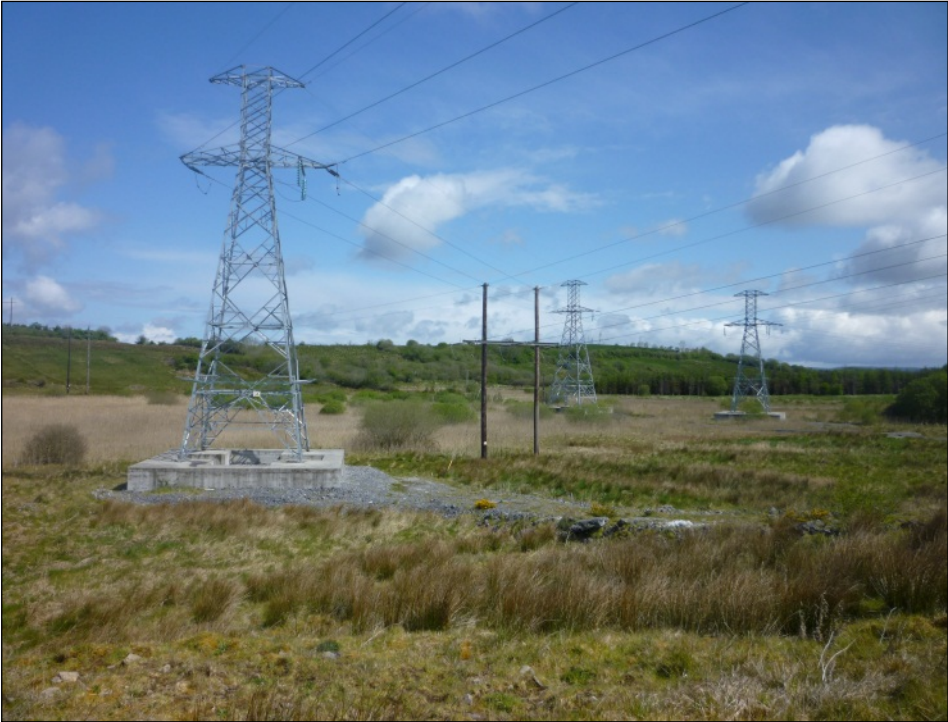
Concrete foundations are required for all steel towers. Foundation size and type is dependent on ground conditions and tower type, but is typically 4m x 4m x 3.1m for each foundation pad. The base installation time is approximately one week.

110kV angle towers at Srananagh Station with exposed substructures

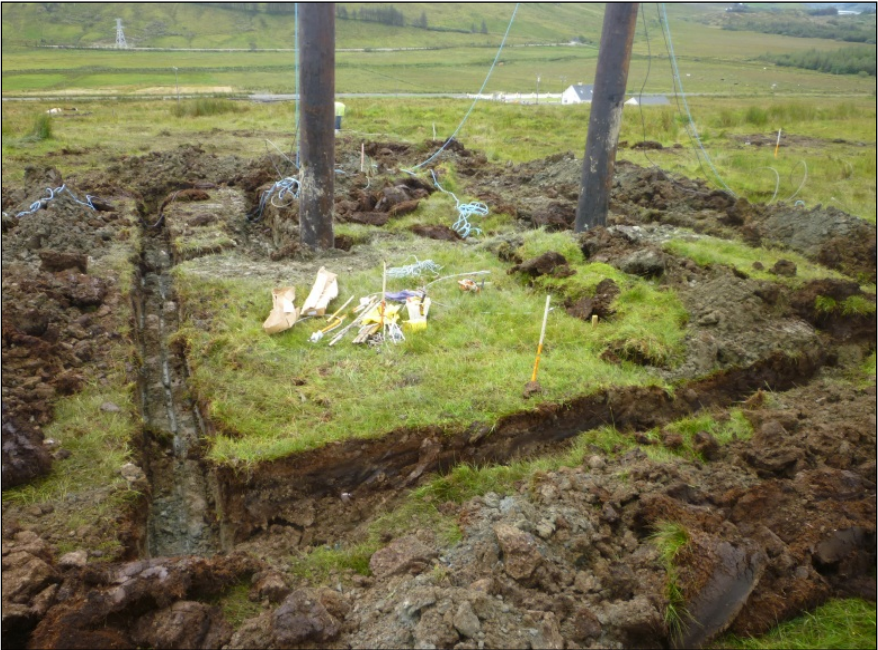
For all transmission lines with earth wires, there is a requirement to install an earth ring or mat at the base of the structure to ground the structure for safety reasons. The ground around the base of structures is excavated after conductors and earthwires are in place and the earth ring is installed.

Earth ring on Donegal 110kV Project

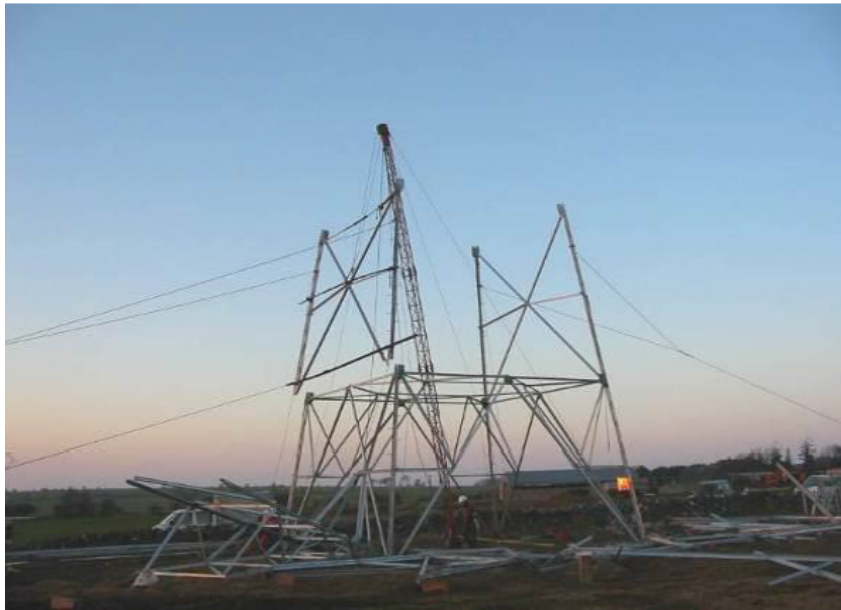
Tower erection can generally commence two weeks after the foundations have been cast. Tower steelwork is usually delivered to site and assembled on site.

Installation of tower using a derrick pole at the base

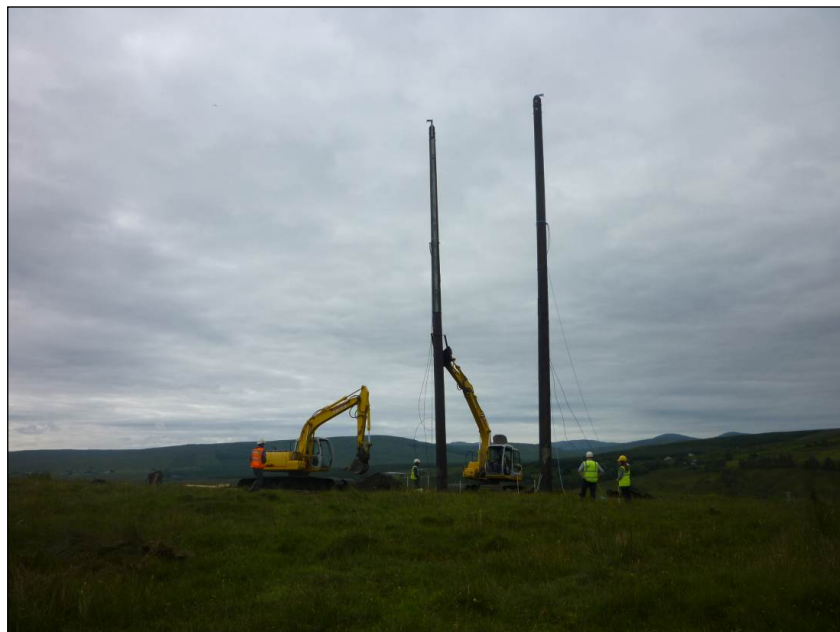
Construction of wooden pole set support structure for Donegal 110 kV Project (Binbane – Letterkenny)

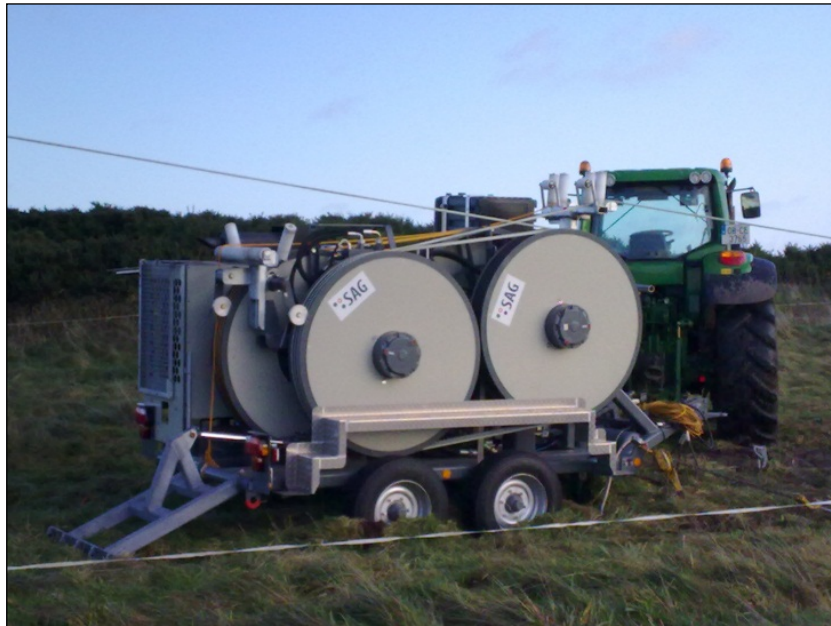
Once angle towers are erected, conductor stringing can commence, installing conductors from angle tower to angle tower via the line intermediate structures. Conductor drums are set up at one end of the straight with special conductor stringing machinery, and pulled from one end to the other.

Stringing Machine

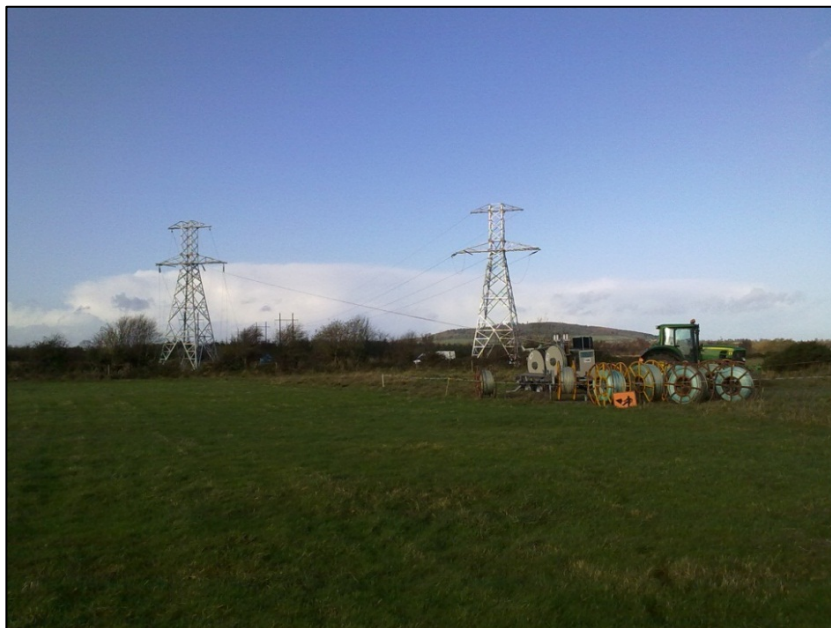
Conductor stringing equipment

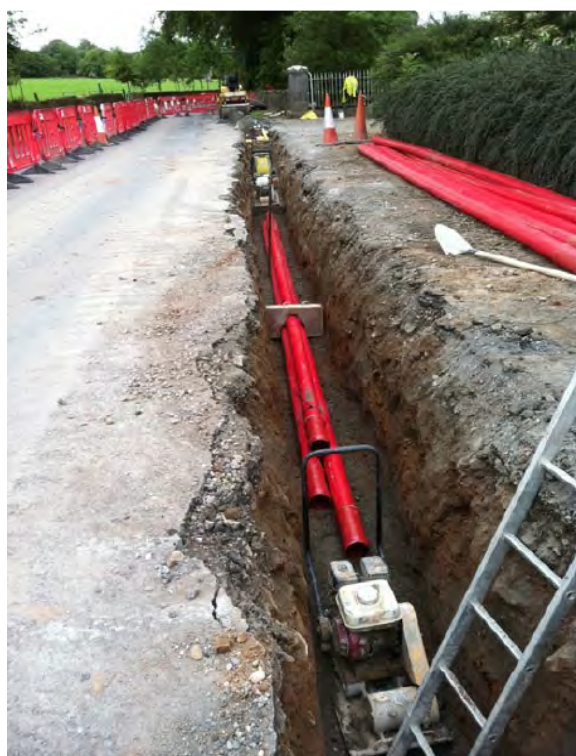
The cable is installed directly into the ground in an excavated trench. The majority of high voltage cable routes are located along public roads and open spaces. It is very unusual for a cable route to cross private open ground but this may be the case on occasion. The civil contractor will scan the ground using a cable avoidance tool (CAT), carry out a visual inspection of existing services and compare the information with the utility service records which they will have obtained from the various service providers in advance. If any previously unidentified services are discovered the site engineer will adjust the cable route accordingly.

Typical 110kV Trench Excavation (Ducts in Trefoil Formation)

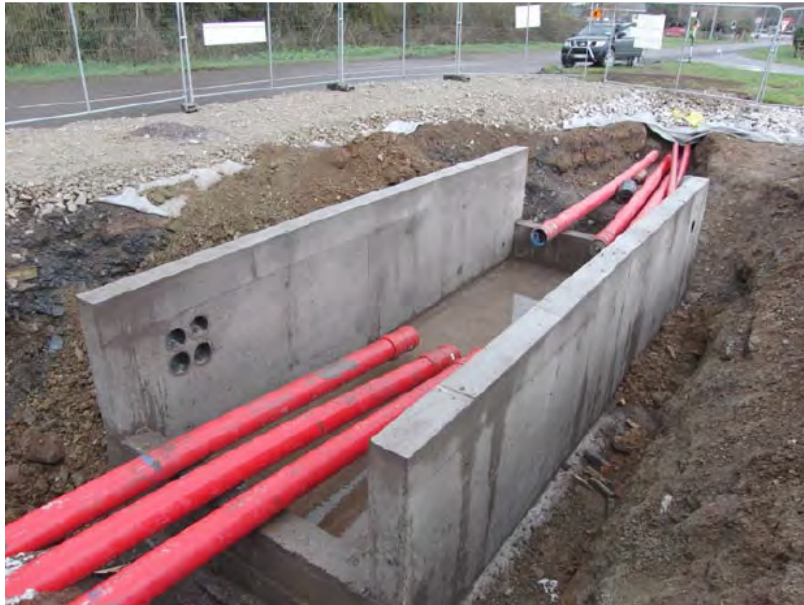
The overall installation of a cable route over a large distance is broken down into sections of cable that are connected using a cable joint. Cable joints are installed in joint bays which are typically concrete structures buried underground, occurring generally every 500–700m along an alignment, and ranging in size up to 6m long, 2.5m wide and 1.8m deep.

Typical Joint Bay Construction Adjacent to Public Road

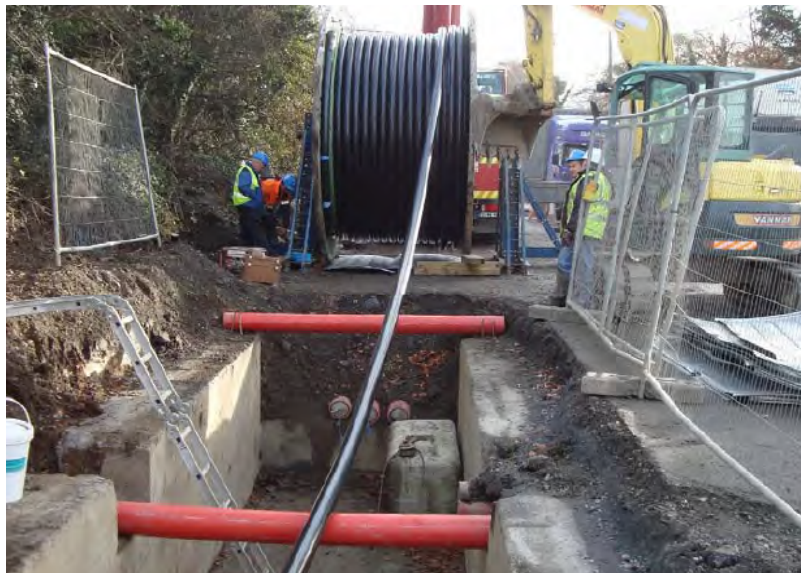
If the cable was installed directly in the ground the entire trench from joint bay to joint bay must be fully excavated. The advantage with installing cable in pre-laid ducts is that only a short section of cable trench, up to 100m is open at any time. This helps to minimise the impact on the local residents and minimise traffic impact at any given time.

Typical HV Cable Installation

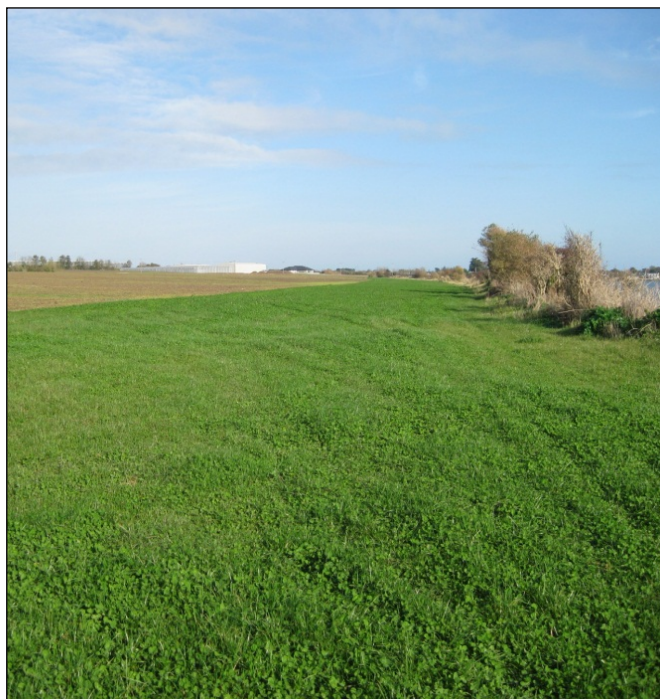
Once installed, the road surface is reinstated. Where a cable route is in an open area, it is returned to agricultural/grassland use. Where a cable passes through forested land the route is not replanted with trees to prevent any damage to the cable by tree root growth.

Re-growth following underground cable construction on agricultural land

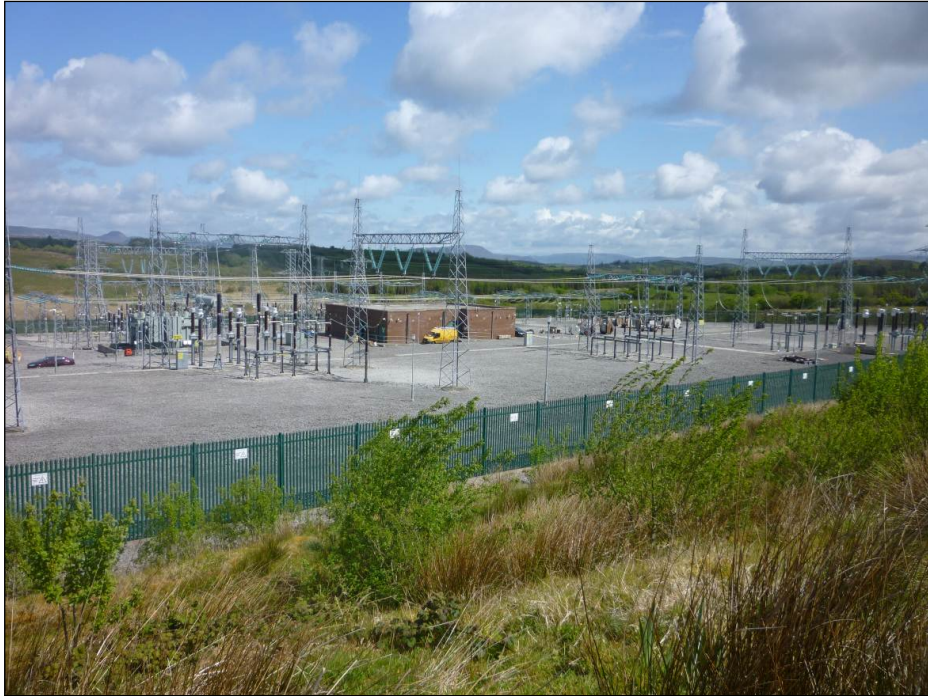
An Air Insulated Switchgear (AIS) substation is where the electrical equipment infrastructure is primarily installed outdoors, with the use of natural air as an insulation between circuits. This option requires a relatively large compound footprint.

Srananagh 220kV/110kV substation, Co Sligo, example of a typical outdoor AIS substation

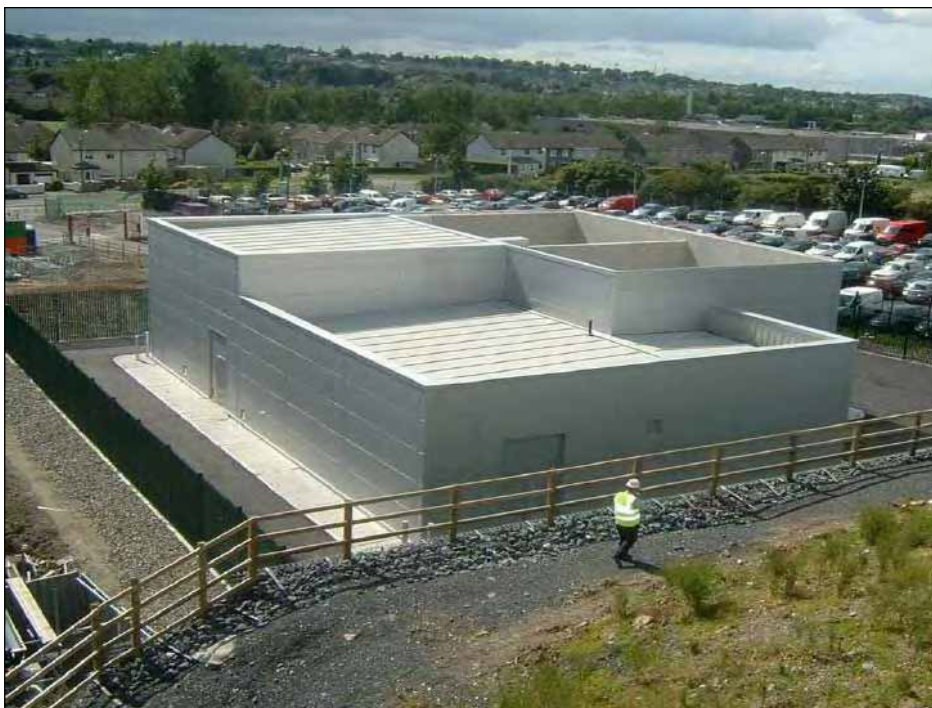
Both options require the associated provision of access roads off and onto the public road network and the provision of associated electrical equipment and infrastructure (including underground cables), as well as ancillary waste water treatment facilities and other site development and landscaping works. Both are therefore significant civil engineering projects.

Example of a typical indoor GIS substation, Co Limerick
