EirGrid Evidence Based Environmental Studies Study 6: Water Quality & Aquatic Ecology

Literature review and evidence based field studies on the effects of high voltage transmission lines on water quality and aquatic ecology in Ireland

May 2016

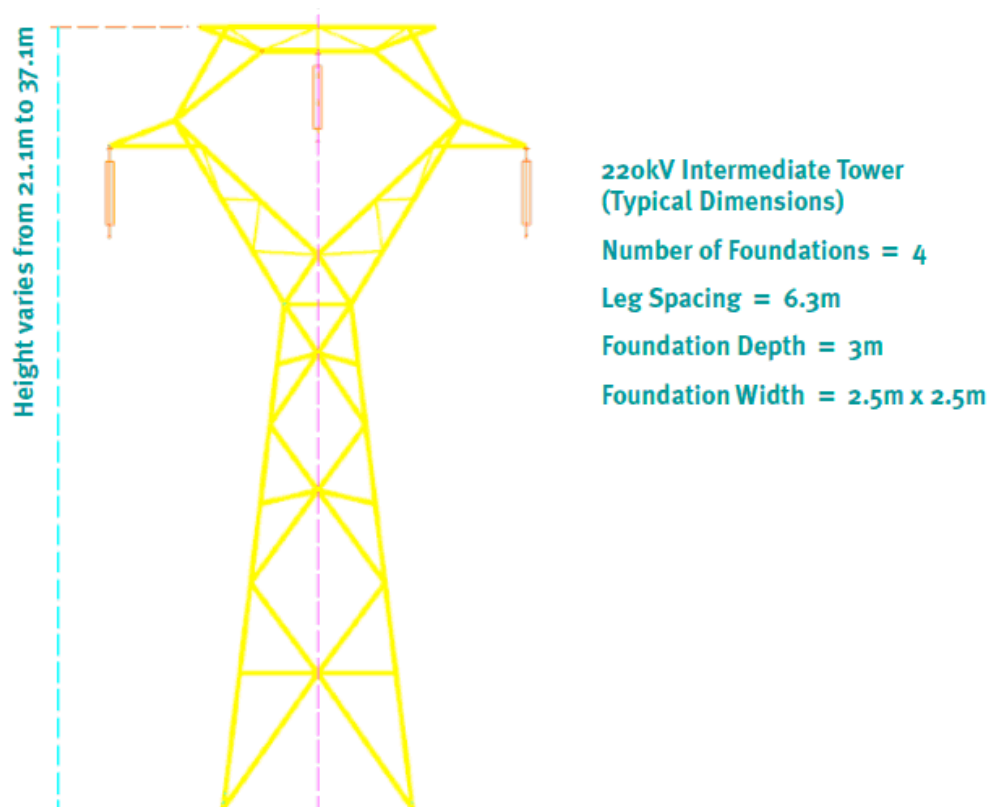
Key Design Features	Range
Height range	21.1m to 37.1m
Maximum width at ground level	8m to 14m
Number of foundations	4
Average span	320m

Figure 3.2 220kV Intermediate Structure – Typical Dimensions (after EirGrid, Ecology Guidelines for Electricity Transmission Projects)

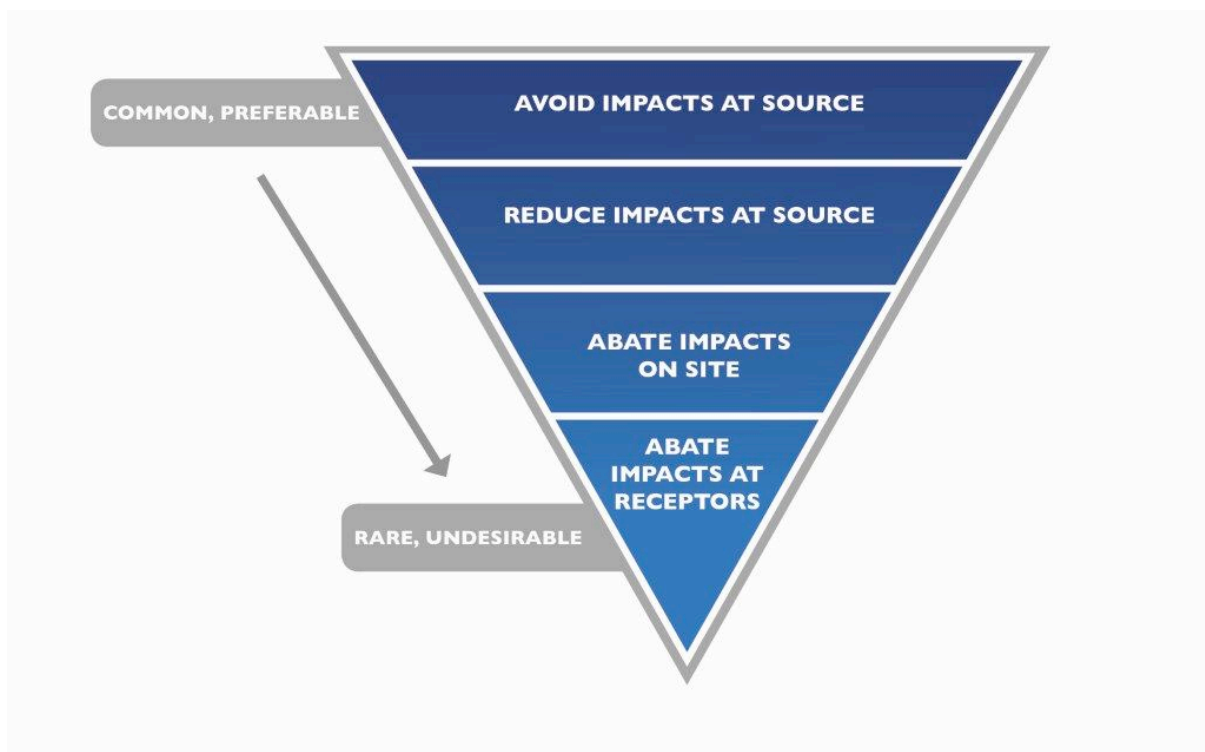
Mitigation should be considered in a hierarchy consisting of avoidance, minimisation, rehabilitation/restoration and compensation. Refer to Figure 4.1.

Figure 4.1 Schematic of Mitigation Hierarchy

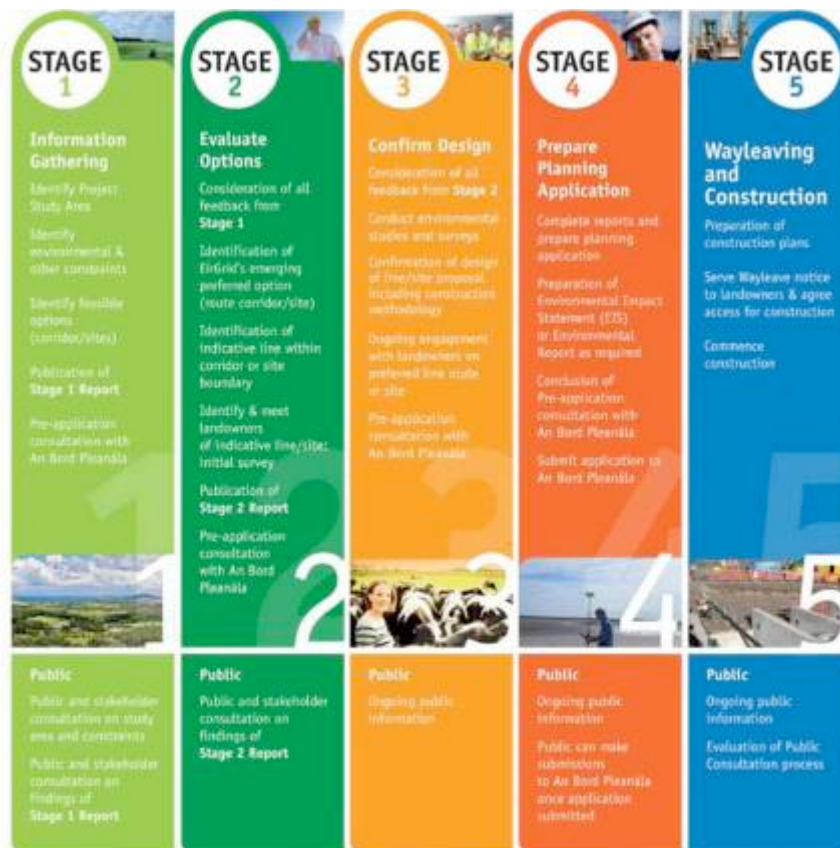
Figure 4.2 EirGrid's Project Development and Consultation Roadmap

Environmental considerations form part of EirGrid's strategy from the earliest stages of a project which is made evident in EirGrid's Project Development and Consultation Roadmap as shown in Figure 4.2. This roadmap approach illustrates that environmental and other constraints are identified in Stage 1, the Information Gathering Stage.

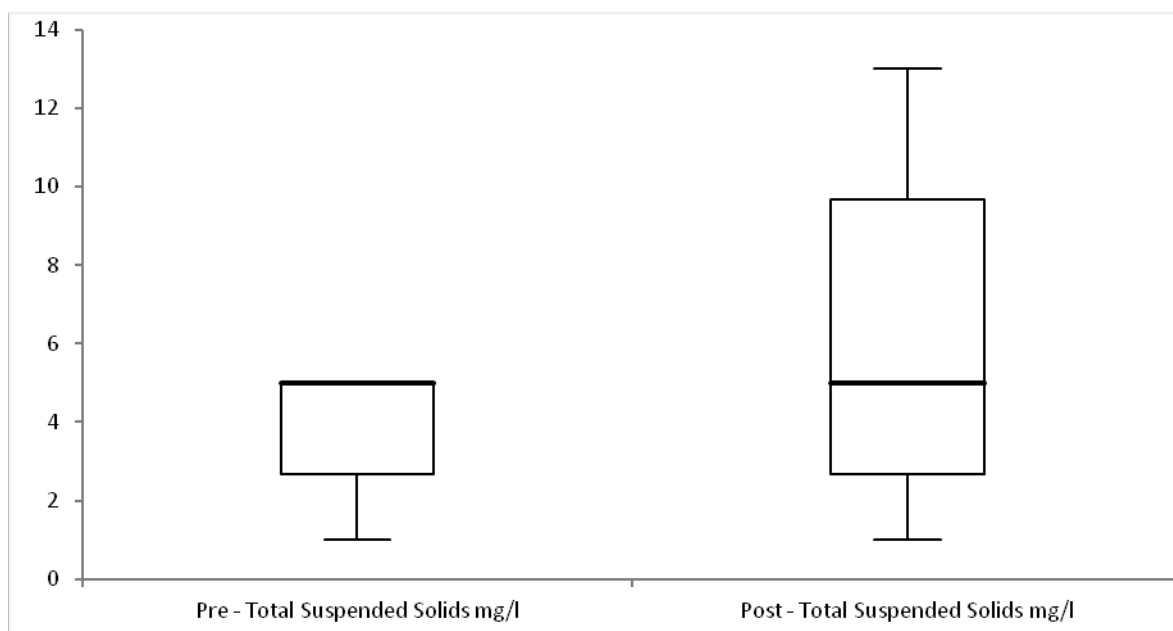
Figures 6.1 and 6.2 below shows the results of the Student's *t*-test analysis carried out on the monitoring results for TSS at both downstream and upstream sampling points respectively, suggesting no statistically significant difference. It is worth noting however that the low sample size (n-number) here affects the probability of detecting an effect, a factor which is accentuated by the high levels of variance.

Figure 6.1 Student t-test analysis on TSS results at AM78 downstream

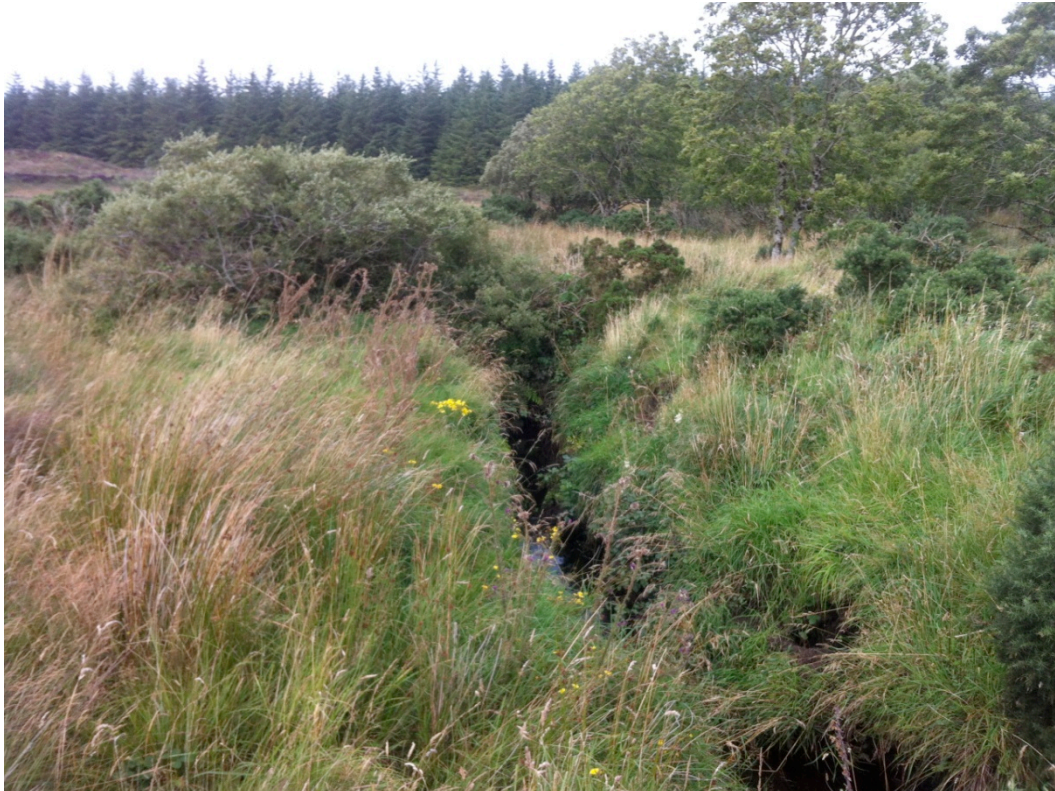
A regeneration of the right hand bank was noted, along with a return to the stability which would have been present prior to construction works, as illustrated in Plates 6.1 and 6.2. As a result, a Hydromorph score of 0.875 was recorded, showing an improvement from Good to High status since the original RHAT survey was carried out.

Plate 6.1 View looking upstream from right bank at AM78 highlighting bank stability and regeneration

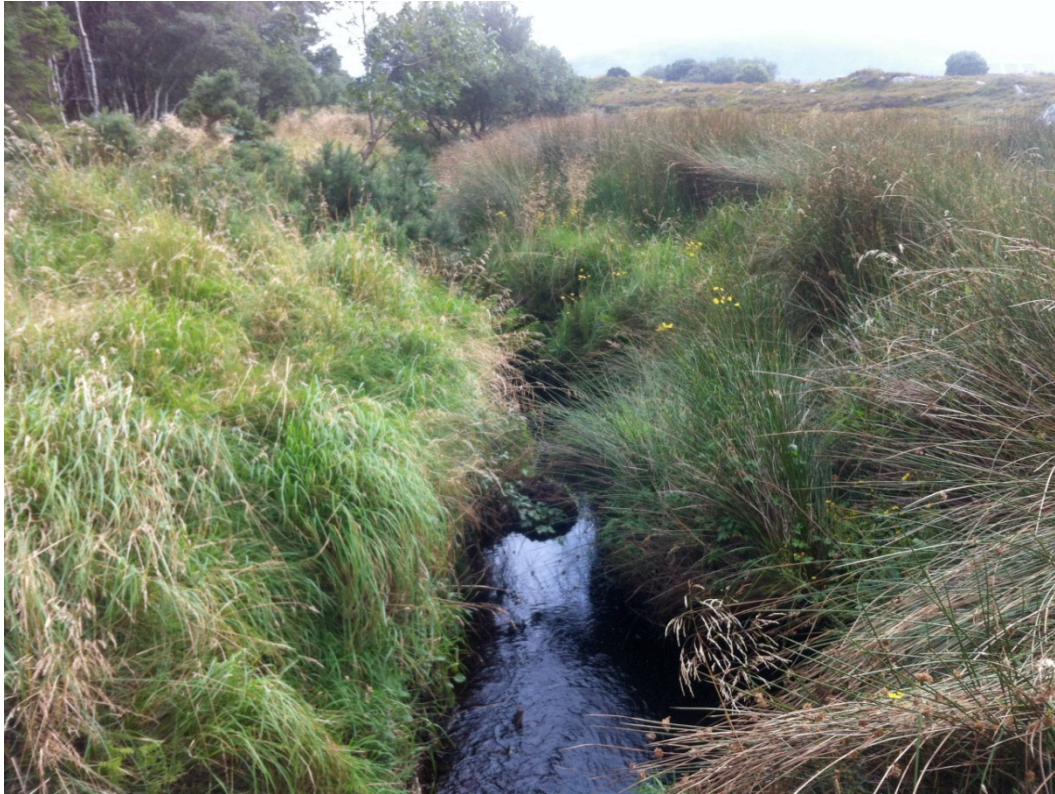
Plate 6.2 View downstream from right bank at AM78 highlighting recovery of bank

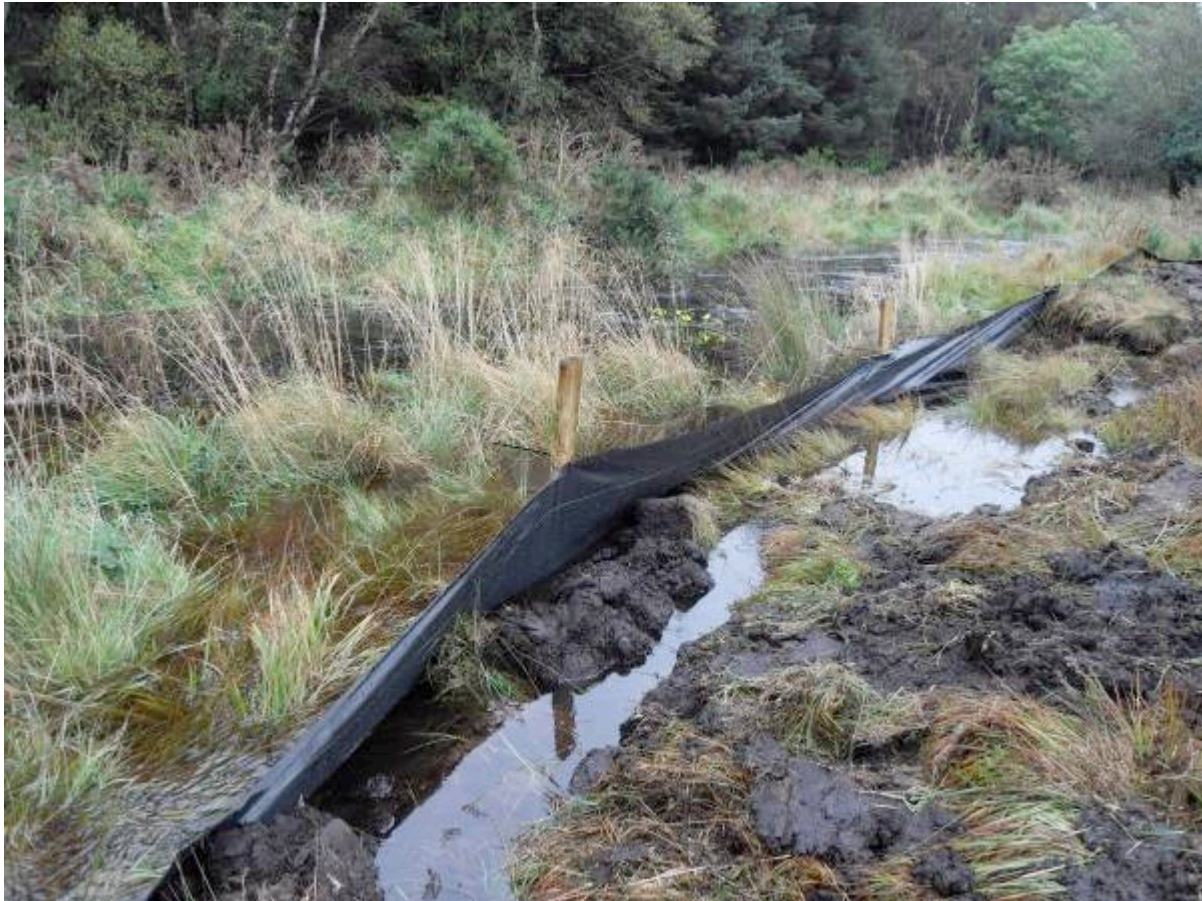
Suspended solids at the downstream site during post construction monitoring were elevated above those for the upstream site during high flow periods in particular. The proximity of the structure to the watercourse and the damage to the bank during site preparatory works have resulted in parts of the site flooding with associated increased run off which is detected in the suspended solids concentrations in the downstream monitoring station. Plate 6.3 below illustrates the damage to the bank and riparian zone and proximity of the site works to the tributary.

Plate 6.3 Site Clearance works at AM 78 and damage to riparian zone and bank structure

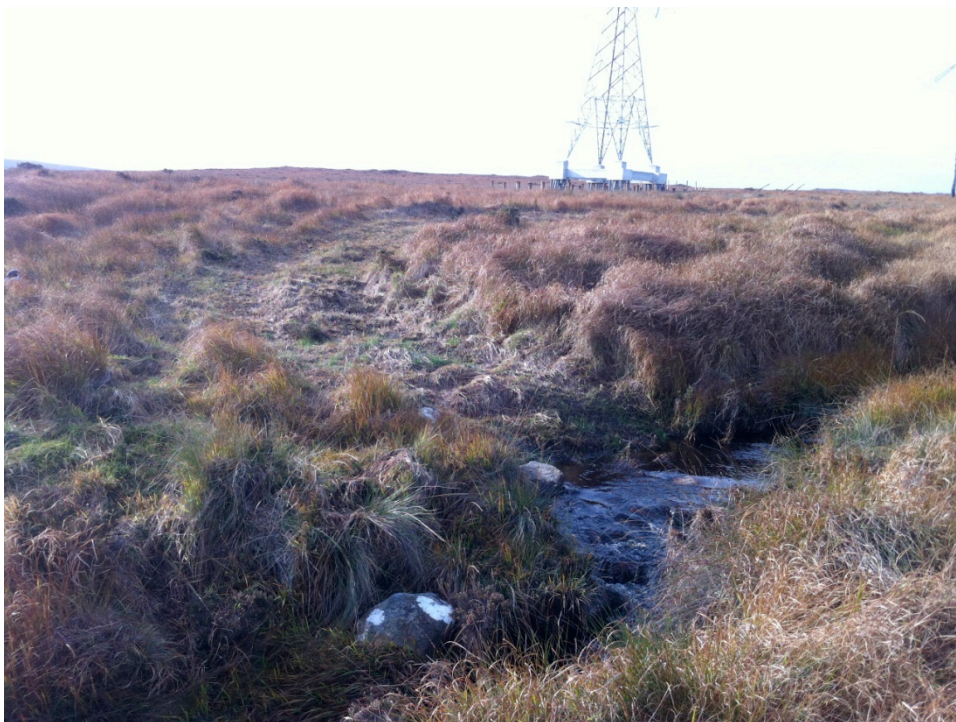
Plate 6.4 Minor physical impact downstream of AM173

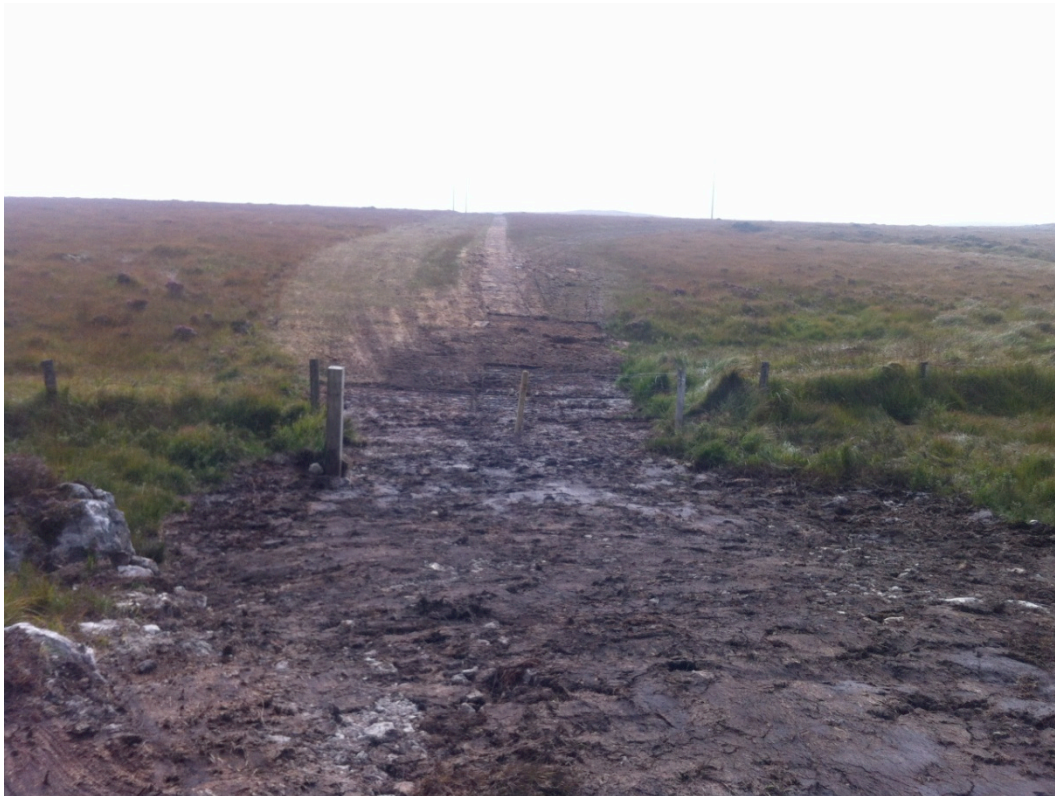
There were no anthropogenic impacts noted such as re-sectioning, embankments, culverts, channel dredging or animal poaching. The small section of the bank vegetation which had been impacted by a small crossing point of the channel during construction has now returned to a natural state, given the measures put in place at the time to minimise the impact of the crossing. The access routes to site and general area in the immediate vicinity of the structure have also recovered, with the comparison between during construction and post-construction shown below in Plates 6.5 and 6.6.

Plate 6.5 Ground disturbance during construction phase at AM173

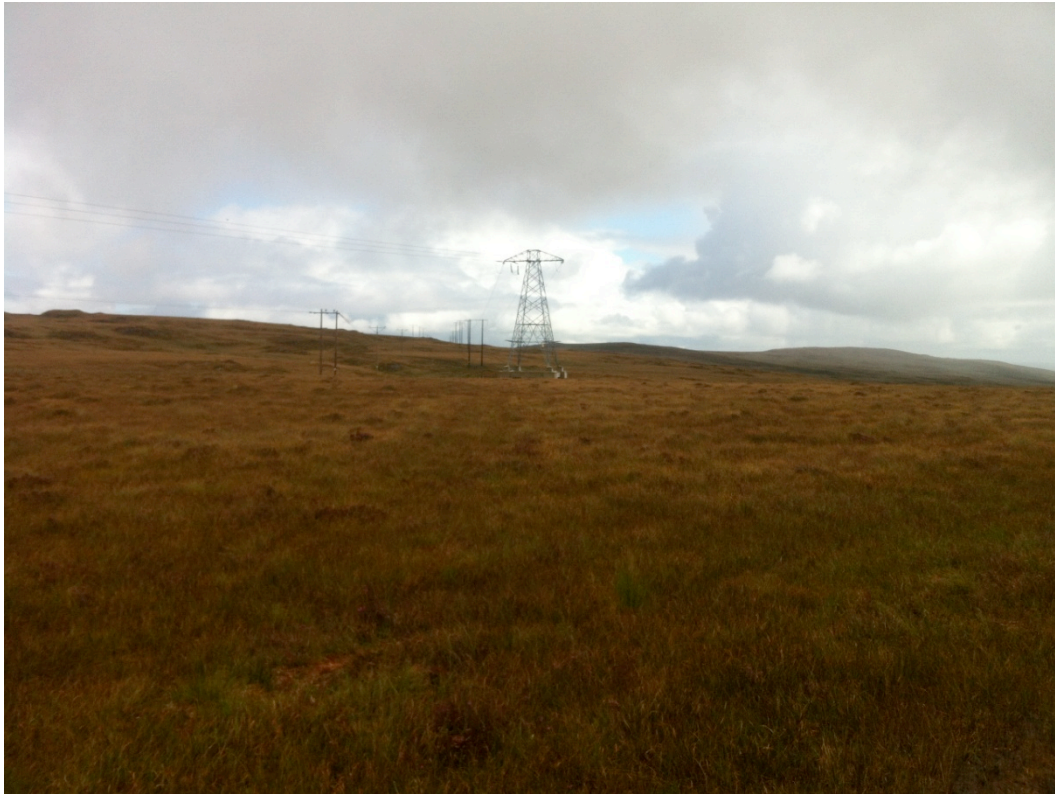
Plate 6.6 Evidence of ground recovery following use as access for construction of AM173

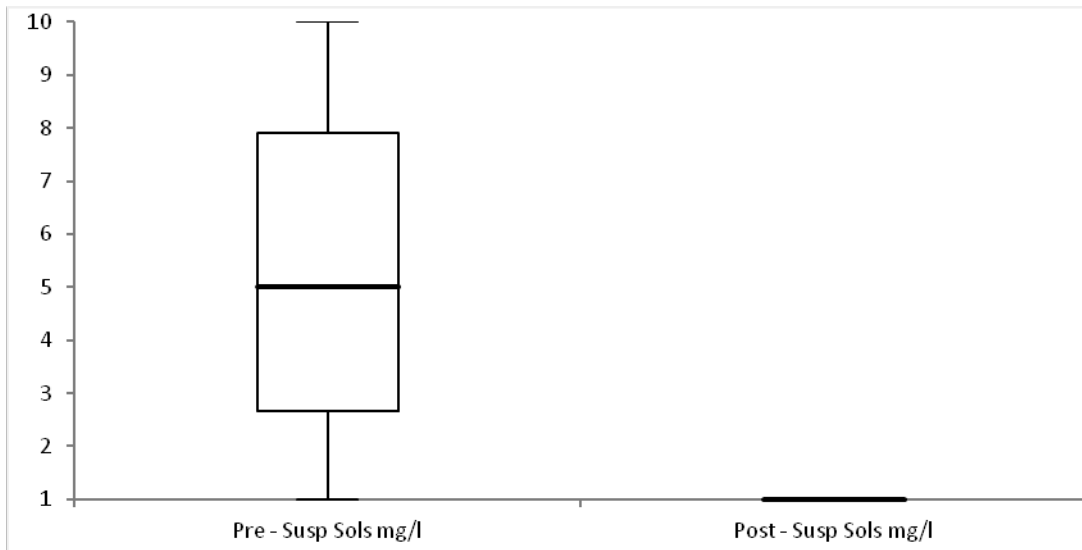
downstream monitoring location during the post-construction phase were found to be lower than those recorded upstream of the structure.

Figure 6.7 Student t-test analysis on TSS results at AM196 upstream

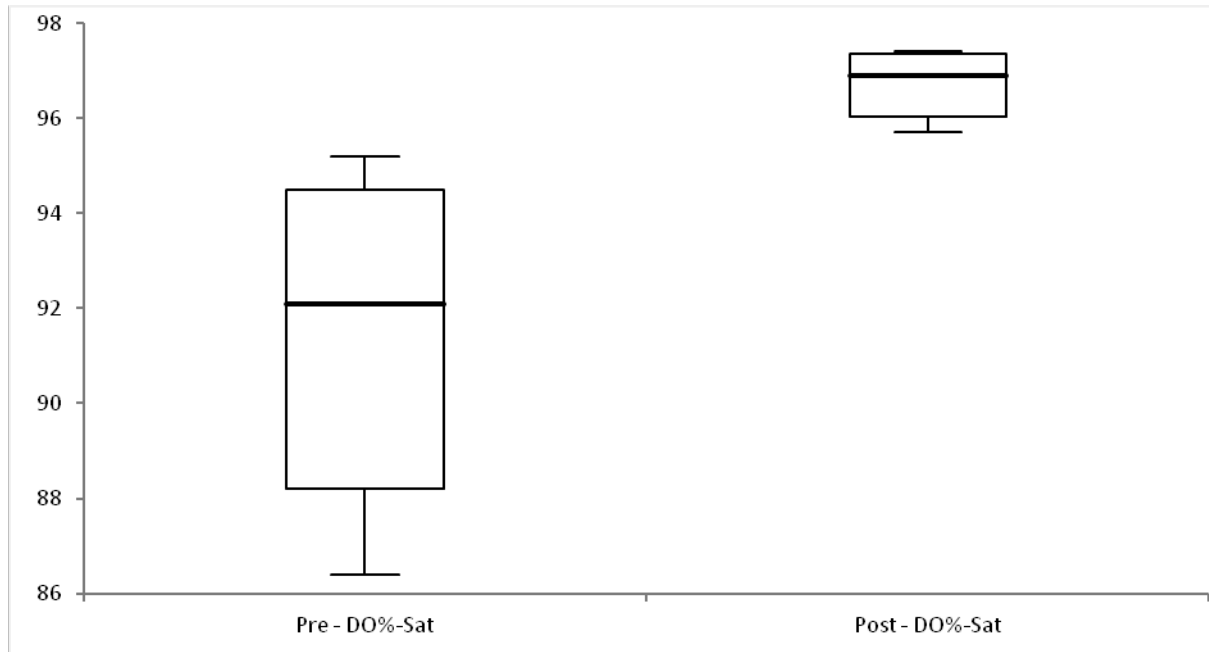
The only parameter which was found to display a statistically significant difference was in the levels of dissolved oxygen, as illustrated below in Figures 6.9 and 6.10. However, both results from both sites follow the same trend pattern, thus it can be accepted that there is no adverse impact as a result of the construction. Elevated levels of dissolved oxygen can often be associated with higher flows and the resulting increased turbulence. However, a further consequence of this would often result in increased turbidity readings and concentrations of suspended solids. As neither of these parameters were found to vary much across the range at AM196, it is more likely that the respiration of the abundant algae and aquatic fauna have contributed to the elevated levels of dissolved oxygen.

Student t test	
Hypothesized difference	0
t statistic	3.45
DF	3
p-value	0.0410

Figure 6.9 Student t-test analysis on DO (% sat) results at AM196 upstream

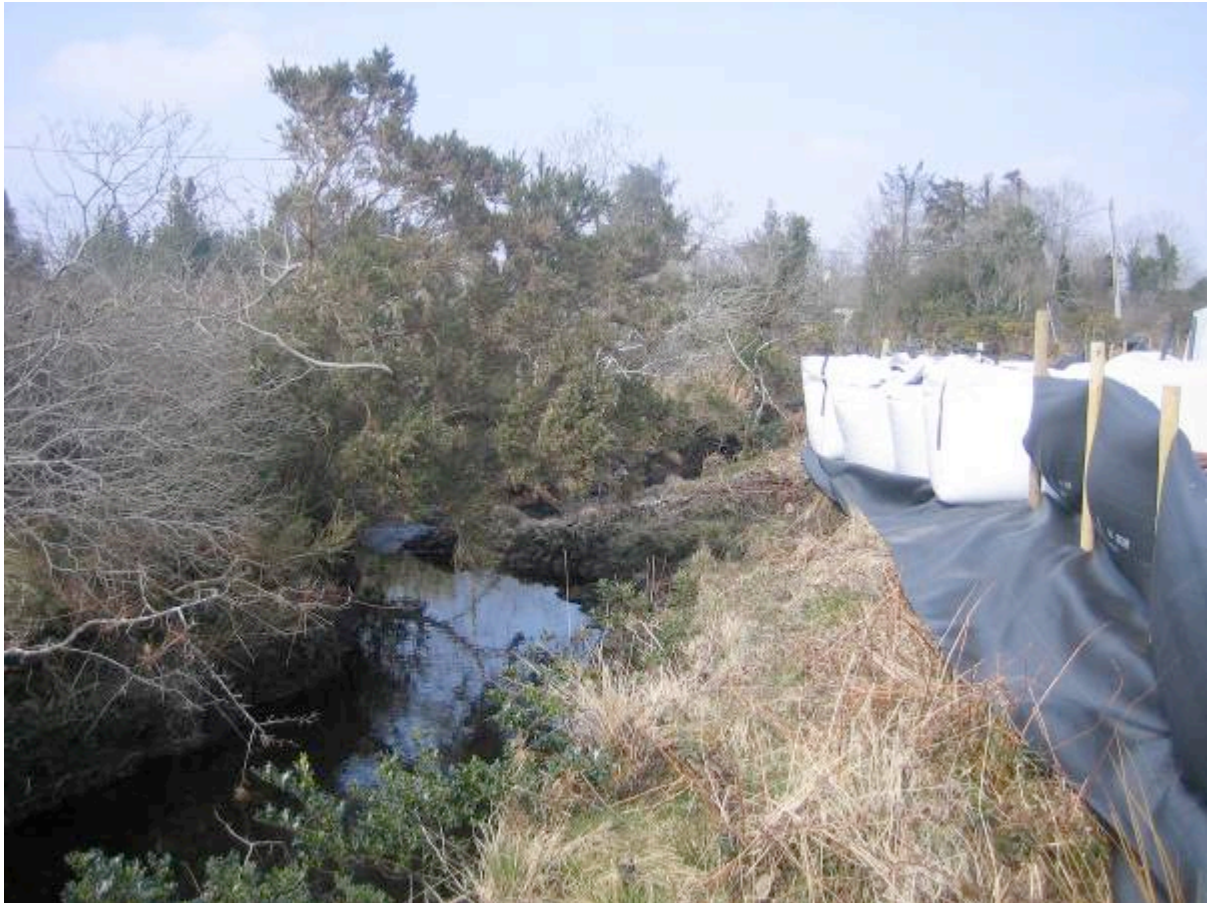
There were no anthropogenic impacts noted such as re-sectioning, embankments, culverts, channel dredging or animal poaching outside of the construction footprint. However at the construction site the development footprint and ground disturbance has resulted in an alteration to the right bank structure/stability due to the location of the angle mast immediately adjacent to the river (Plate 6.7).

Plate 6.7 Riparian zone modifications at Owenwee River AM196

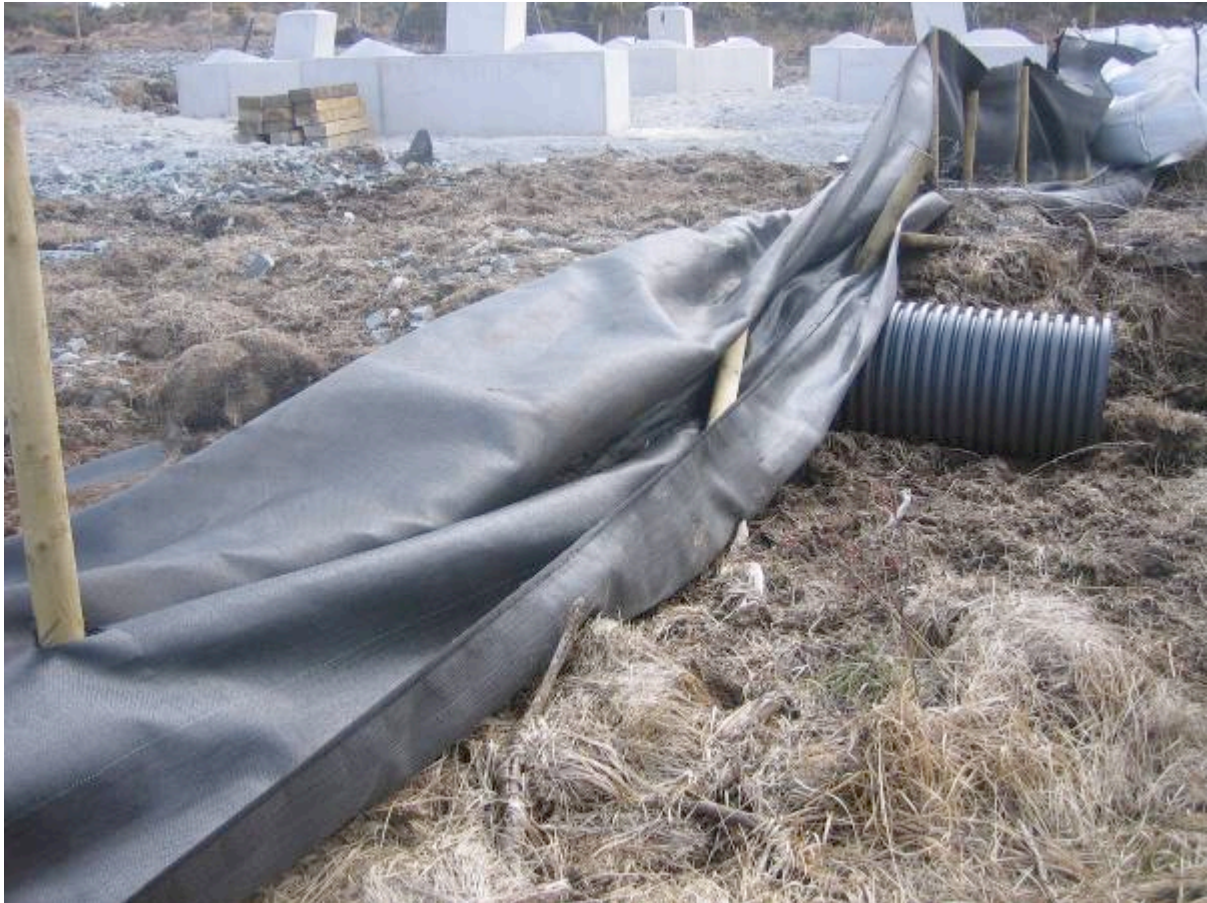
Control measures in the form of a single silt fence and a series of one tonne gravel bags over a distance of 20m were put in place to mitigate potential site run-off. The silt fencing was found to be inadequate allowing peat laden water to filter underneath it where it follows a preferential flow path to a pipe discharging from the site towards the river (Plate 6.8).

Plate 6.8 Silt fence bypassed by pipe which was a source of peaty silt

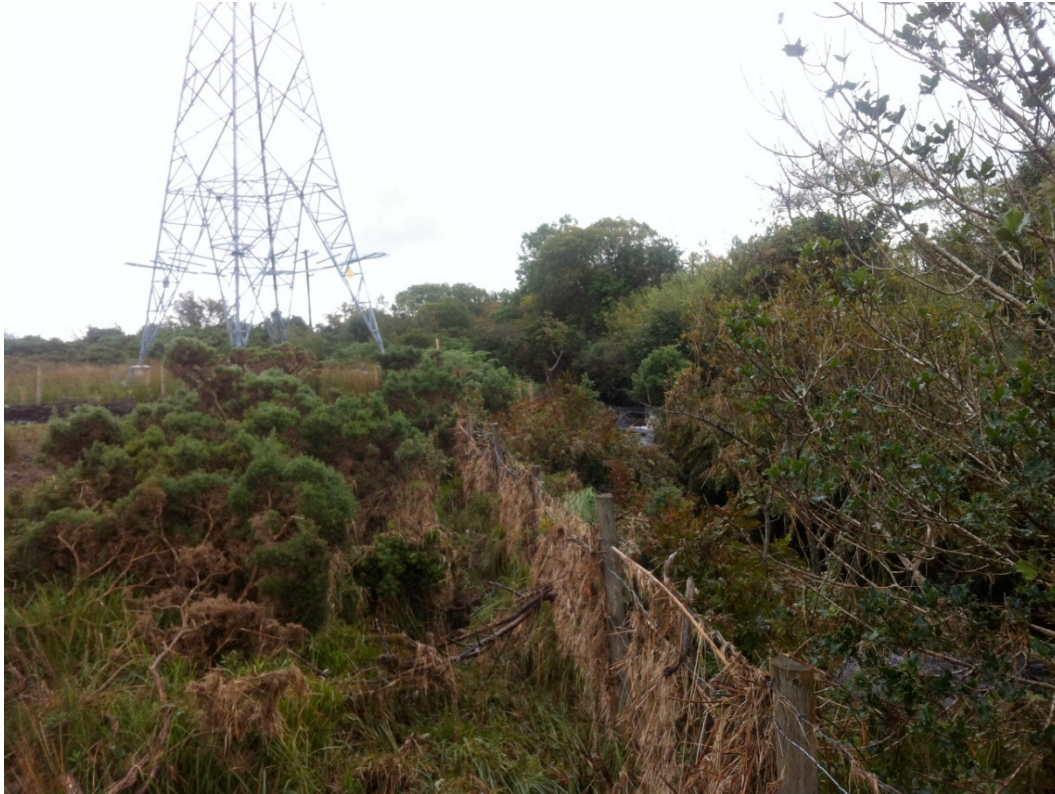
This RHAT survey also closely examined the possibility that these impacts were still prevalent, but noted significant regeneration of vegetation and re-establishment of bank stability and riparian cover, as shown in Plate 6.9.

Plate 6.9 Image showing successful recovery of bankside vegetation and stability at AM196

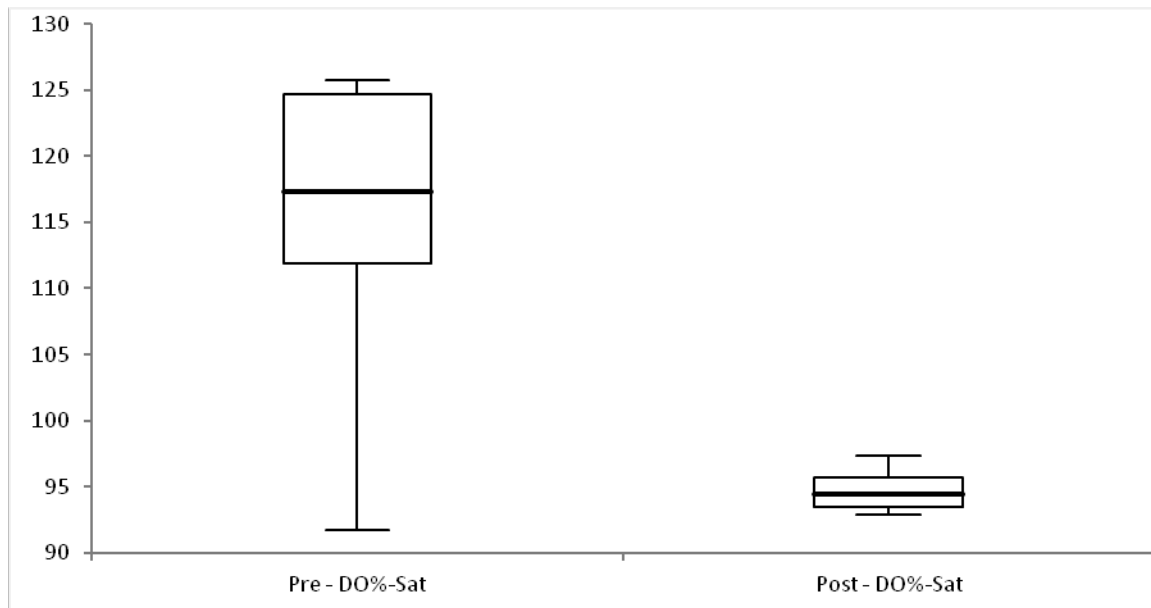
When applying a Student's *t*-test to the data, as shown in Figures 6.13 and 6.14, it can be stated that there is a statistically significant difference between the results. As previously stated, consideration should be given to the low sample size and the skewed distribution of the data as a result.

Student t test	
Hypothesized difference	0
t statistic	-3.78
DF	5
p-value	0.0129

Figure 6.13 Student t-test analysis on DO (% sat) results at AM119 upstream

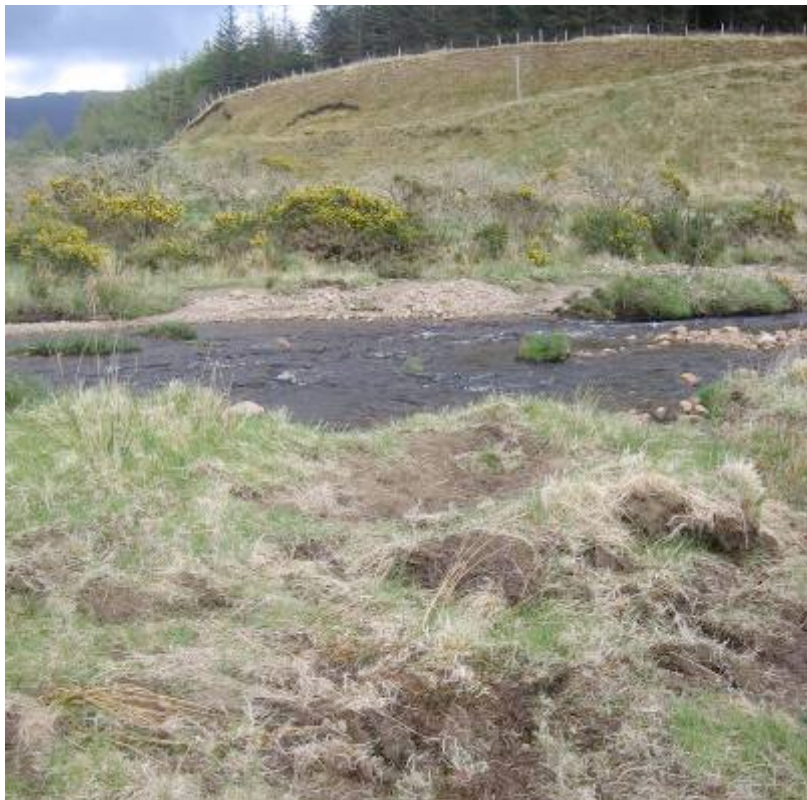
Plate 6.10 Fording area across Shallogan River

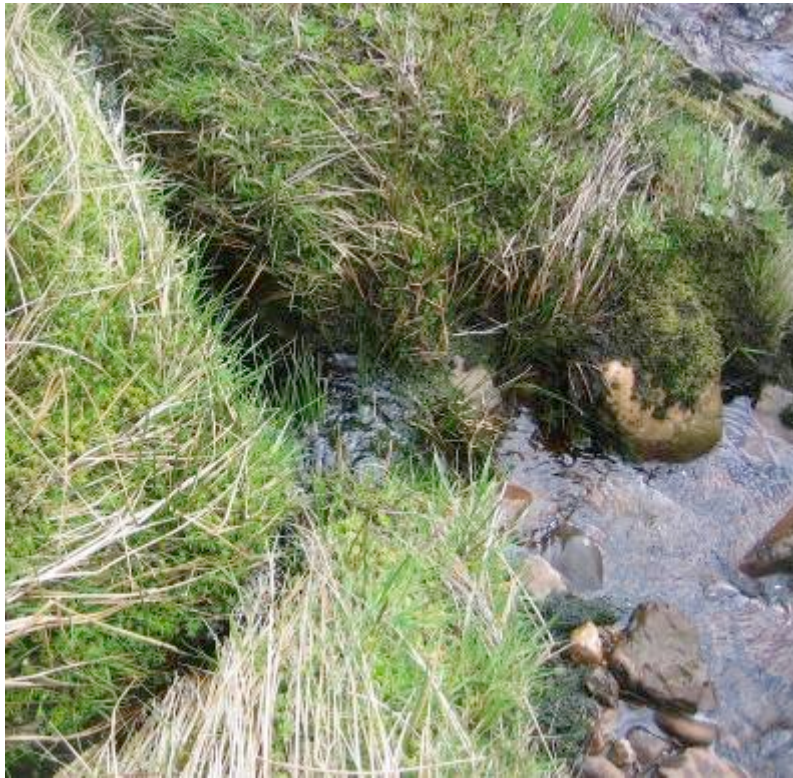
Plate 6.11 Forestry Drain discharging to main channel

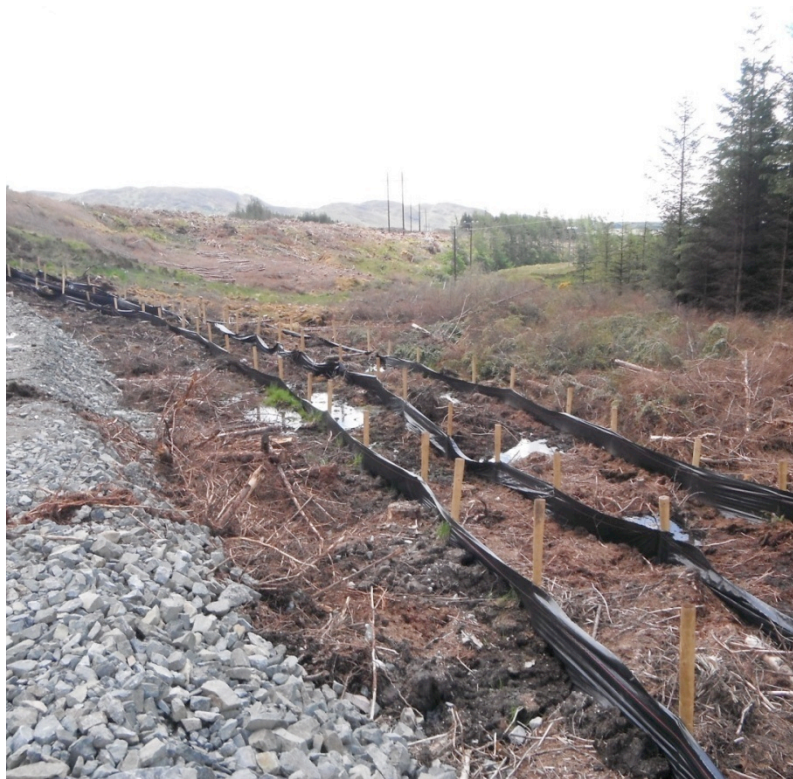
There has been no apparent impact from the construction of the angle masts and polesets upstream of this location where the structures run parallel to the tributary of the Shallogan River. This is demonstrated in both the physico-chemical and macroinvertebrate surveys, which are consistent with the EPA monitoring carried out in August 2012, and the RHAT survey which has identified other pressures along the reach that have resulted in a reduced morphological score. The occurrence of the forest drains means the forestry felling and access to accommodate the construction of AM119 could result in sediment and nutrient pressures with a direct pathway to the Shallogan River. However extensive silt trapping measures were deployed with a series of triple silt curtains installed around the site for the construction phase, as shown in Pates 6.12 and 6.13.

Plate 6.12 Silt curtain installation around AM119

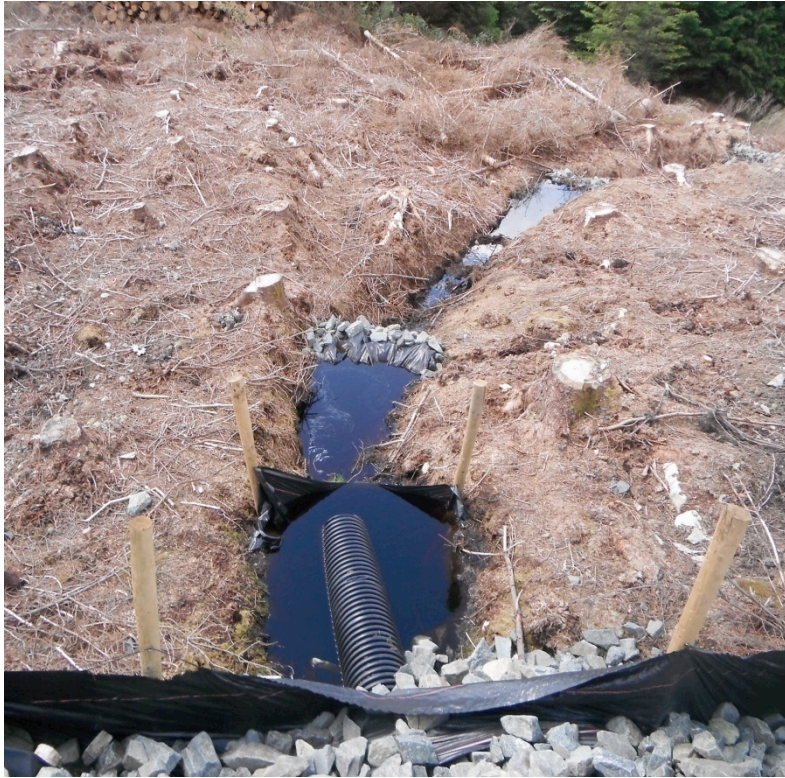
Plate 6.13 Silt curtains installed in drainage run-off from AM119

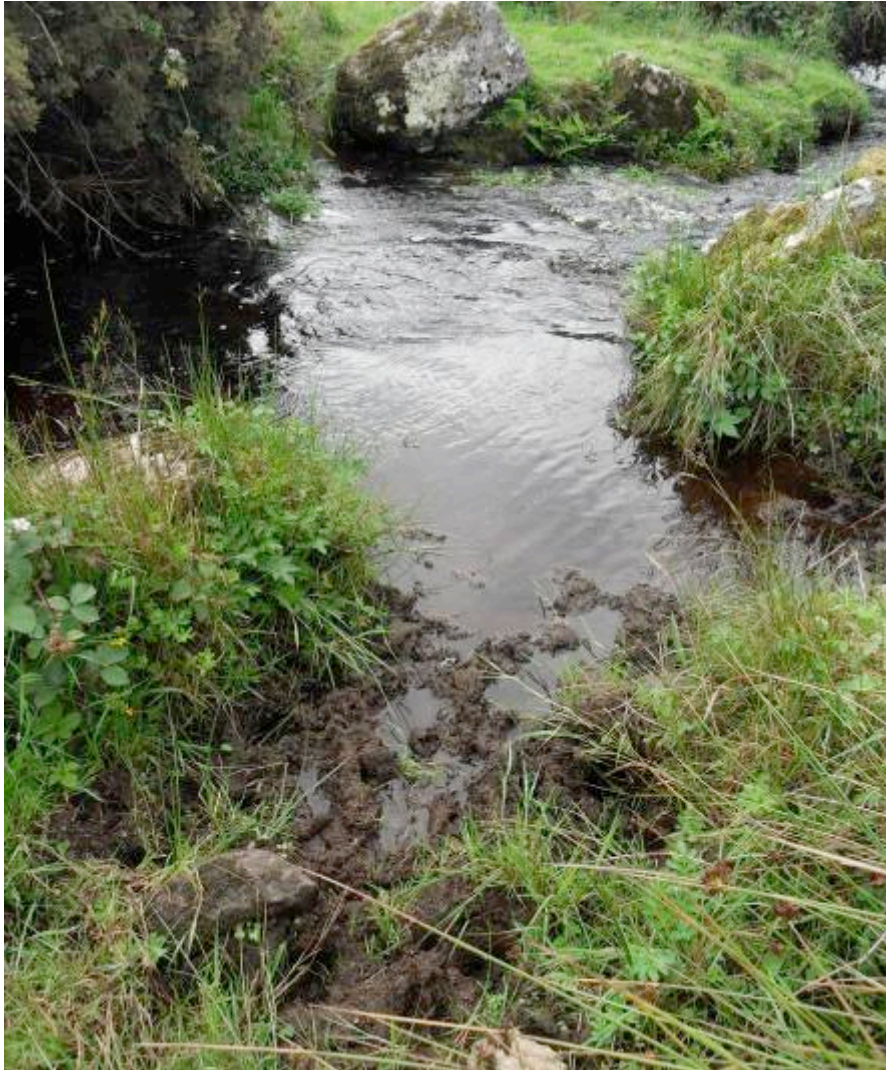
While the bank structure and stability is effected by cattle poaching through direct access for drinking water it does not affect more than one third of the bank length therefore the bank stability score remains good and whilst the substrate condition and riparian zone scores are reduced the overall RHAT scoring for the watercourse indicates a WFD morphological status of high.

Plate 6.14 Cattle poaching on left bank of Barna Stream

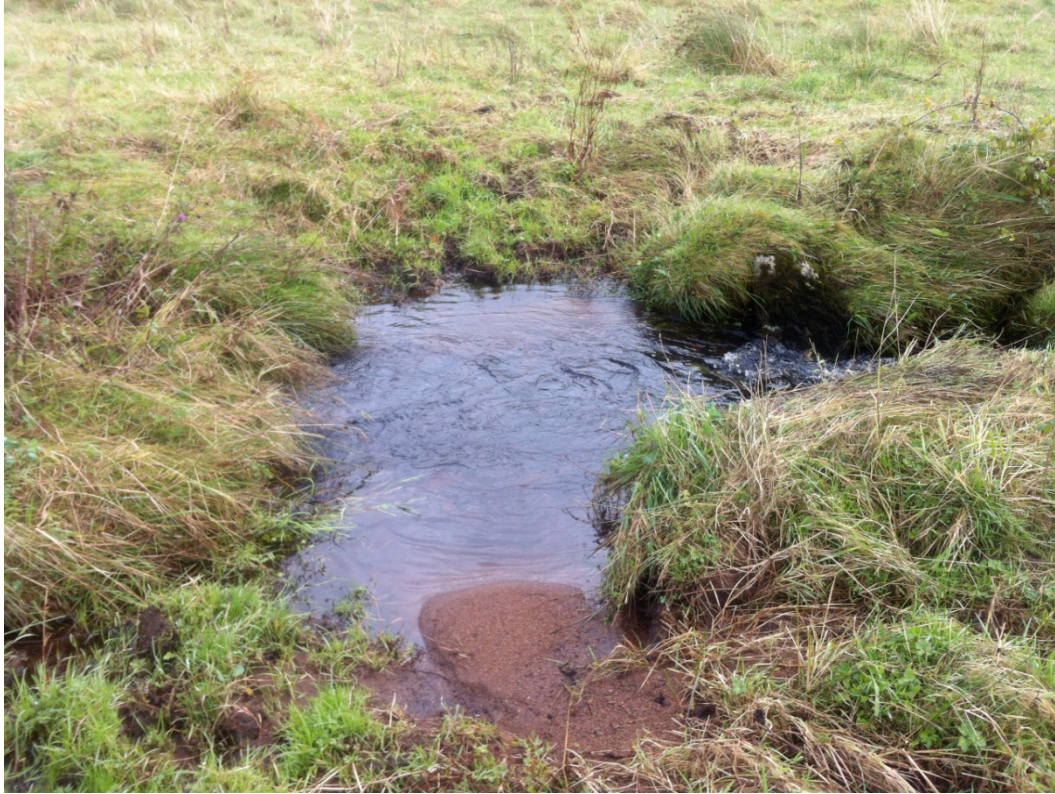
Significant animal poaching was evidently still an issue on both banks, with visible signs of livestock crossing points (Plate 6.15).

Plate 6.15 Example of cattle crossing point on Barna Stream at AM9 with elevated levels of sand and silt

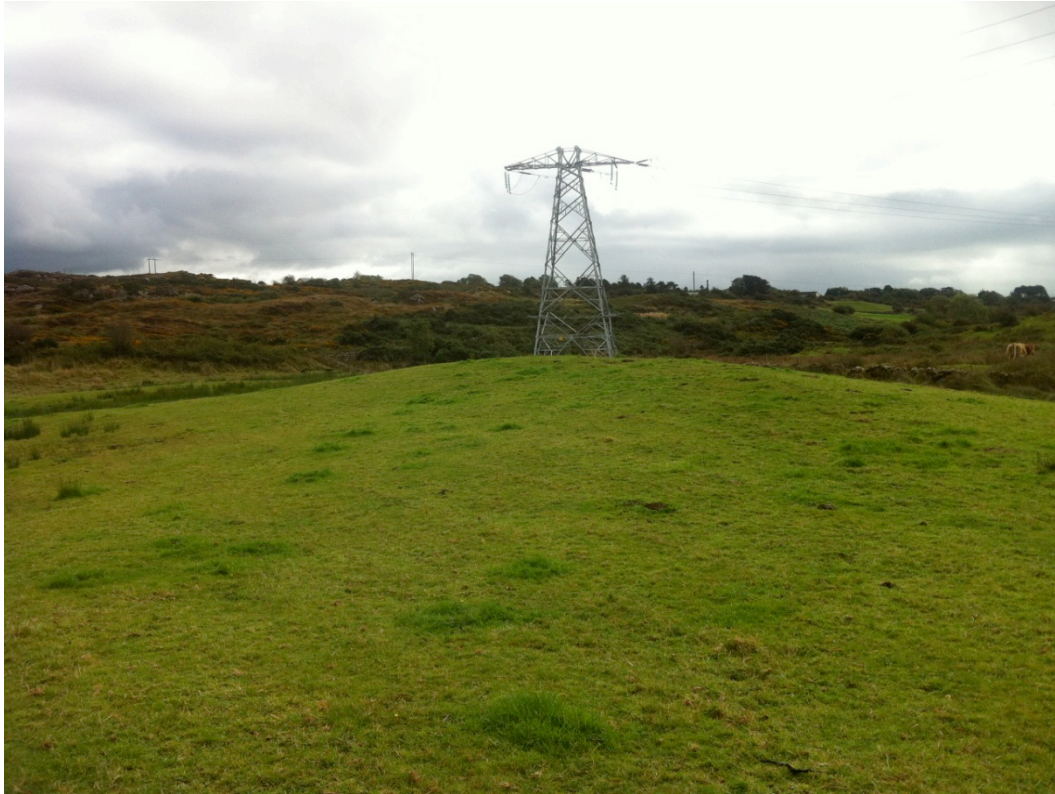
The presence of submerged macrophytes was still evident, indicative of increased nutrients and siltation of the substrate as a result of the obvious cattle poaching. Despite these pressures having a negative impact on the bank structure and stability, the areas are still limited to less than one third of the bank length therefore the bank stability score remains good. Following recent flooding at the site it was noted that floodplain connectivity was improved in comparison to the previous study, and whilst the channel and bank vegetation zone scores have been reduced the overall RHAT scoring for the watercourse still indicates a WFD morphological status of high, with a rise in Hydromorph score from 0.83 to 0.875.

Plate 6.16 Evidence of complete recovery of field used for access during construction of AM9

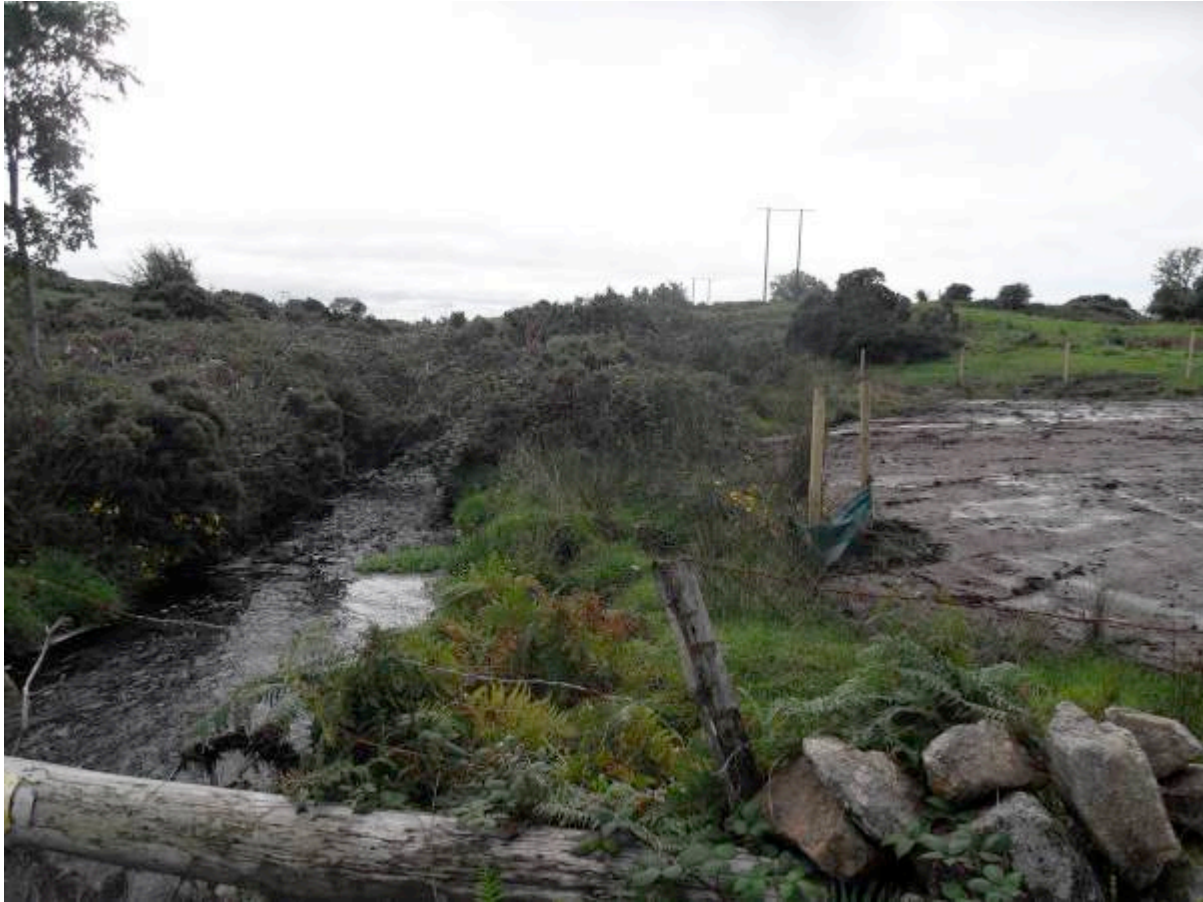
site clearance works seems excessive and has resulted in an increased risk of impact from the construction works reducing the riparian buffer to two to three metres (Plate 6.17).

Plate 6.17 Site clearance works adjacent to the Barna Stream at AM9

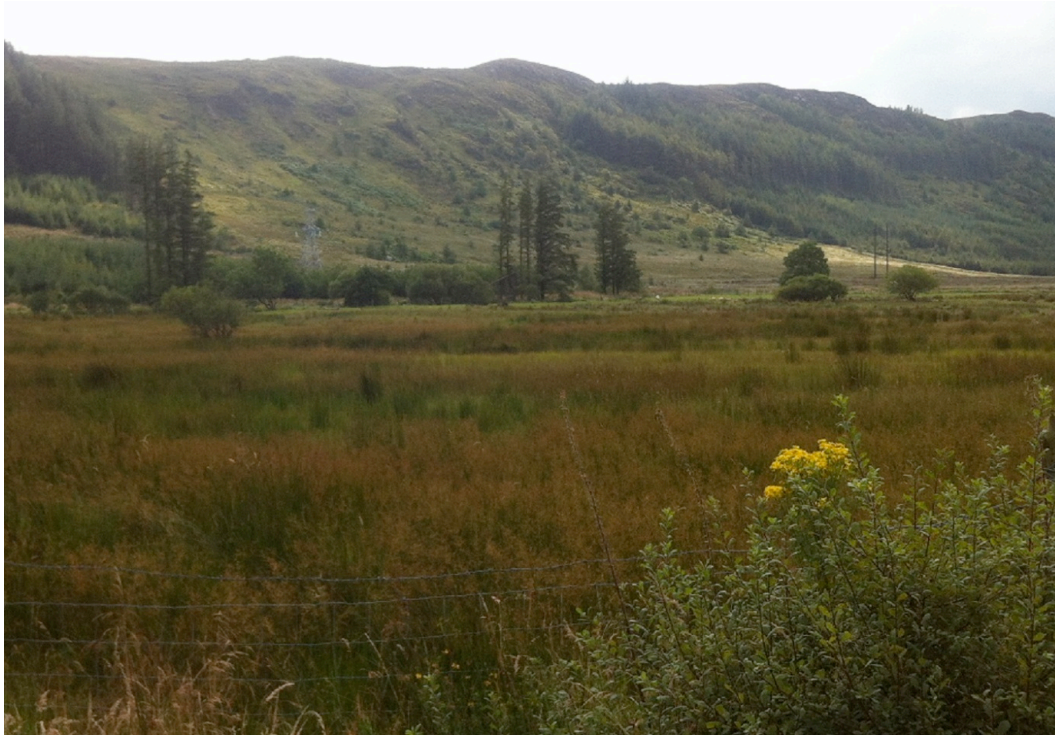
Plate 6.18 Illustration of land use in vicinity of AM144

A post construction RHAT survey was conducted in 2015 (09/09/15) over a 160m reach beginning approximately 100m upstream of the angle mast structure. The surrounding land use is predominantly rough grazing and forestry, as shown in Plate 6.18.

The overall channel type was recorded as lowland meandering. The width of the river was four metres and the depth was estimated to be two metres at the time of survey.
