EirGrid Evidence Based Environmental Studies Study 6: Water Quality & Aquatic Ecology

Literature review and evidence based field studies on the effects of high voltage transmission lines on water quality and aquatic ecology in Ireland

May 2016

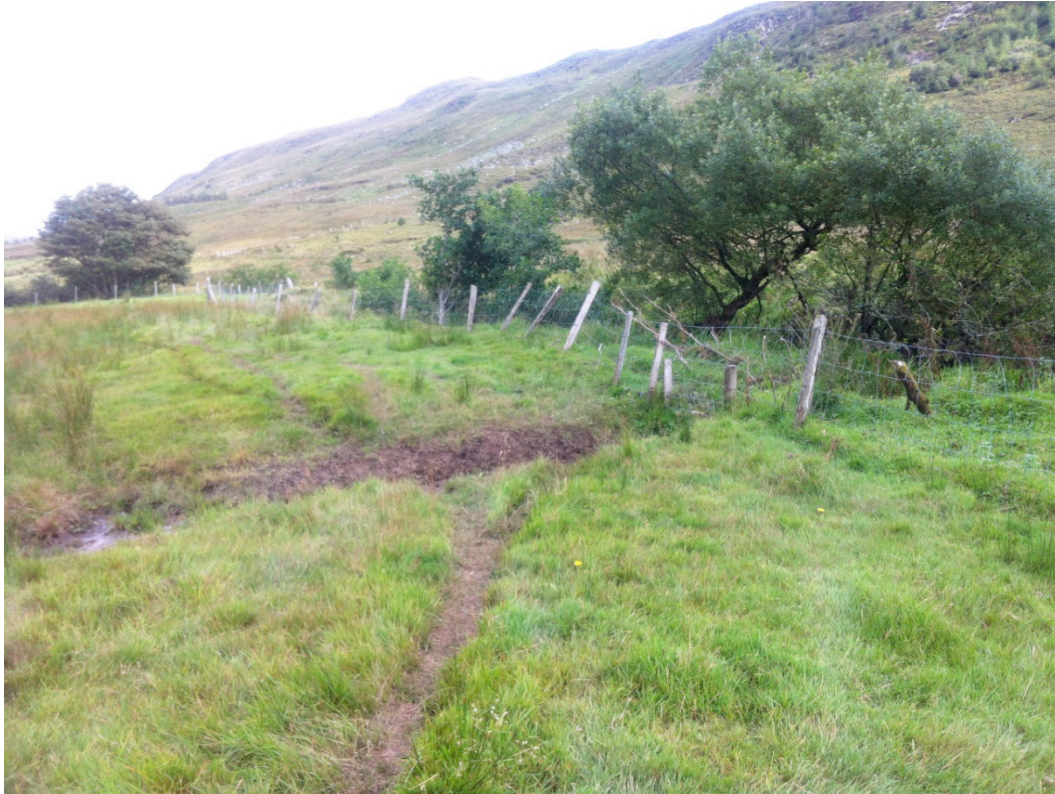
As noted in the original hydromorphological survey carried out in October 2012, there was significant bank erosion and undercutting evident and new field drains had been recently excavated. Animal poaching is a recurring feature along this reach, as shown in Plate 6.19, and there are also significant stands of forestry in the area. All other morphological features such as channel form and flow, channel vegetation, and substrate condition scored high and the overall morphological status was considered to be high, as per the previous survey.

Plate 6.19 Example of livestock trampling/poaching and field drainage adjacent to AM144
