Modified Access Routes April 2016

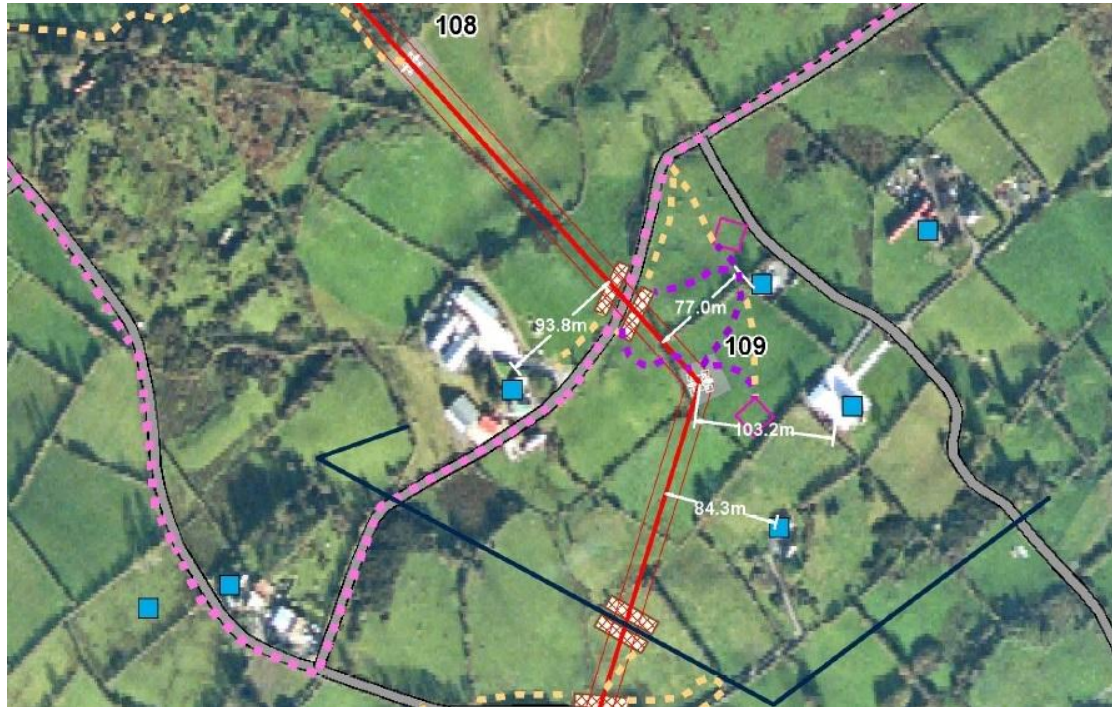
Figure 1

Tower 109 – LCT 13 & LCT 14

Environmental Review Topic	Tower 109 Access Route Comment
Ecology	The access route delineated in purple crosses improved pasture and a single moderate value hedgerow to the west of tower location. This route will require the temporary clearance of a short section of moderate hedgerow. There is no change to the overall ecological impact evaluation as the impact remains imperceptible.
Cultural Heritage	There are no additional CH considerations for this location.
Traffic	Access to Tower 109 is still accessed via the L75031. No change to traffic movements.
Water/Soils/Geology	No significant issues with either access route option.
Agronomy	The access route delineated in purple will increase the length of access route crossing LCT-011, 012 & 013 and decrease the length of access route crossing LCT-014. There will be no change in impact on either land parcel LCT-011, 012 & 013 or LCT-014.

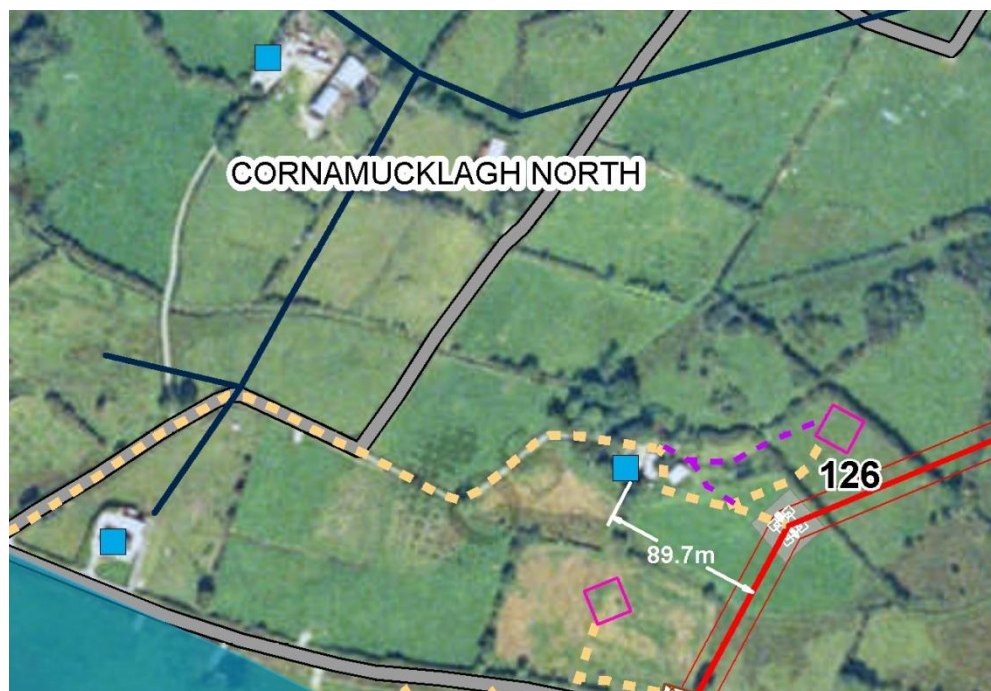
Figure 2

Tower 126 – LCT 056 & 056A

Environmental Review Topic	Tower 126 Access Route Comment
Ecology	The access route delineated in purple avoids the requirement to remove a mature tree and also a hedgerow crossing at a reported badger sett. The route crosses improved agricultural land using an existing track and field entrance to the stringing location. There is no change to the overall ecological impact evaluation; the impact is evaluated as imperceptible in the local context.
Cultural Heritage	There are no additional cultural heritage issues regarding the alternative temporary access to Tower 126.
Traffic	Access to Tower 126 is still accessed via the L34201. No change to traffic movements.
Water/Soils/Geology	No significant issues with either access route option.
Agronomy	There is no significant difference between the access route delineated in purple and the access route as submitted in the application and there will be no change in the impact evaluation.

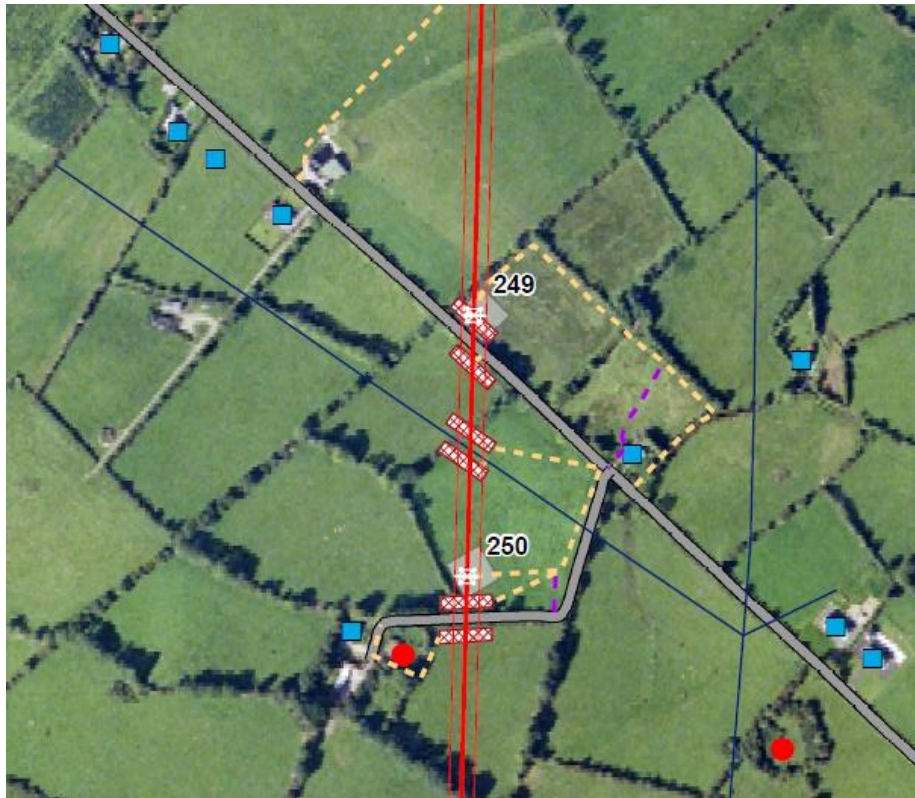
Figure 3

Tower 249 – LMC 155

Environmental Review Topic	Tower 249 Access Route Comment
Ecology	The access route delineated in purple uses an existing field entrance via a gate off the main road and crosses improved pasture to the tower location. There is no change to the overall ecological impact evaluation.
Cultural Heritage	There are no additional CH considerations for this location.
Traffic	Access to Tower 249 is still accessed via the L68011. No change to traffic movements.
Water/Soils/Geology	No significant issues with either access route option.
Agronomy	The access route delineated in purple utilises an existing entrance to the field and it crosses the field rather than using an existing laneway. The access route delineated in purple will not change the impact evaluation.

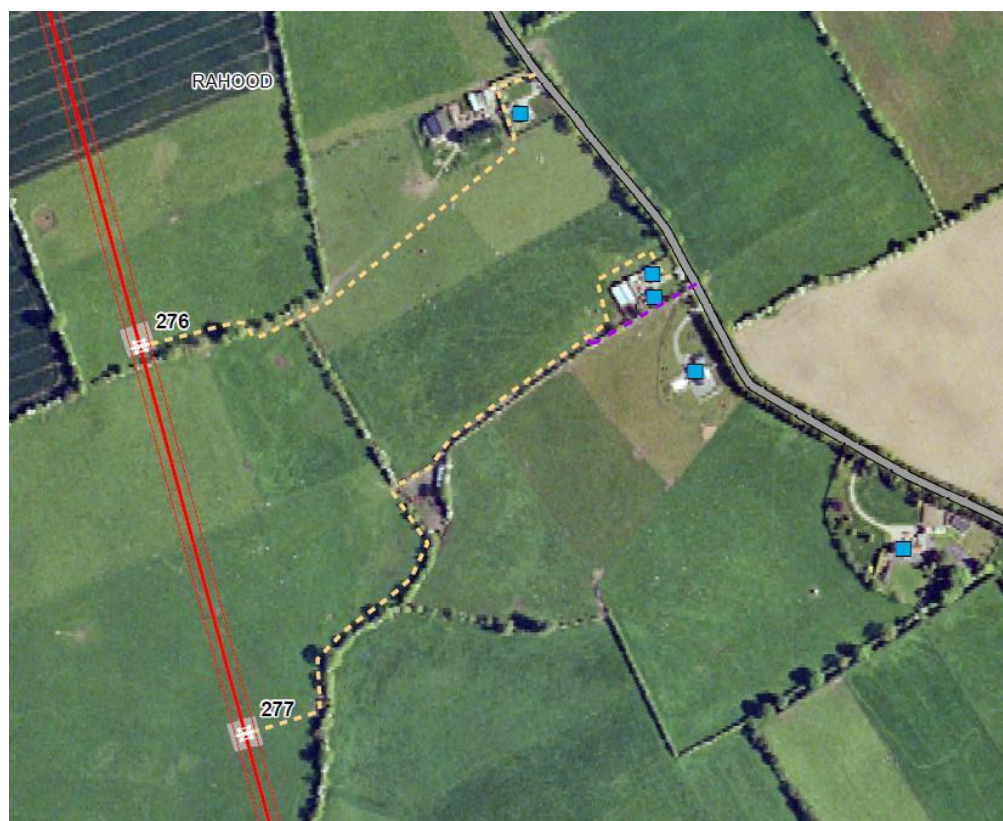
Figure 4

Tower 277 – LMC 128

Environmental Review Topic	Tower 277 Access Route Comment
Ecology	The access route delineated in purple uses an existing laneway entrance off the main road. It crosses improved pasture and an existing hedgerow gap to the tower location. There is no change to the overall ecological impact evaluation.
Cultural Heritage	The route delineated in purple is a minor adjustment to the original access route. As with the original, the route follows a townland boundary wall towards the tower location. There are no CH considerations for this location.
Traffic	Access to Tower 277 is still accessed via the L34021. No change to traffic movements.
Water/Soils/Geology	No significant issues with either access route option.
Agronomy	There is no significant difference with the access route delineated in purple. The access route delineated in purple will not change the impact evaluation.

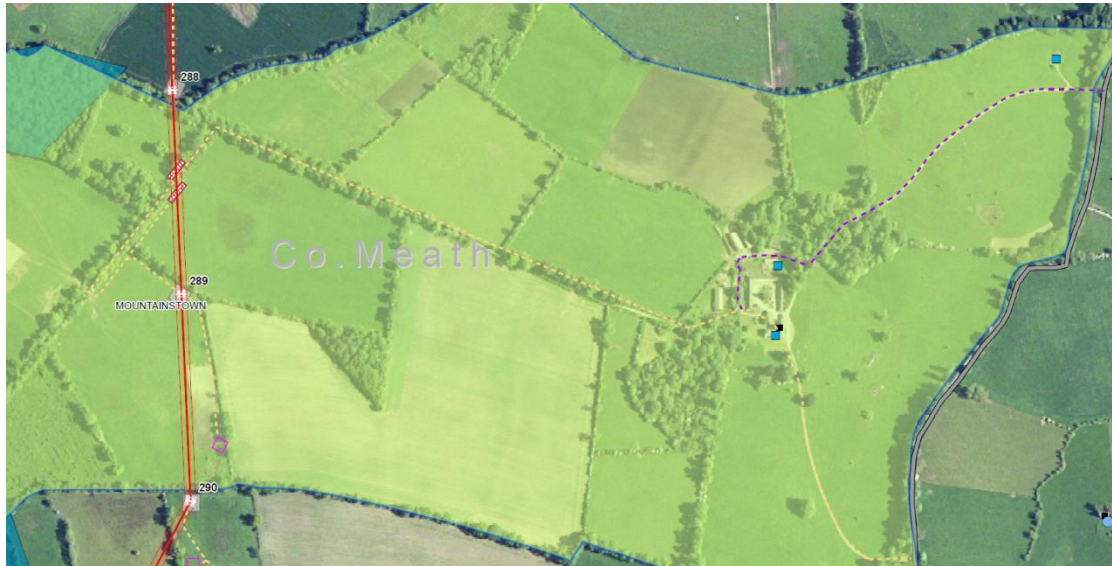
Figure 5

Tower 289 – LMC 216

Environmental Review Topic	Tower 289 Access Route Comment
Ecology	The access route delineated in purple uses an existing laneway entrance off the main road and follows the internal access roads within the estate. There is no change to the overall ecological impact evaluation.
Cultural Heritage	There are no additional cultural heritage considerations.
Traffic	The alternative access to Tower 289 is accessed via the same local road L3406. No change to traffic movements.
Water/Soils/Geology	No significant issues with either access route option.
Agronomy	There is no significant difference with the access route delineated in purple. The access route delineated in purple will not change the impact evaluation.

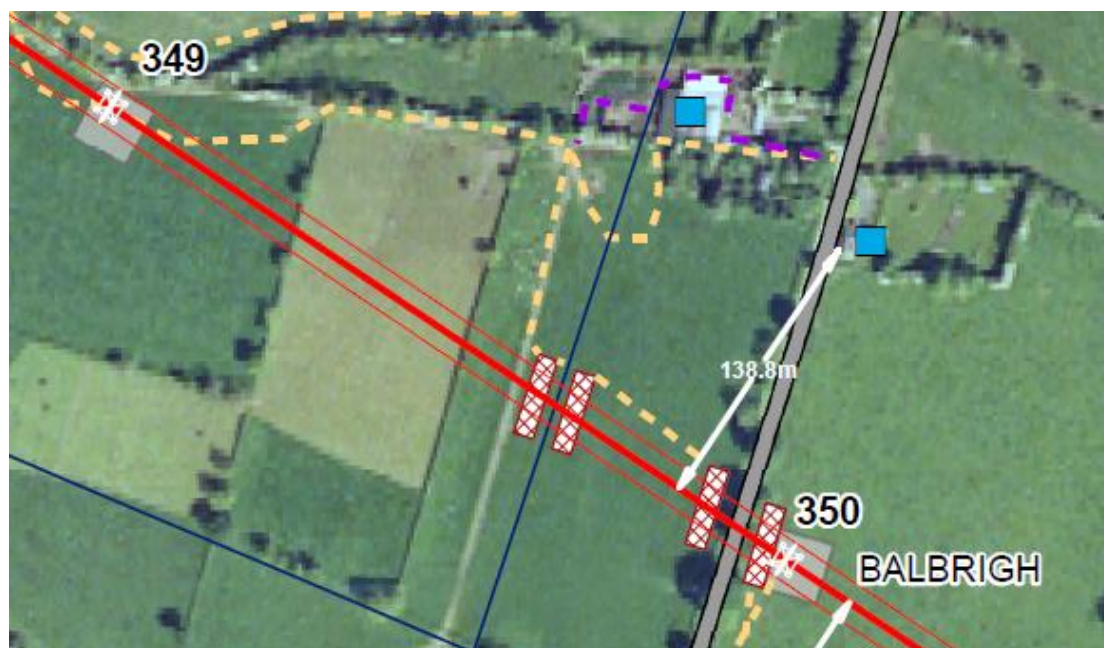
Figure 6

Tower 349 – LMC 050

Environmental Review Topic	Tower 349 Access Route Comment
Ecology	The access route delineated in purple uses an existing laneway entrance off the main road. It follows an existing farm access route and access track to improved agricultural grassland to the tower location. There is no change to the overall ecological impact evaluation.
Cultural Heritage	There are a number of farm buildings depicted on the 1 st Edition Map in the vicinity of both the modification and the existing route. Any extant vernacular features should be demarcated and avoided.
Traffic	Access to Tower 349 is still accessed via the L40071. No change to traffic movements.
Water/Soils/Geology	No significant issues with either access route option.
Agronomy	There is no significant difference with the access route delineated in purple. The access route delineated in purple will not change the impact evaluation.

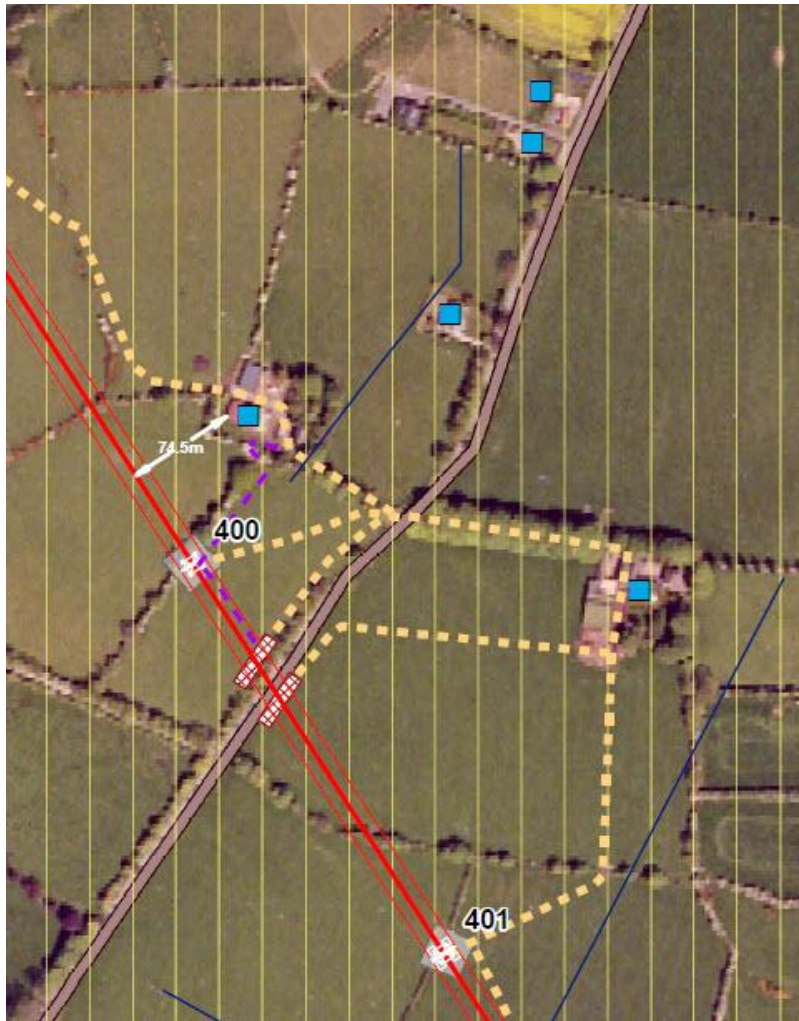
Figure 7

Tower 400 – LMC 016

Environmental Review Topic	Tower 400 Access Route Comment
Ecology	The access route delineated in purple uses an existing gated entrance. It crosses improved pasture and an existing hedgerow gap to the tower location. There is no change to the overall ecological impact evaluation.
Cultural Heritage	There are no CH considerations for this location.
Traffic	Access to Tower 400 is still accessed via the R125. No change to traffic movements.
Water/Soils/Geology	No significant issues with either access route option.
Agronomy	There is no significant difference with the access route delineated in purple. The access route delineated in purple will not change the impact evaluation.

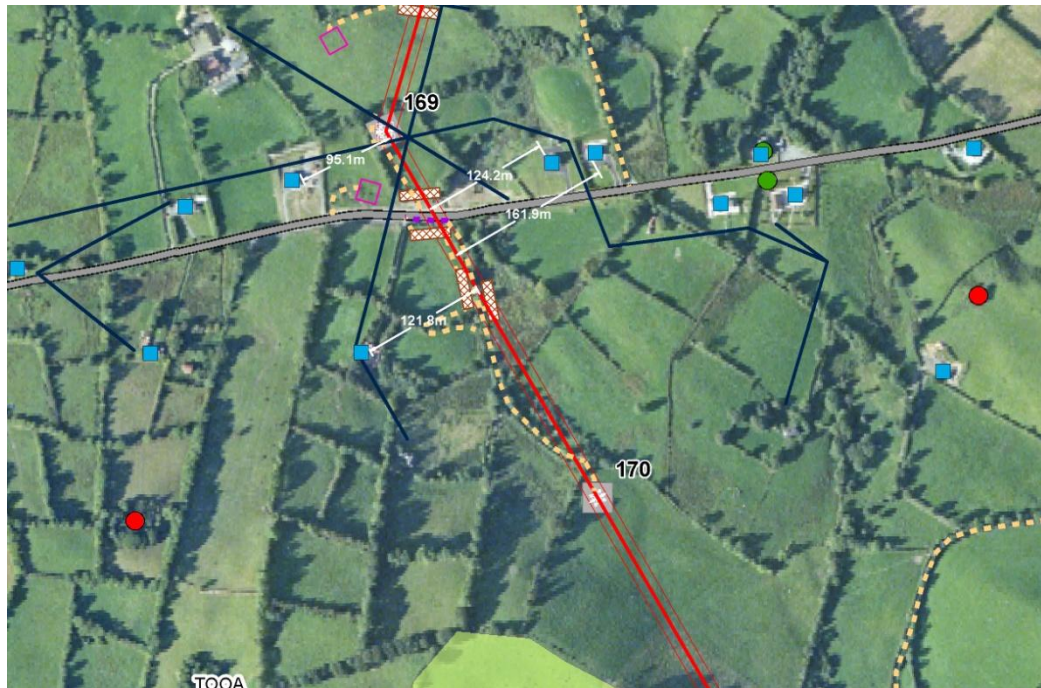
Figure 8

Tower 170 LCT 135

Environmental Review Topic	Tower 170 Access Route Comment
Ecology	The access route delineated in purple follows an existing laneway parallel to the main road. There is no change to the overall ecological impact evaluation.
Cultural Heritage	There are no additional CH considerations for this location.
Traffic	Access to Tower 170 is still accessed via the R181. No change to traffic movements.
Water/Soils/Geology	No significant issues with either access route option.
Agronomy	The access route delineated in purple utilises an existing entrance to the field and requires a slightly longer route length. The access route delineated in purple will not change the impact evaluation.

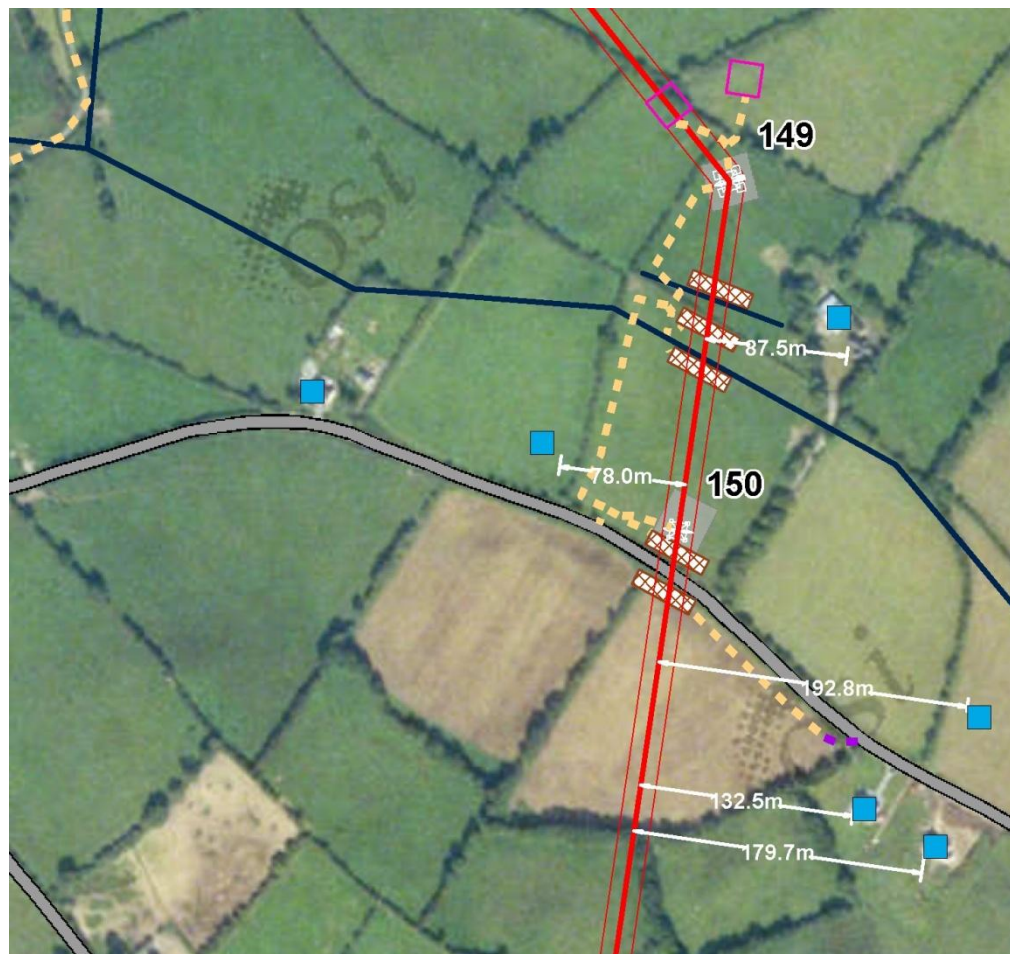
Figure 9

Guarding South of Road Span 150 - 151– LCT 091

Environmental Review Topic	Guarding South of Road Span 150 – 151 Access Route Comment
Ecology	The access route delineated in purple crosses improved pasture and utilises an existing entrance to the road. There is no change to the overall ecological impact evaluation, as the impact remains imperceptible.
Cultural Heritage	There are no additional CH considerations for this location.
Traffic	Access to guarding between Towers 150 and 151 south of the L7211 is still accessed via the L7211 No change to traffic movements.
Water/Soils/Geology	No significant issues with either access route option.
Agronomy	The access route delineated in purple utilises an existing entrance to the field and requires a slightly longer route length. The access route delineated in purple will not change the impact evaluation.

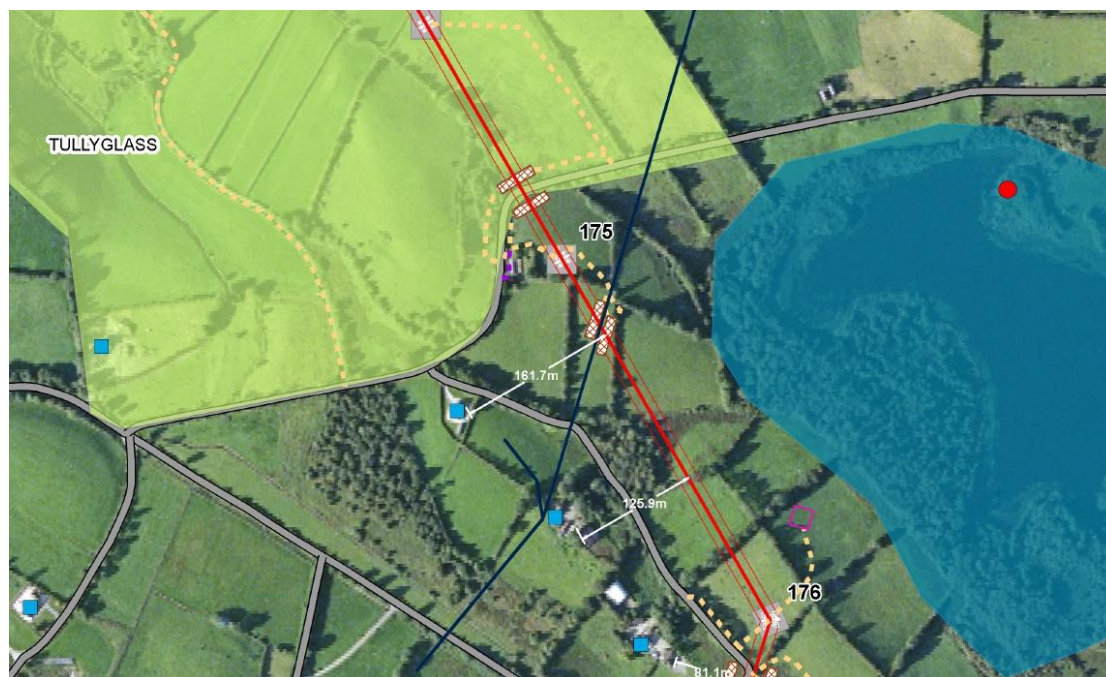
Figure 10

Tower 175 – LCT 141

Environmental Review Topic	Tower 175 Access Route Comment
Ecology	The access route delineated in purple uses an existing farm entrance from the main road. The route delineated in purple avoids direct disturbance to a stone wall at the roadside. There is no change to the overall ecological impact evaluation.
Cultural Heritage	Access to tower 175 passes through the yards of a farmstead depicted on the 1st edition OS Map. There is no change to the overall cultural heritage evaluation.
Traffic	Access to Tower 175 is still accessed via the L4010. No change to traffic movements.
Water/Soils/Geology	No significant issues with either access route option.
Agronomy	The access route delineated in purple utilises an existing entrance to a farm yard – the impact on which is already assessed. The access route delineated in purple will not change the impact evaluation.

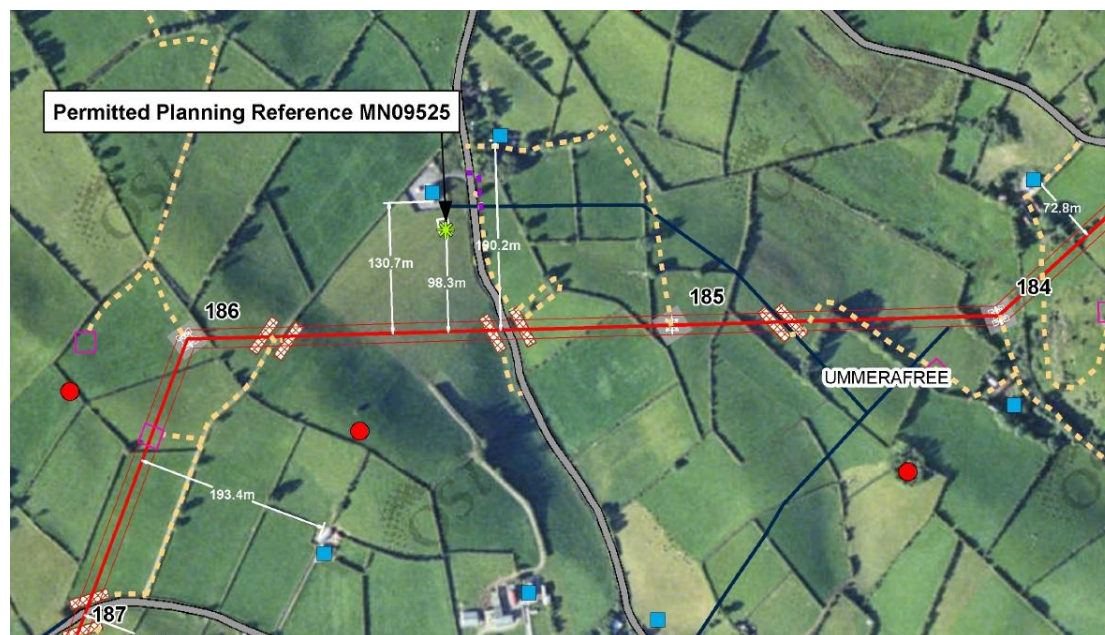
Figure 11

Guarding North of Road Span 185-186 – LCT 153

Environmental Review Topic	Span 185-186 Access Route Comment
Ecology	The access route delineated in purple uses an existing field entrance from the main road. The route delineated in purple avoids direct disturbance to a low value hedgerow at the roadside. There is no change to the overall ecological impact evaluation.
Cultural Heritage	There are no additional CH considerations for this location.
Traffic	Access to guarding on east side of L40121 is still accessed via the L40121. No change to traffic movements.
Water/Soils/Geology	No significant issues with either access route option.
Agronomy	The access route delineated in purple utilises an existing entrance to the field and requires a slightly longer route length – staying close to the same field boundary. The access route delineated in purple will not change the impact evaluation.

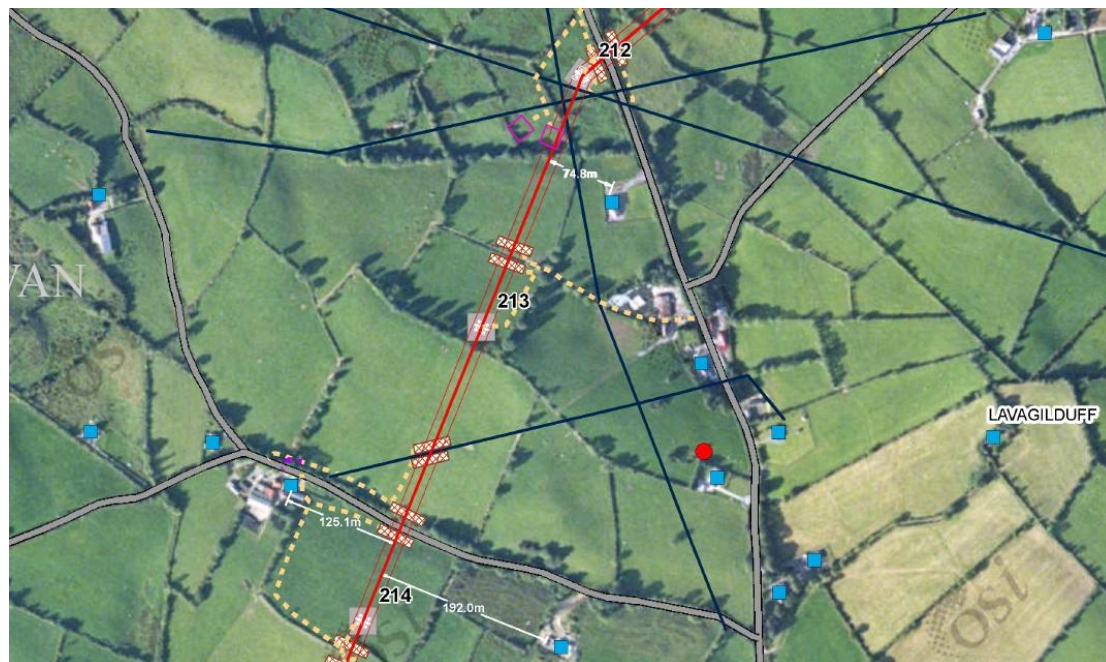
Figure 12

Guarding North of Road Span 213-214 – LCT 206

Environmental Review Topic	Guarding North of Span 213-214 Access Route Comment
Ecology	The access route delineated in purple uses an existing field entrance along the main road. This route avoids direct disturbance to a Sycamore and Ash treeline at the roadside with only minor trimming required. There is no change to the overall ecological impact evaluation.
Cultural Heritage	There are no additional CH considerations for this location.
Traffic	Access to guarding on east side of L7555 is still accessed via the L7555. No change to traffic movements.
Water/Soils/Geology	No significant issues with either access route option.
Agronomy	The access route delineated in purple utilises an existing entrance to the field and requires a slightly shorter route length. The access route delineated in purple will not change the impact evaluation.

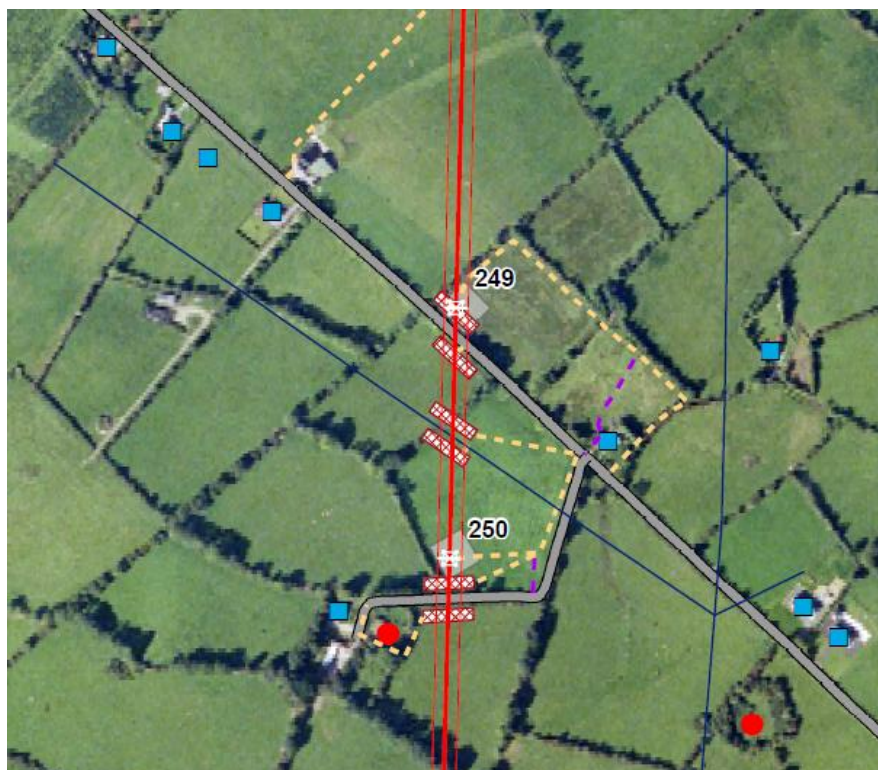
Figure 13

Tower 250 and Guarding – LMC 154

Environmental Review Topic	Tower 250 and Guarding Access Route Comment
Ecology	The access route delineated in purple uses an existing field entrance off the public road and crosses improved agricultural grassland to the tower location, avoiding disturbance to low value hedgerow at the roadside. There is no change to the overall ecological impact evaluation.
Cultural Heritage	The access route delineated in purple is a minor adjustment to the access route originally shown in an area where there are no previously recorded archaeological or architectural heritage features at the location of the access route. There are no cultural heritage issues with the access route delineated in purple.
Traffic	Access to Tower 250 and guarding is still accessed via the L68016. No change to traffic movements.
Water/Soils/Geology	No significant issues with either access route option.
Agronomy	There is no significant difference with the access route delineated in purple. The access route delineated in purple will not change the impact evaluation.

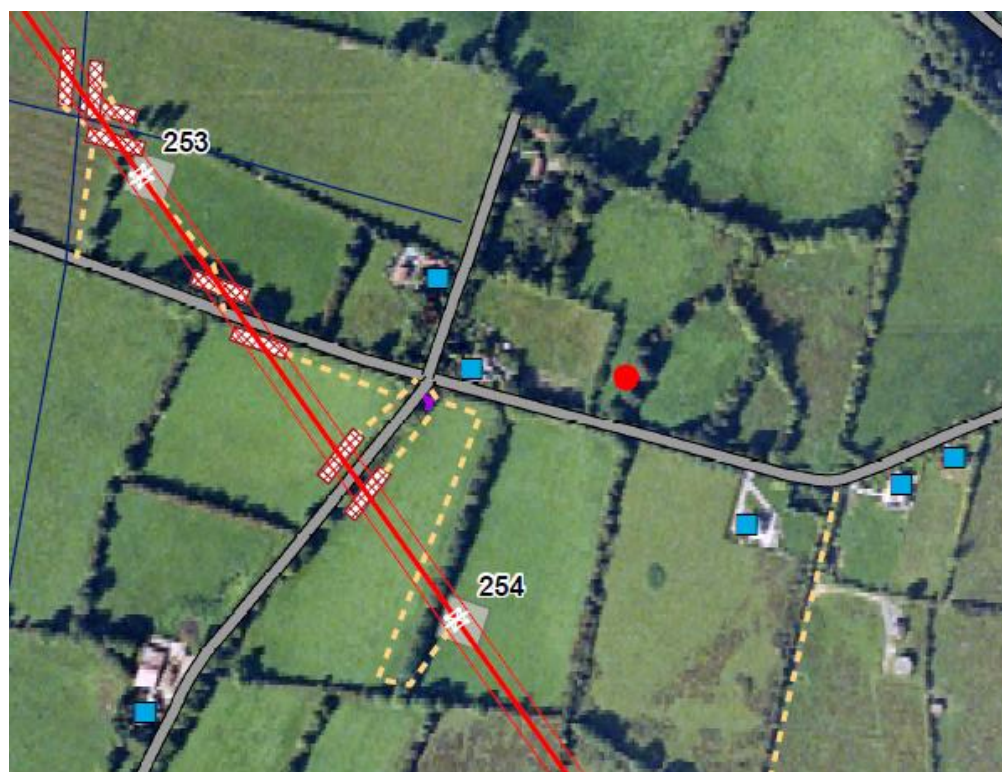
Figure 14

Tower 254 & Guarding – LMC 149 & 150

Environmental Review Topic	Tower 254 Access Route Comment
Ecology	The access route delineated in purple uses an existing field entrance from the public road and crosses improved pasture to the tower location. This route also uses an existing gap in hedgerow between two fields and avoids direct disturbance to a hedgerow at the roadside. There is no change to the overall ecological impact evaluation.
Cultural Heritage	The access route delineated in purple is a minor adjustment to the original route. The adjacent cross roads was used for local dances. There are no additional CH considerations for this location as a result of the access route delineated in purple.
Traffic	Access to Tower 254 and guarding is still accessed via the L28021. No change to traffic movements.
Water/Soils/Geology	No significant issues with either access route option.
Agronomy	There is no significant difference with the access route delineated in purple. The access route delineated in purple will not change the impact evaluation.

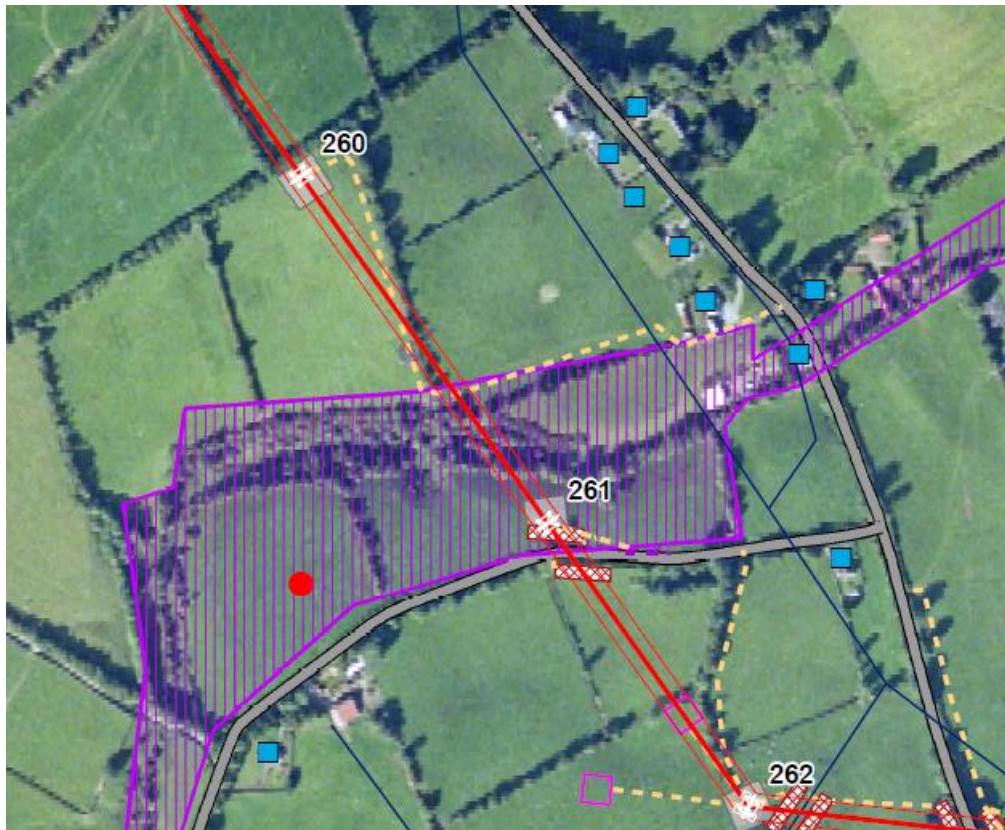
Figure 15

Tower 261 – LMC 139

Environmental Review Topic	Tower 261 Access Route Comment
Ecology	The access route delineated in purple uses an existing gap in the hedgerow. This route avoids direct disturbance to a low value hedgerow at the roadside. There is no change to the overall ecological impact evaluation.
Cultural Heritage	The route delineated in purple is a minor adjustment to the access route. There are no cultural heritage issues with the access route delineated in purple.
Traffic	Access to Tower 261 and guarding is still accessed via the L68371. No change to traffic movements.
Water/Soils/Geology	No significant issues with either access route option.
Agronomy	The access route delineated in purple will be slightly longer than the original access route, however there will be no change in the impact evaluation.

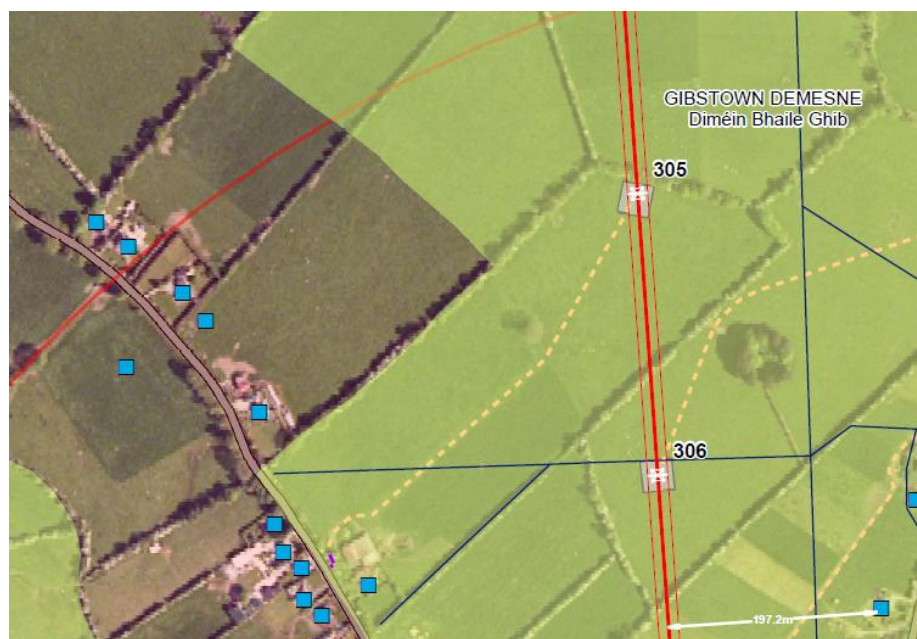
Figure 16

Tower 305 – LMC 101

Environmental Review Topic	Tower 305 Access Route Comment
Ecology	The access route delineated in purple uses an existing field entrance from the main road. The route delineated in purple avoids direct disturbance to a low value hedgerow at the roadside. There is no change to the overall ecological impact evaluation.
Cultural Heritage	The route delineated in purple enters into a field from the local road that leads into the old Gibbstown Estate. The entrance is an existing farm access. There are no cultural heritage issues with the access route shown in purple.
Traffic	Access to Tower 305 is still accessed via the L3409. No change to traffic movements.
Water/Soils/Geology	No significant issues with either access route option.
Agronomy	There is no significant difference with the access route delineated in purple. The access route delineated in purple will not change the impact evaluation.

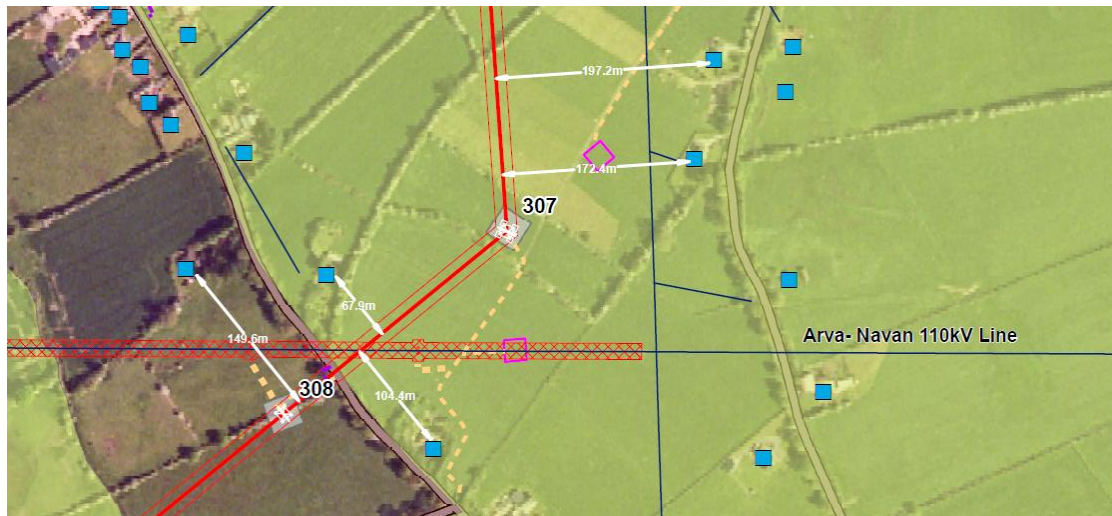
Figure 17

Tower 308 – LMC 099

Environmental Review Topic	Tower 308 Access Route Comment
Ecology	The access route delineated in purple uses an existing entrance off the main road. It crosses improved pasture to the tower location. There is no change to the overall ecological impact evaluation.
Cultural Heritage	There are no CH considerations for this location.
Traffic	Access to Tower 308 is still accessed via the L3409. No change to traffic movements.
Water/Soils/Geology	No significant issues with either access route option.
Agronomy	There is no significant difference with the access route delineated in purple. The access route delineated in purple will not change the impact evaluation.

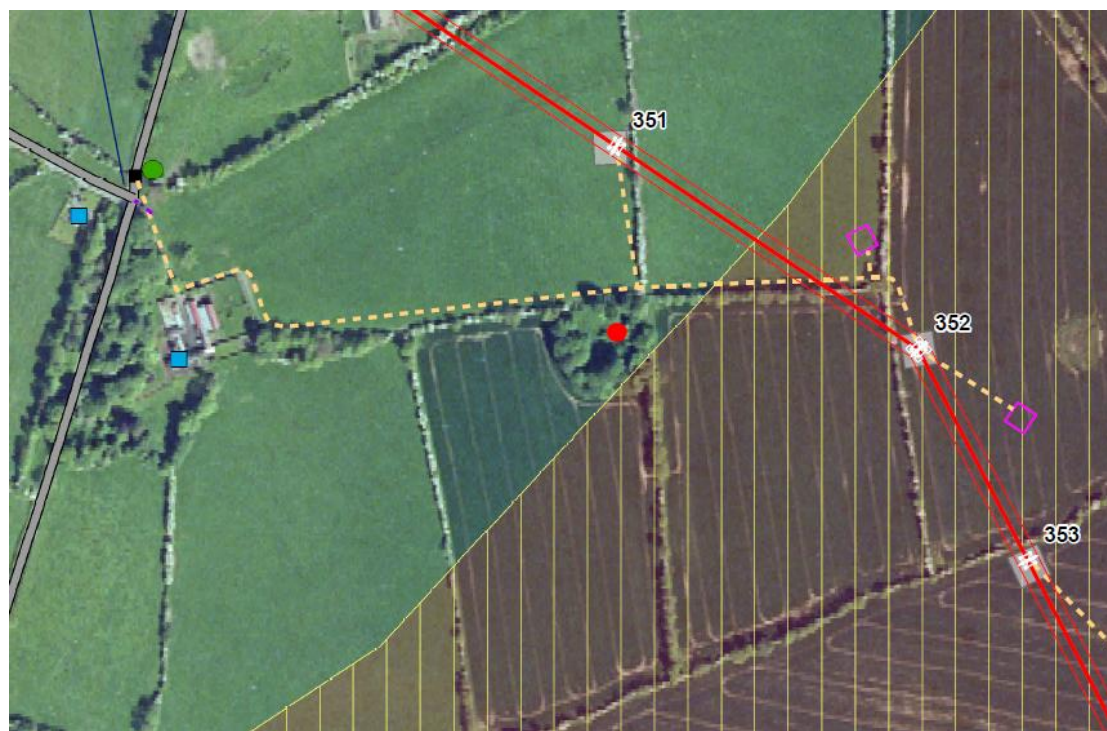
Figure 18

Tower 351 and 352 – LMC 049

Environmental Review Topic	Tower 351 and 352 Access Route Comment
Ecology	The access route delineated in purple connects to an existing entrance laneway off the public road. There is no change to the overall ecological impact evaluation.
Cultural Heritage	The route shown in purple is a minor adjustment to the original access route. Access to towers 351 & 352 are via the entrance to Balbray stud, or Balbrigh House as it appears on the 2nd ed. Map. The entrance is formally arranged, recessed and consists of a wrought iron ornamental gate with capped gate piers, adjoining a capped rubble stone wall. Care should be taken to avoid any impacts.
Traffic	Access to Towers 351 and 352 is still accessed via the L40071. No change to traffic movements.
Water/Soils/Geology	No significant issues with either access route option.
Agronomy	There is no significant difference with the access route delineated in purple. The access route delineated in purple will not change the impact evaluation.
