# The Grid West Project

Lead Consultant's Stage 1 Report

Route Corridor Evaluation Report

Revised September 2014

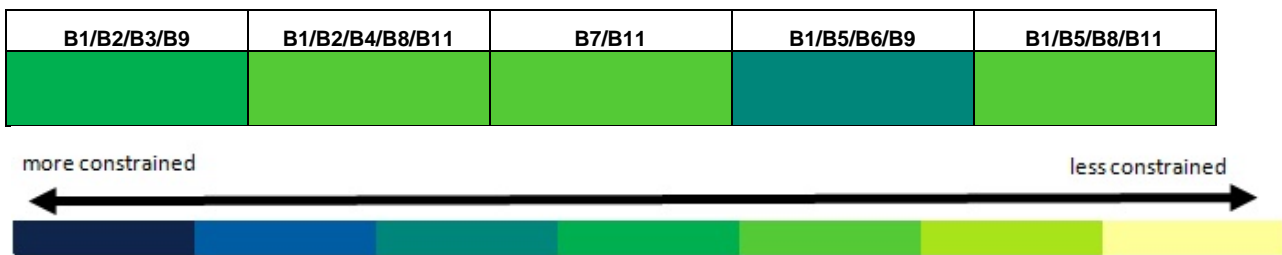
**Table 3-1 Bellacorick Route Corridor Options Evaluation**

For the Bellacorick route corridor options, in terms of settlements, Table 3-1 presents the outcomes of the evaluation process for each of the route corridor options.

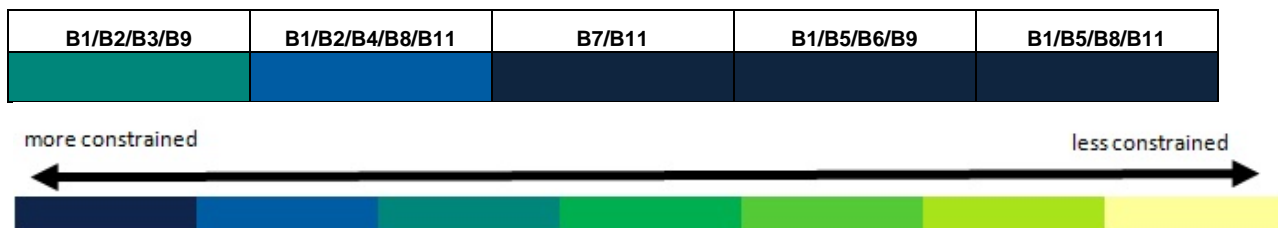
**Table 3-4 Bellacorick Route Corridor Options Ecology Evaluation**

For the Bellacorick route corridor options, in terms of ecology, Table 3-4 presents the outcomes of the evaluation process for each of the route corridors.

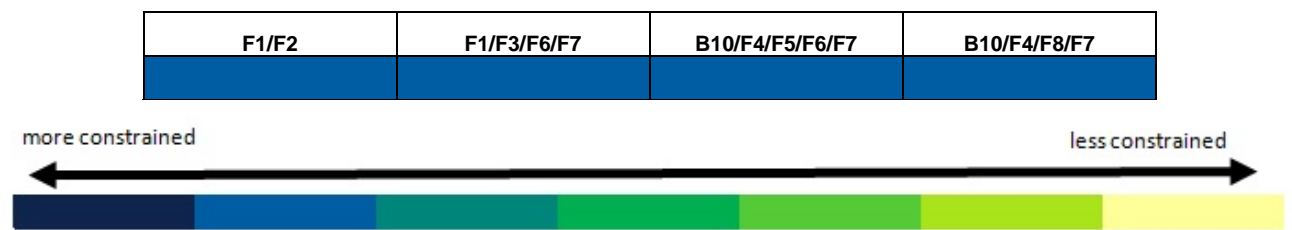
**Table 3-6 Flagford Route Corridor Options Ecology Evaluation**

All of the Flagford route corridors have localised ecological constraints, in particular regarding the relatively sensitive upland nature of the River Moy SAC catchment crossed and extensive raised bog habitat crossed which include relatively non degraded (high conservation value) examples.

For the Flagford route corridor options, in terms of ecology, Table 3-6 presents the outcomes of the evaluation process for each of the route corridors.

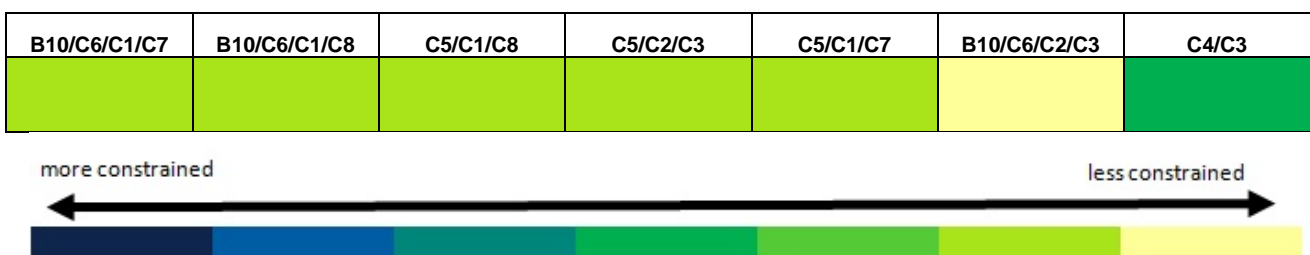
**Table 3-23 Cashla Route Corridor Options Evaluation**

The Cashla route corridors options from Mid-Mayo are all technically feasible; however, due to the routing of the preferred Bellacorick route corridor options, the total cumulative length of the corridors from Bellacorick to Cashla are significantly longer than the Flagford alternatives, thus the associated

For the Cashla group of route corridor options, in terms of technical constraints, Table 3-23 presents the outcomes of the evaluation process for each of the route corridors.

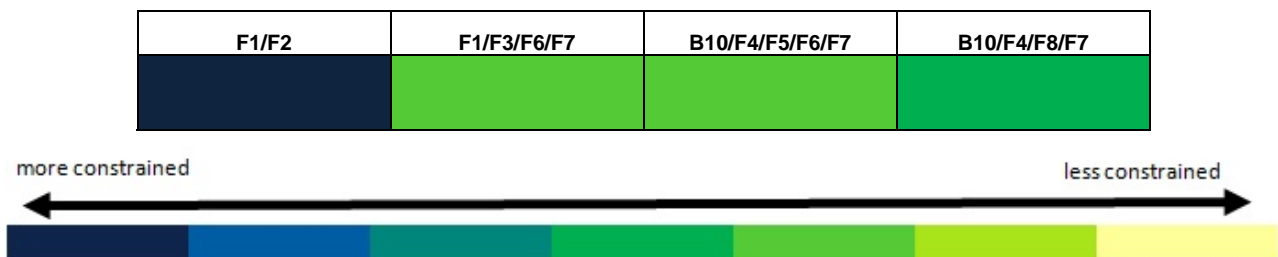
**Table 3-24 Flagford Route Corridor Options Evaluation**

The Flagford route corridor options are generally shorter than the alternative Cashla route corridor options; however geotechnical conditions along the Flagford route corridors require crossing more cutover and blanket peat, which increases the difficulty of implementation and access for construction.

For the Flagford group of route corridor options, in terms of technical constraints, Table 3-24 presents the outcomes of the evaluation process for each of the route corridors.
