Step 4C Development Options and Evaluation Report

North Connacht 110 kV Project

July 2021

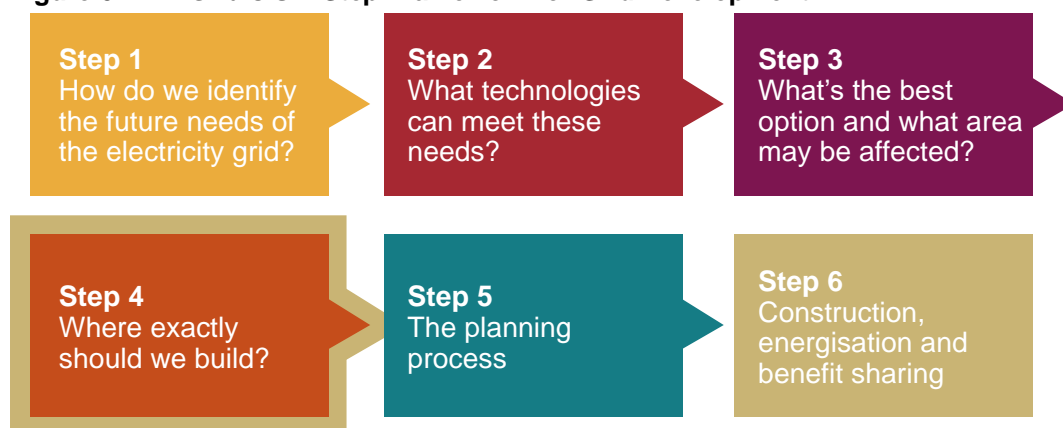
Figure 0.1: EirGrid's Six-Step Framework for Grid Development

The Project is being developed in accordance with EirGrid's Framework for Grid Development and is currently in Step 4.

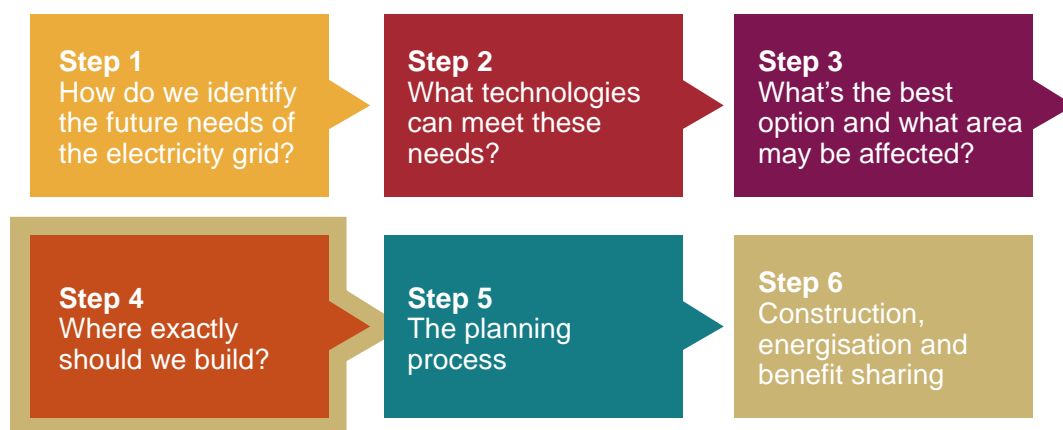
Figure 1.1: EirGrid's Six-Step Framework for Grid Development

The Project is being developed in accordance with EirGrid's Framework for Grid Development and is currently in Step 4.

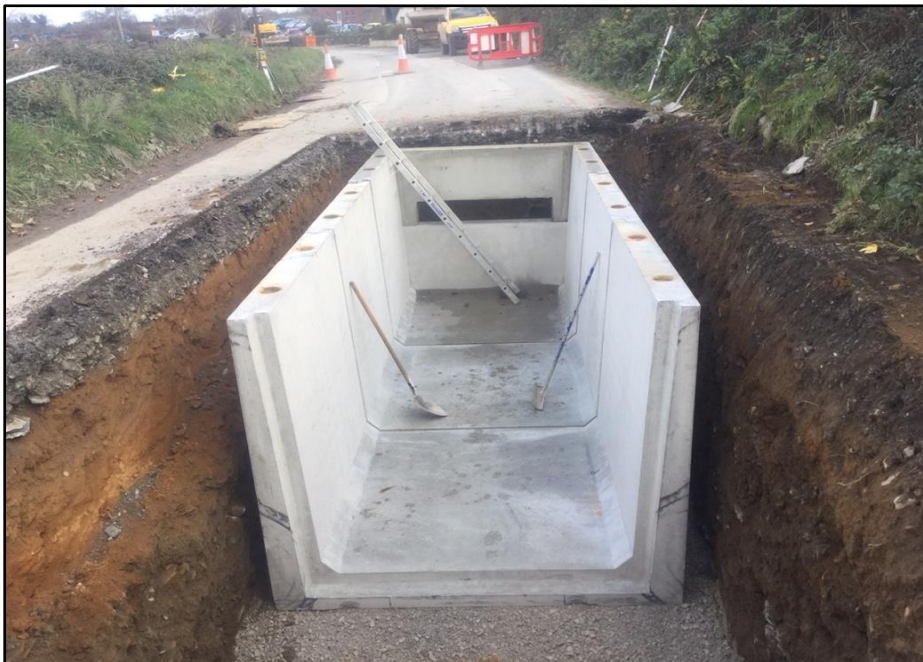
Figure 4.1: Typical joint bay

Joint bays are not readily accessible during operation as there is no ongoing maintenance required; however, they need to be immediately accessible in the unlikely event of cable failure requiring cable replacement.

An image of a typical joint bay is presented in Figure 4.1, and a reinstated road at a joint bay is shown in Figure 4.2.

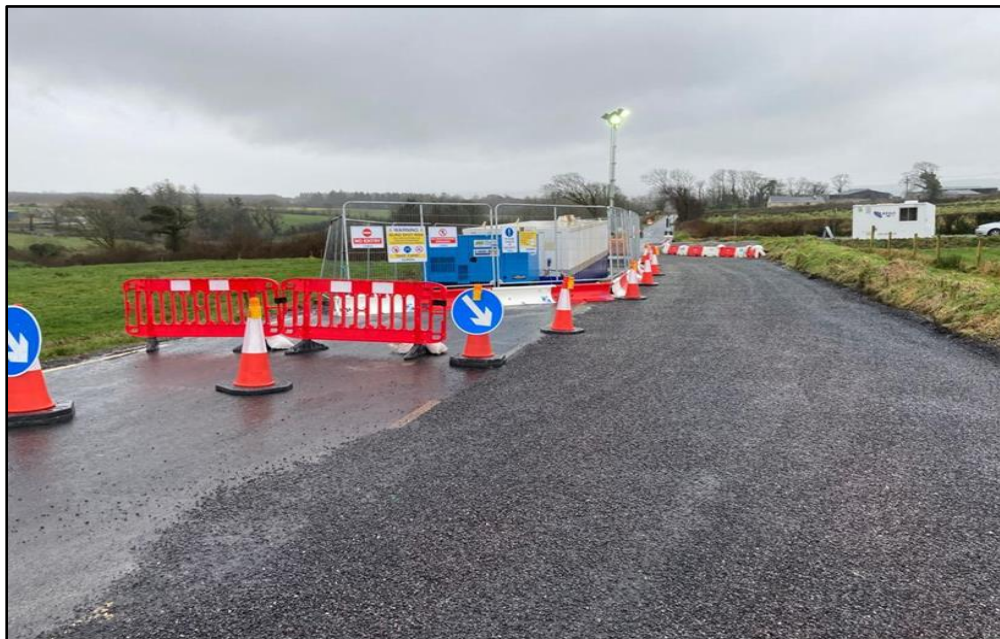
Figure 4.3: Typical Passing Bay

To facilitate traffic management at locations where joint bays are located within the carriageway, the use of temporary passing bays is proposed. A typical passing bay is shown in Figure 4.3.

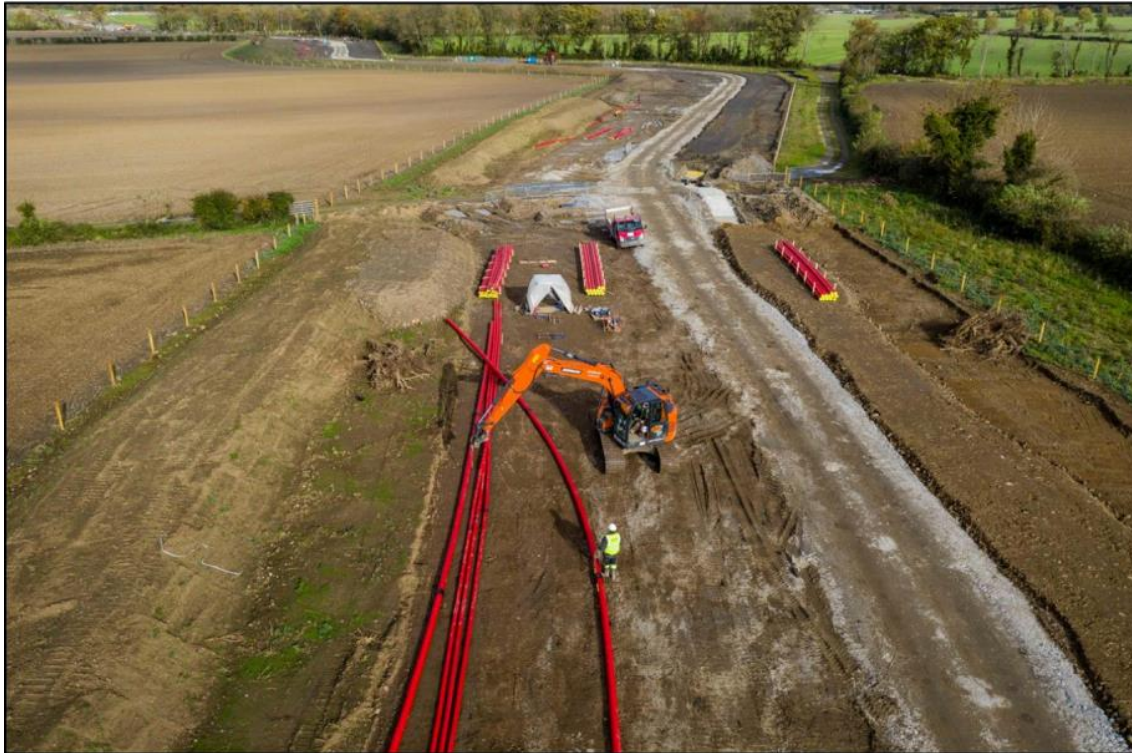
Figure 4.4: Typical UGC Construction in Agricultural Lands

Figure 4.4 shows a typical temporary working strip on agricultural land for electricity cable installation.

On completion of works on agricultural land a permanent easement is required in order to ensure the safety and security of the cable and to facilitate access to the cable and any repair or maintenance that may be required in the future by restricting land uses (e.g. development and tree planting) within this area. Normal farm cropping practices can resume on the easement strip on completion of the work and reinstatement of the land; however, this precludes planting of trees or any plants with deep root systems.

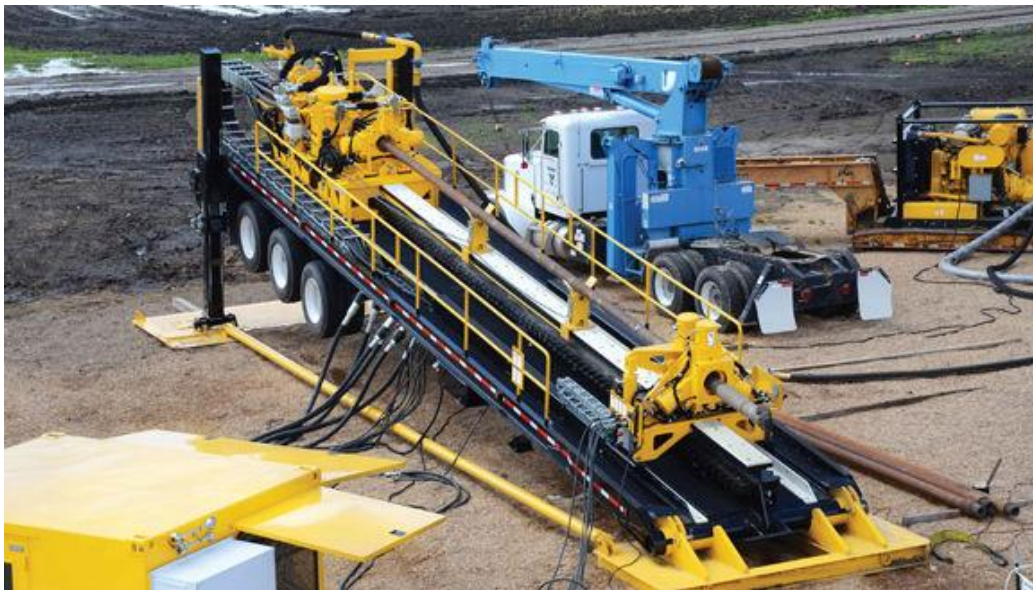
Figure 4.5: Typical HDD Drilling Rig

A typical HDD works drilling rig is shown in Figure 4.5 below.

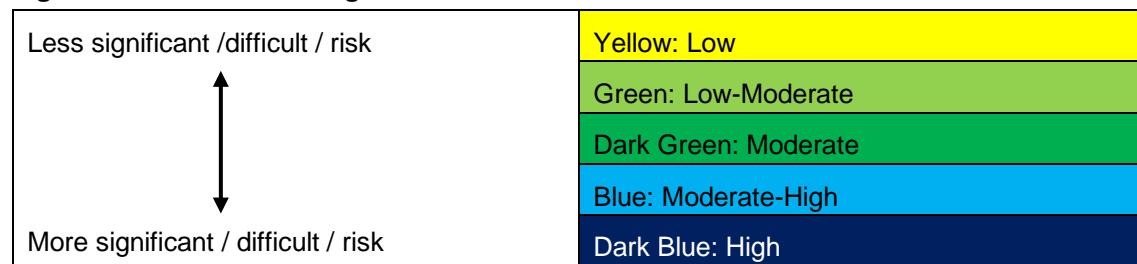
Figure 5.1: Criteria Ranking

The MCA approach facilitates a balanced consideration of the technical, economic, environmental, social and deliverability aspects of the Project. The overall evaluation in MCA is informed by various tools such as publicly available datasets and established guidelines or other documents, as well as feedback received from public and stakeholder engagement. In this instance, the MCA has had regard to assessment and analysis informed by field surveys undertaken to date in respect of the Project. The key decision-making tool in the MCA approach is the performance matrix (Figure 5.1). This is a qualitative tool which uses the standard set of criteria to assess all options by means of

colour coding. Evidence substantiating the colour coded matrix is also documented. This ensures visibility and transparency in the evaluation process.

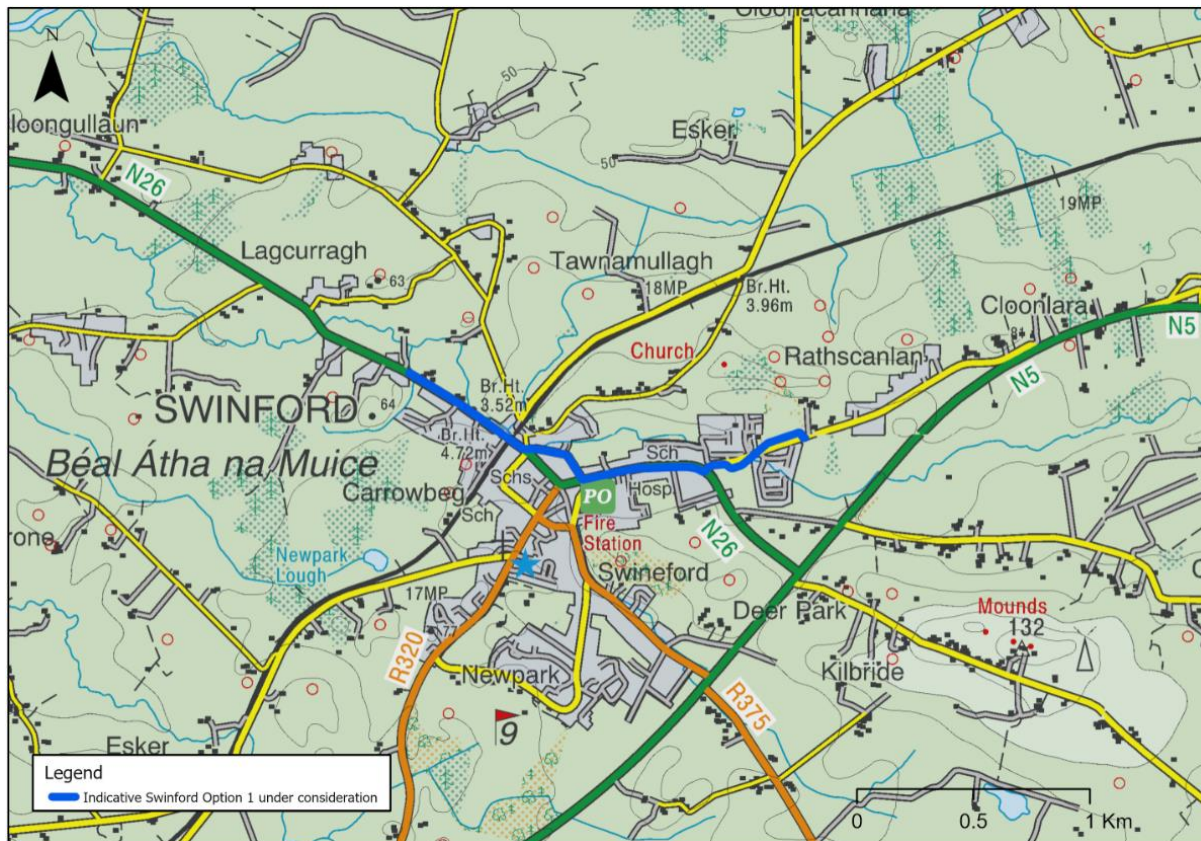
Figure 7.1: Option 1 Swinford

Option 1 Swinford is illustrated in the Figure 7.1 below.

There are three intersections of option 1 with EPA registered watercourses (EPA Code: Swinford_010, WFD Framework Status – Good). One crossing is located along the Cloonlara Road at which HDD is proposed, the remaining two are located on the section of route between Bridge Street and Ballina Road.
