West Galway 110/38kV Substation

EirGrid

Site Selection

Review of Environmental Constraints

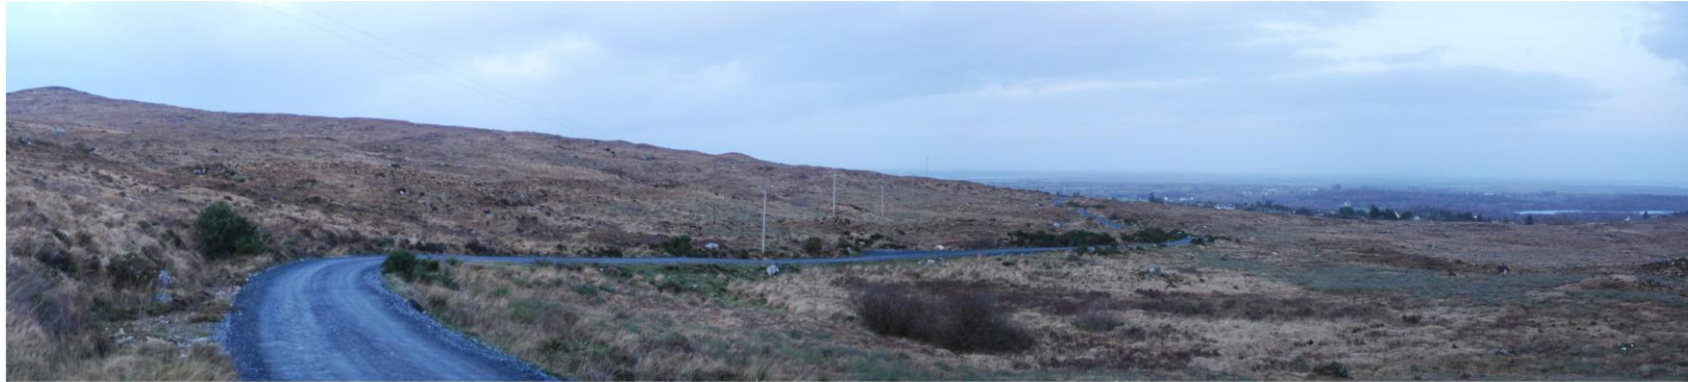
Plate 1 (Panoramic): View northeast from an access track in the Northern Location.

This location is an exposed landscape on a hill slope with no vegetation of any significant height. The elevated position results in panoramic open views from the site of north-eastern, eastern and south-eastern lower lying areas. The absence of vegetation in this location would result in high visibility within 1km of the site, but the topography limits close range views from the west, north and south. The site survey of the wider area indicated that intervening vegetation would screen most of the potential views. Where views would be possible, the proposal would be seen against the hill range in the background, reducing the magnitude of visual effects.

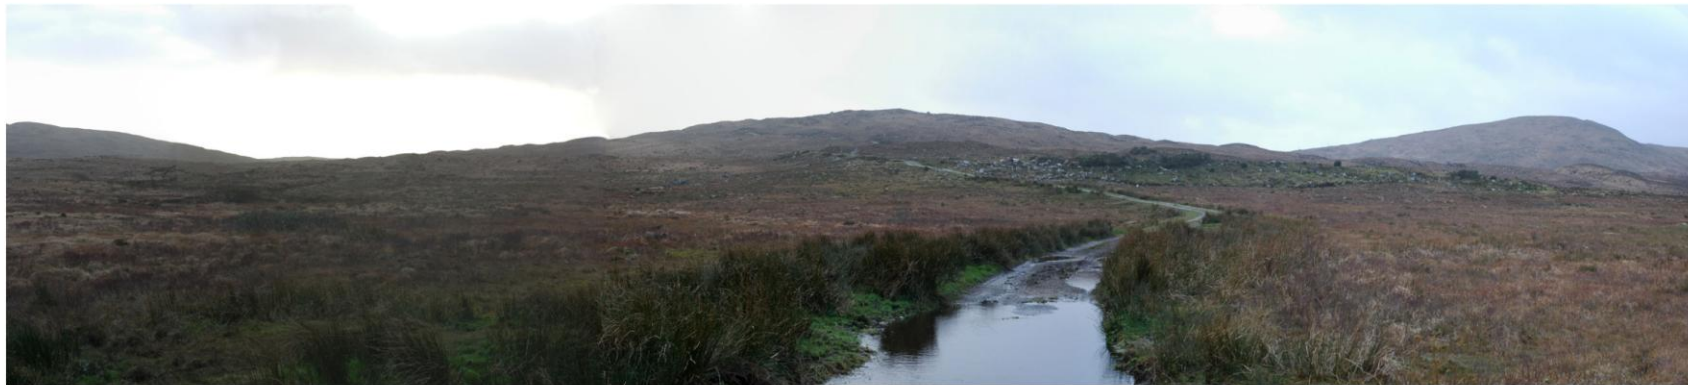
Plate 2 (Panoramic): View southwest from an access track towards the Middle Location, which is approximately 600m away from this location.

Location characteristics (Due to flooding of the local access road, the site was inaccessible on the day of the site survey, but the surveyor was able to observe the site from a distance of 600m):

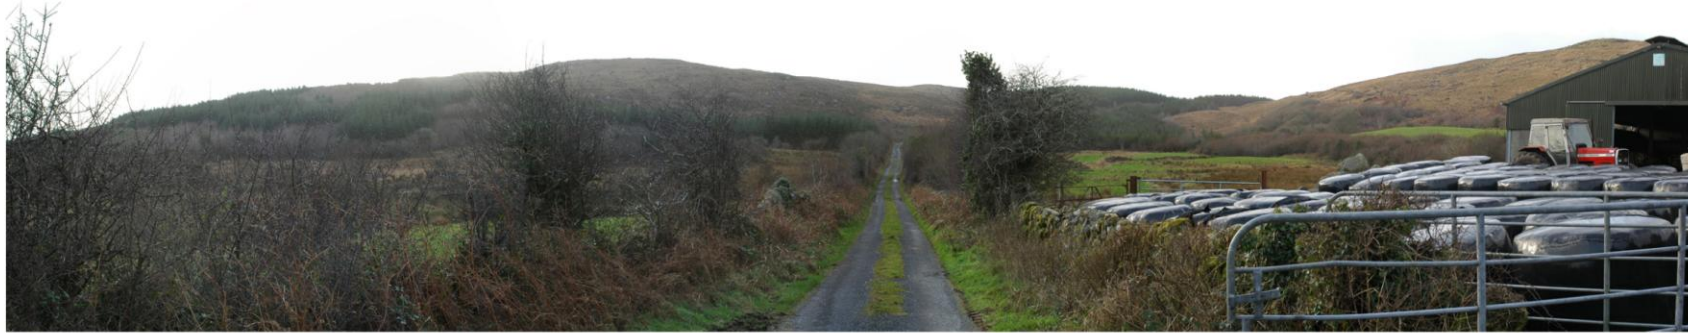
Plate 3 (Panoramic): View southwest from access road across the Southern Location.

1.3.3 Southern Location (refer to Photosheet 2 – Plates 3 & 4)

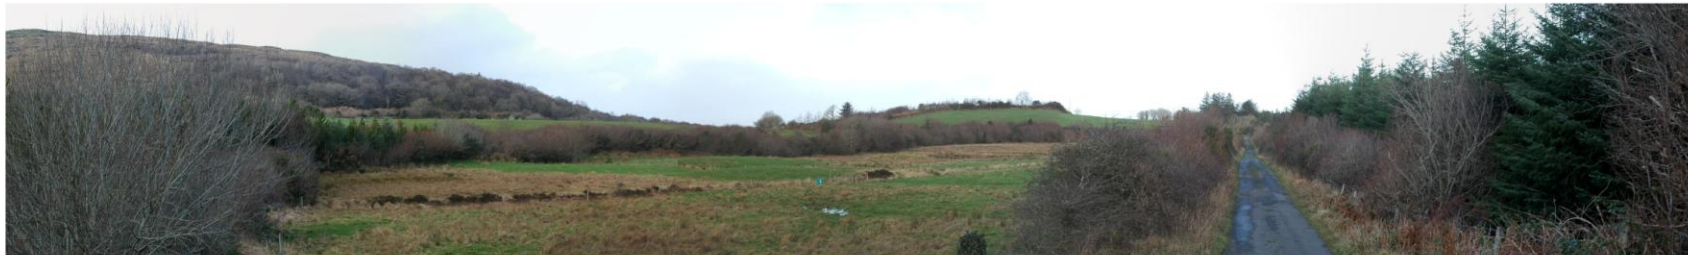
Plate 4 (Panoramic): View northeast from access road across the northern part of the Southern Locations.

This location is situated within an area enclosed by higher ground with screening provided by surrounding hills and hummocks. The Southern Location is partially located within a natural depression containing a small stream and rises steadily towards the south-western, north-western and north-eastern boundaries. Further screening of the location is provided by bands and pockets of low woodland, scrub and coniferous plantations. The topography and vegetation limits localised visibility to approximately 700m. The site survey of the wider area indicated that intervening vegetation would screen most of potential views. Where views would be possible, the upper parts of the proposal would be seen against the hill range in the background, reducing significantly the magnitude of visual effects.

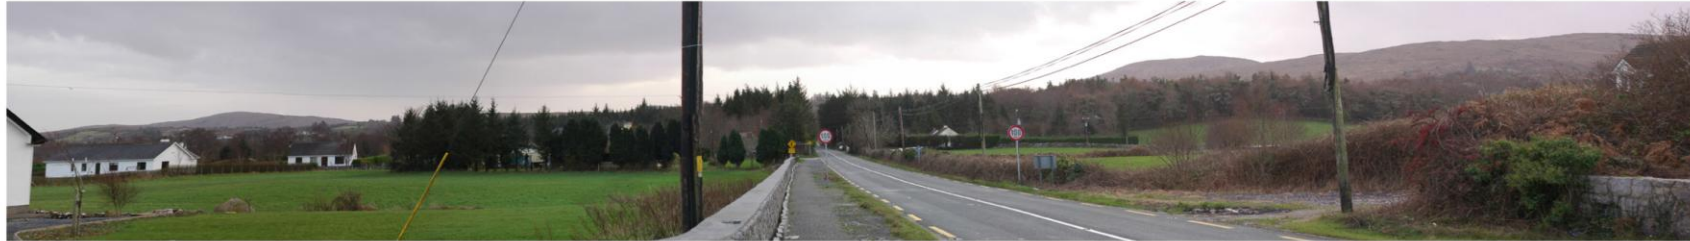
Plate 5: View south, southwest from the N59 in the vicinity of Rosscahill towards the Northern (approx. 2km distance), Middle (approx. 2.5km distance) and Southern Locations (approx. 4km distance).

The above panoramic photographs show views from distant lower lying areas northeast and east of the substation locations. Intervening vegetation and small hummocks screen the majority of views towards all substation locations. Due to its elevation, the proposal would be seen against the hills in the background and not against the sky in all three locations. Considering the scale of the field of vision, the proposal would only be a minor component in the wider view and could be missed by the casual observer. Potential visibility would be highly dependant on weather and light conditions. The Southern Location would be the least visible due to its secluded topographical location.

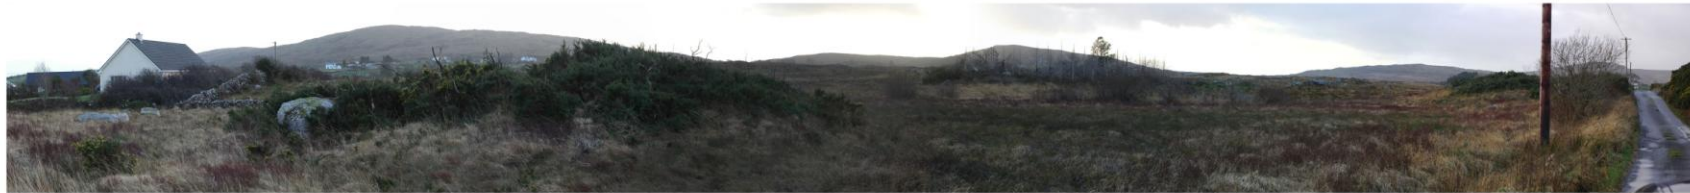
Plate 6: View southwest from local road northeast of the townland of Shanballyoghery towards the Middle Location (approx. 1.6km distance).

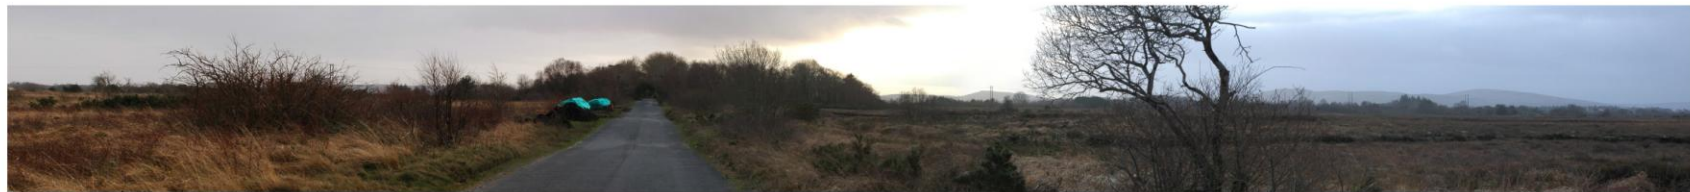
Plate 7: View southwest from local road west of the townland of Ower towards the Northern (approx. 4.8km distance), Middle (approx. 4.8km distance) and Southern Locations (approx. 5.4km distance).

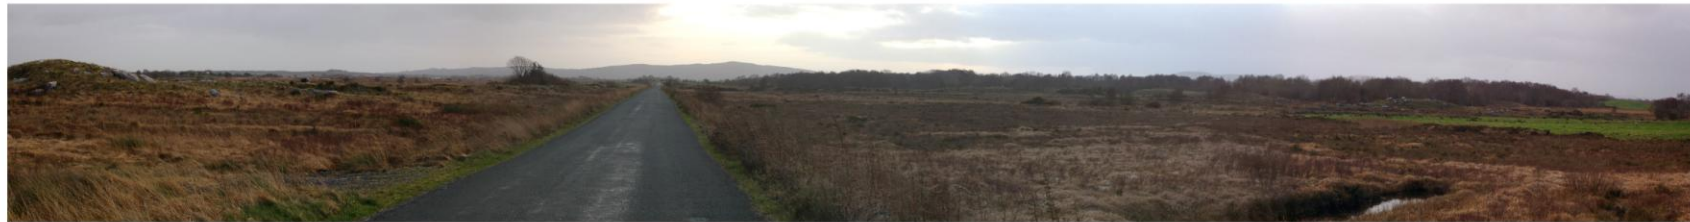
Plate 8: View southwest from local road northeast of the townland of Pollagh towards the Northern (approx. 6km distance), Middle (approx. 6km distance) and Southern Locations (approx. 7km distance).

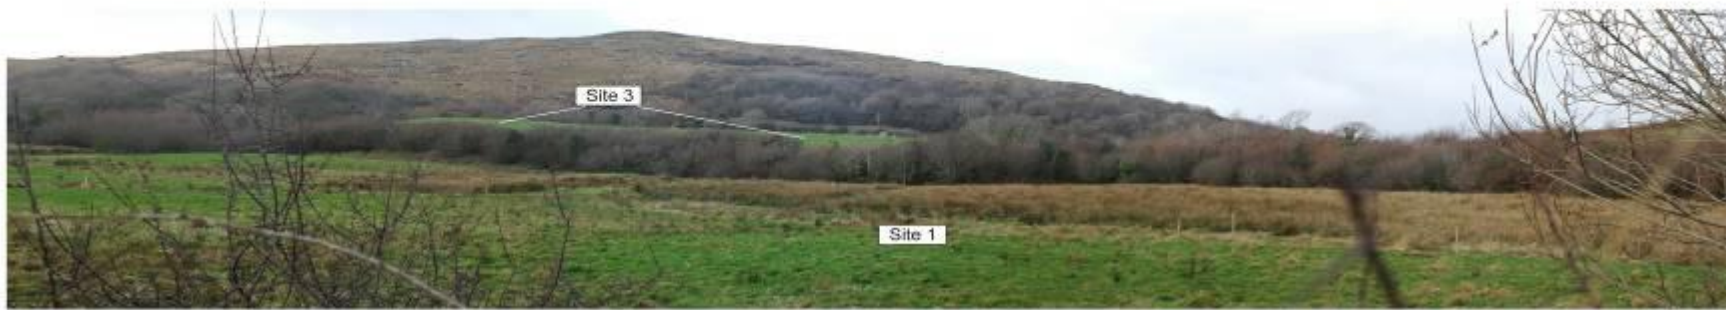
Plate 9 (Panoramic): View northwest from access road across Site 1 and of Site 3

Site 1 (*refer to Photosheet 4 - Plates 9 & 10 and Photosheet 7 - Plates 15 & 16*)

Site 3 (refer to Photosheet 4 - Plate 9 and Photosheet 7 - Plates 15, 16 & 17)

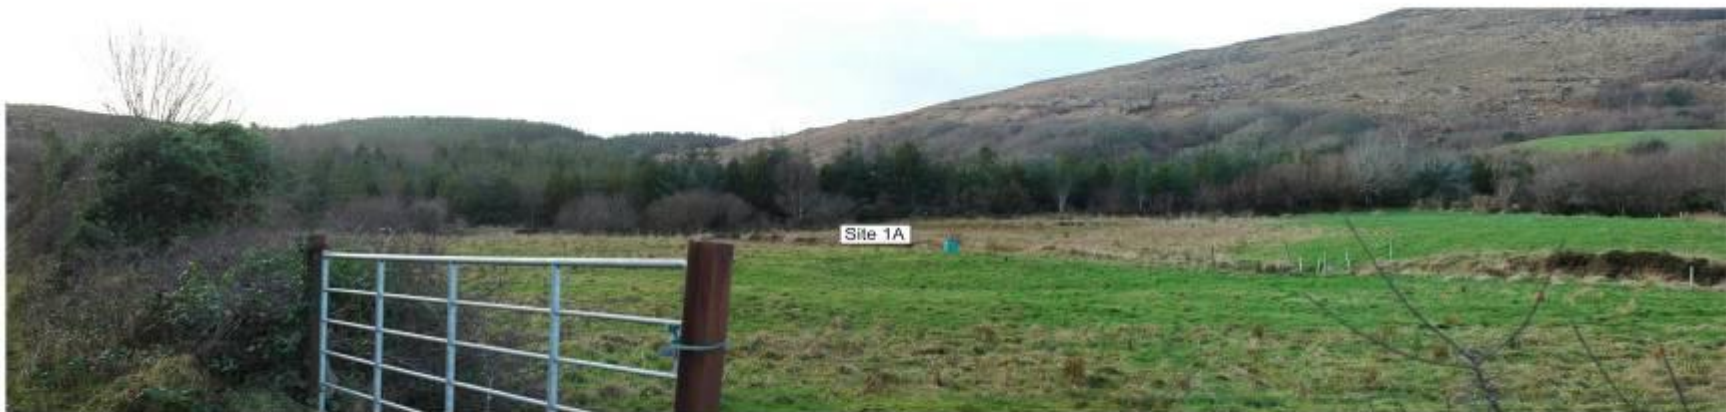
Plate 10 (Panoramic): View southwest from access road across Site 1A

Site 1A (refer to Photosheet 4 - Plate 10 and Photosheet 7 - Plate 15)

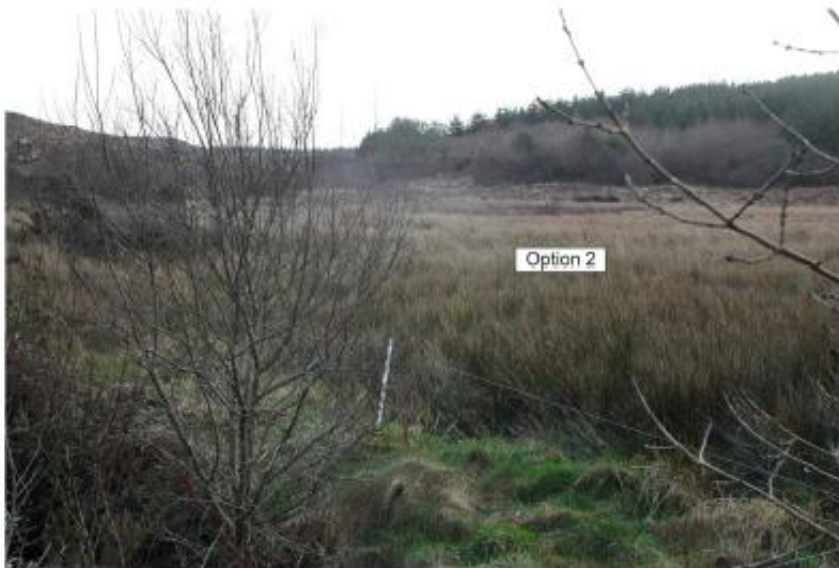
Plate 11: View south from access road across north-eastern part of Option 2

Site 2 (refer to Photosheet 5 - Plates 11 & 12 and Photosheet 6 – Plates 13 & 14)

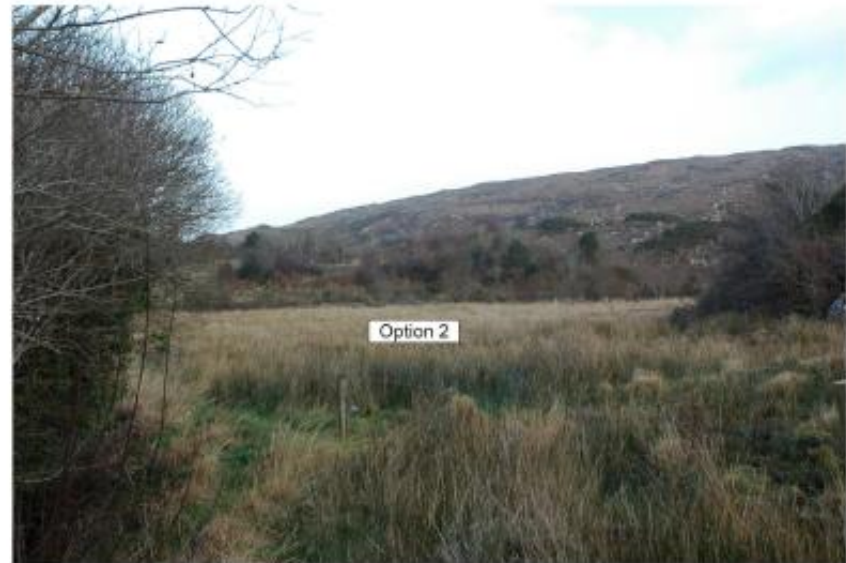
Plate 12: View northeast from access road across south-western part of Option 2

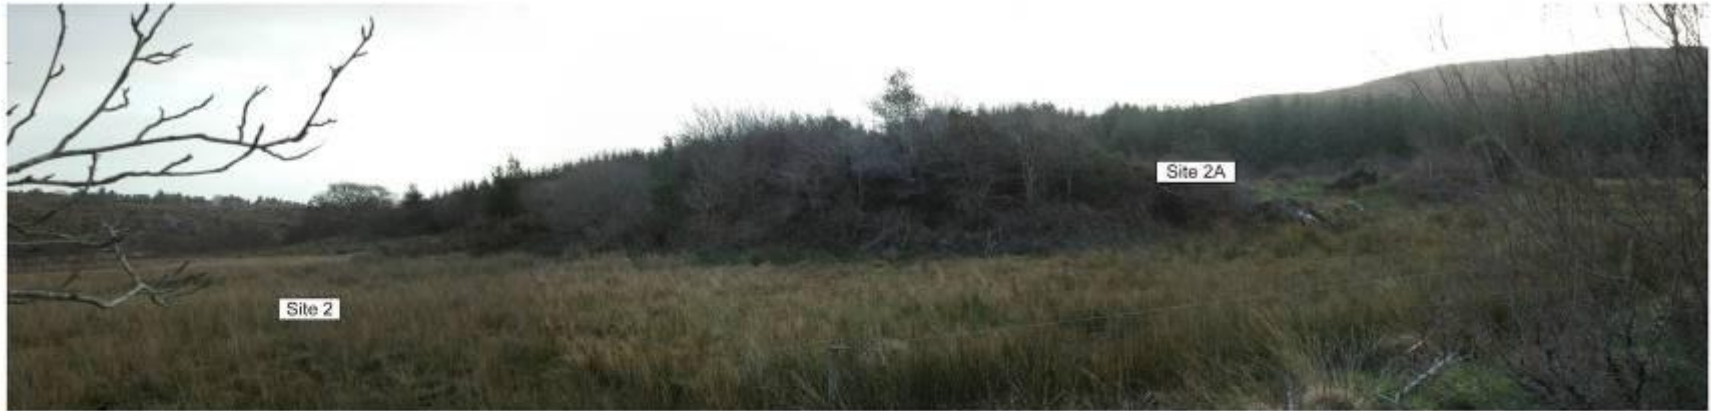
Plate 13 (Panoramic): View south from access road across Site 2A

Site 2A (refer to Photosheet 6 - Plates 13 & 14)

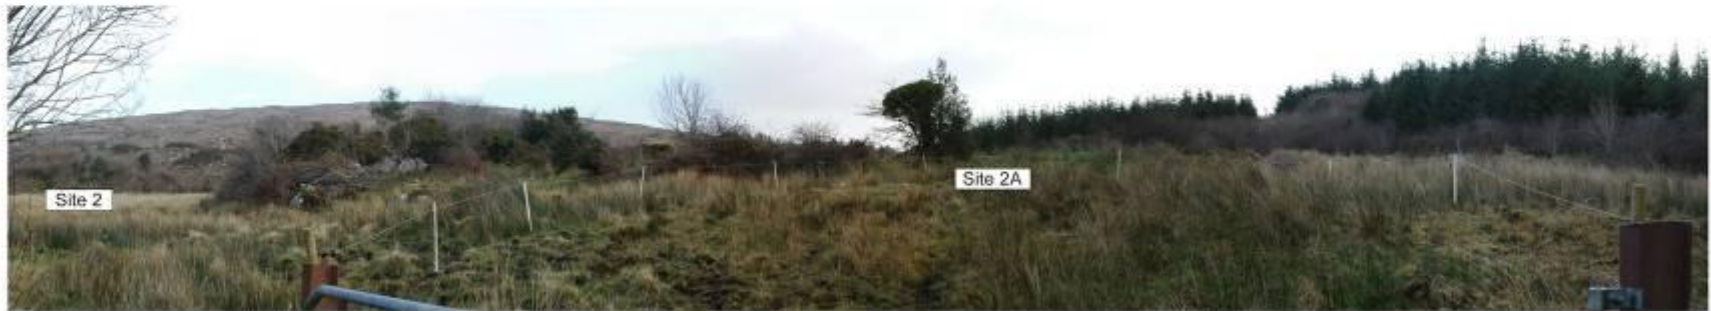
Plate 14 (Panoramic): View southeast from access road across Site 2A

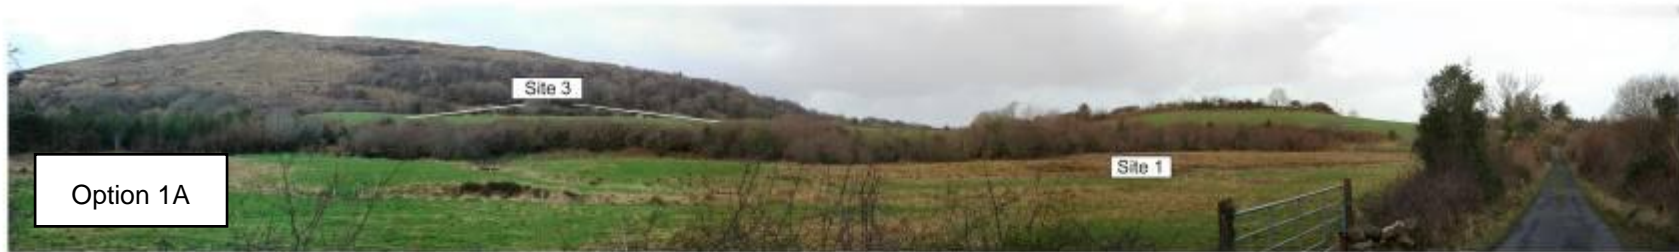
Plate 15 (Panoramic): View north from access road across Site 1, Site 1A and of Site 3

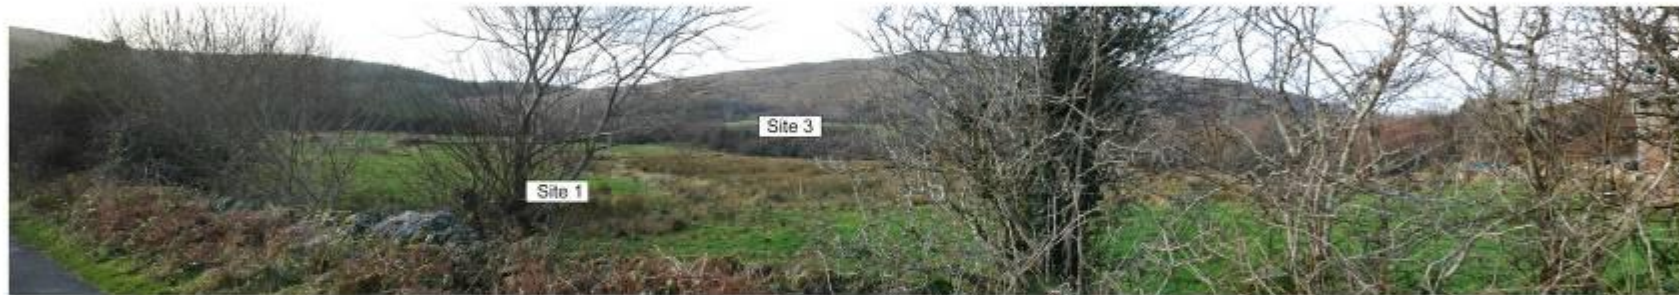
Plate 16 Panoramic): View west from access road of Site 1 and Site 3

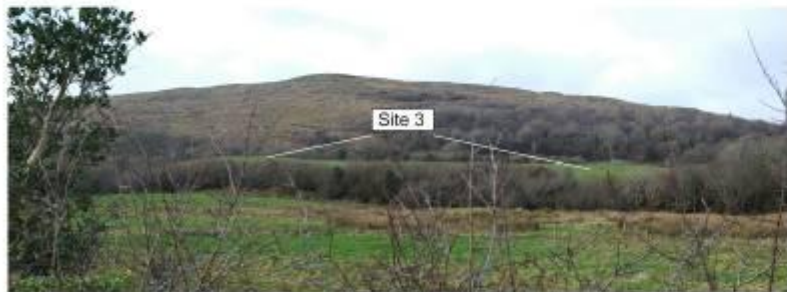
Plate 17 (Panoramic): View northwest of Site 3

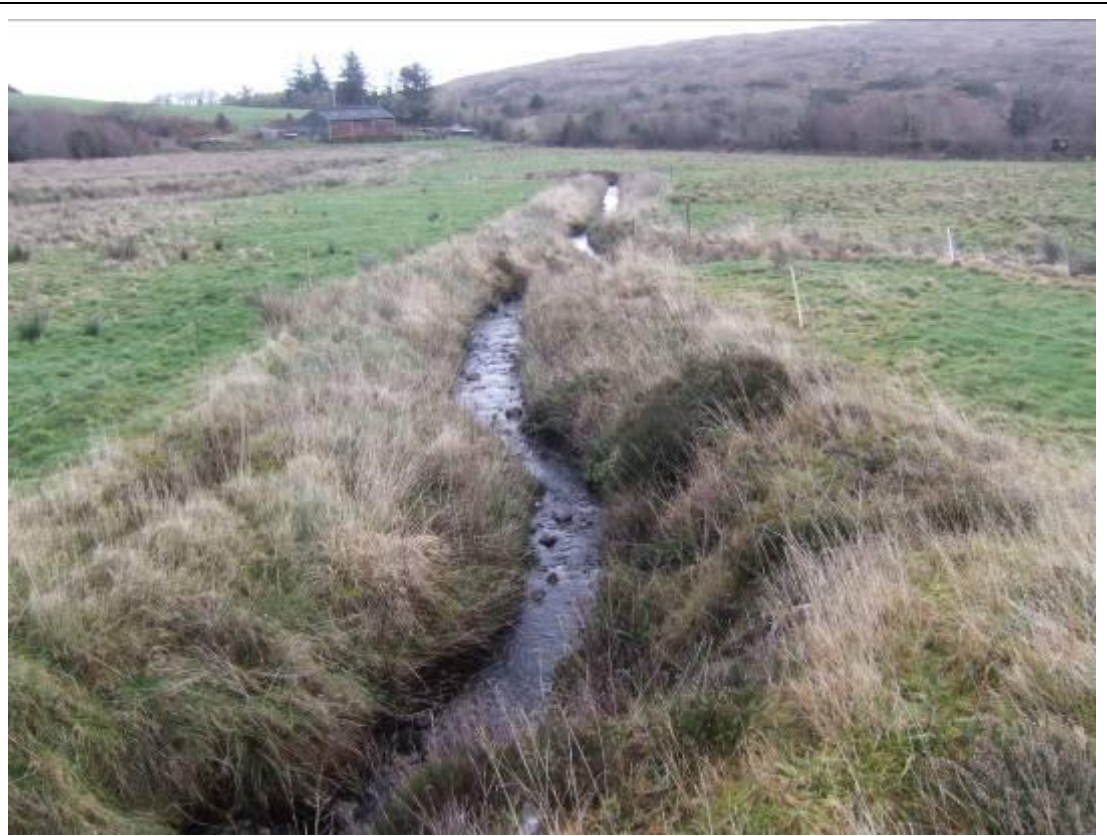
This site is fairly evenly divided from east to west by a tributary stream of the Knockbane River (see Plate 1). The stream was observed to be generally less than 1 metre in width, with a gravel bottom. At the time of survey water clarity was good.

This site is fairly evenly divided from east to west by a tributary stream of the Knockbane River (see Plate 1 in Ecology Report, Appendix 2). The stream was observed to be generally less than 1 metre in width, with a gravel bottom. At the time of survey water clarity was good.

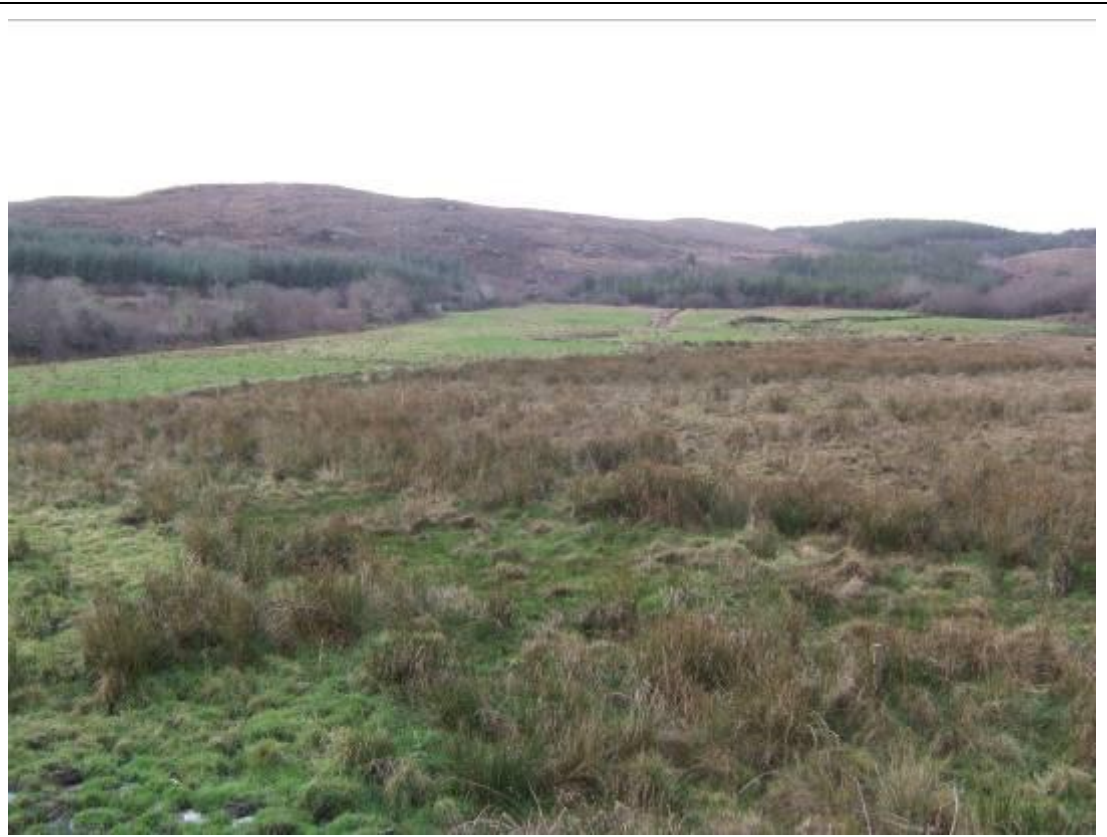
Plate 2

Plate 2. South Substation location, Option 1 - view looking SW over site. Wet grassland and improved grassland are the principal habitats.

The sector north of the stream can be divided into three main habitats. The western part is further improved grassland, while the eastern sector is wet grassland (GS4) dominated heavily by rushes (mostly *Juncus effusus*) (see Plate 2).

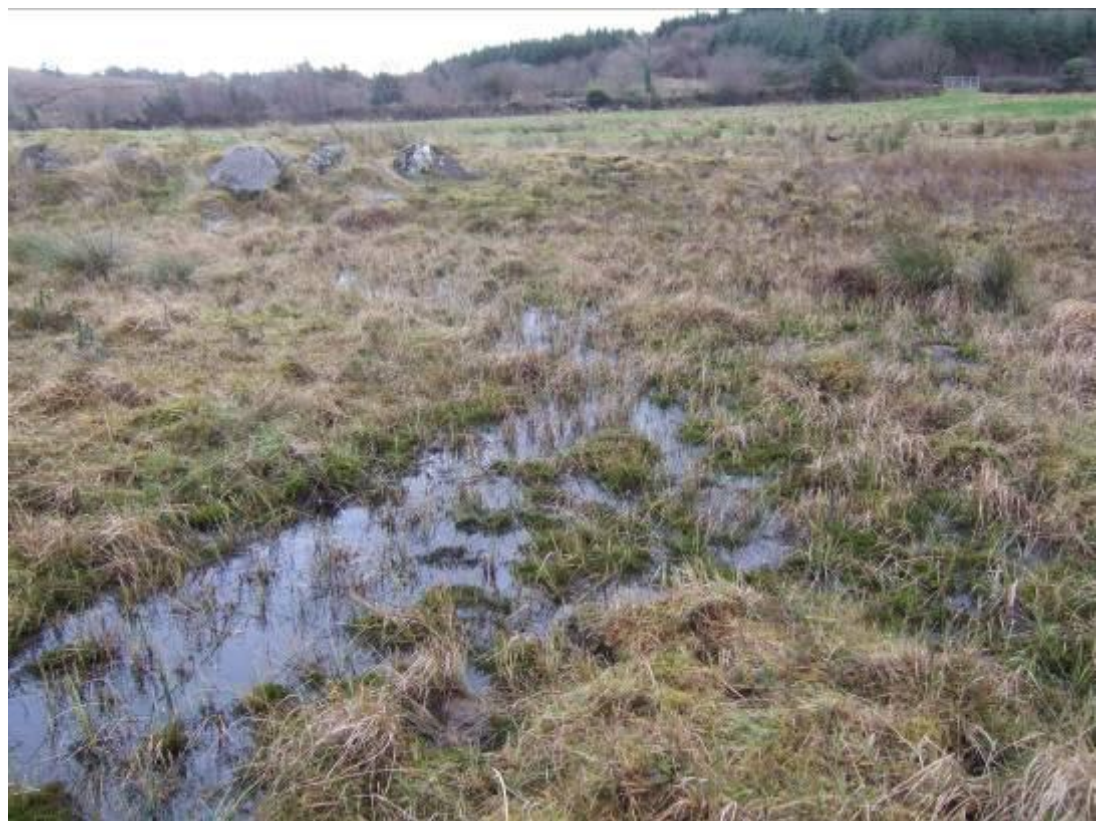
Plate 3

Plate 3. South Substation location, Option 1 – view of flush vegetation.

Between the wet grassland and improved grassland, there is a small area of remnant peatland habitat that is dominated by poor fen or flush vegetation (considered as 'poor fen and flush' PF2). This extends from the woodland strip just to the north of the site (co-ordinates 16929 33947 to 16891 33916) across the site to the stream where it enters as two small channels (at co-ordinates 16972 33910 & 16940 33894). (note that this area is readily visible on the 2000 and 2005 aerial images on the OSI map viewer). The area is extremely wet and supports a range of sedges and rushes (see Plate 3) and would undoubtedly be species rich during summer. The source of the wetness is not known but is likely to be a spring or seepage line.

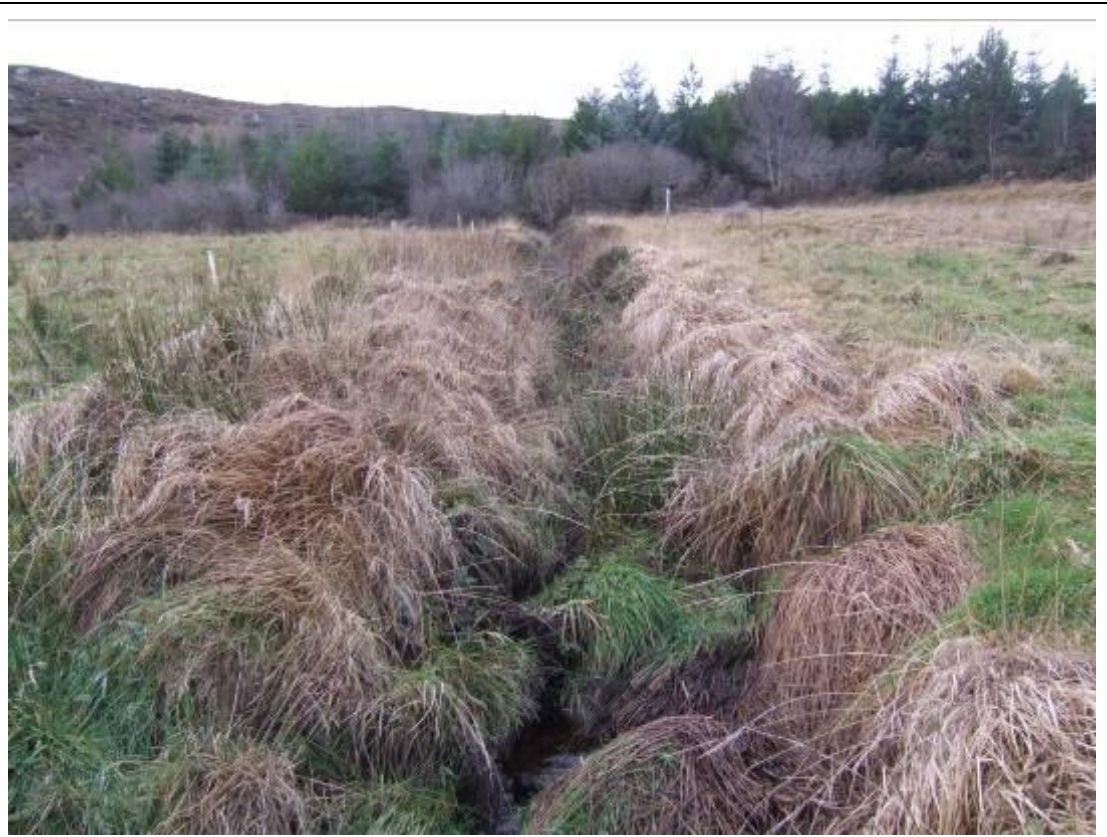
Plate 4

Plate 4. South Substation location, Option 1A – view of drainage channel, looking westwards towards conifer forest.

This site is fairly evenly divided between grassland and a conifer forest. The grassland is divided by a drainage channel (FW4) which flows north-east to the main stream (see Plate 4). This channel originates within the adjoining forest.

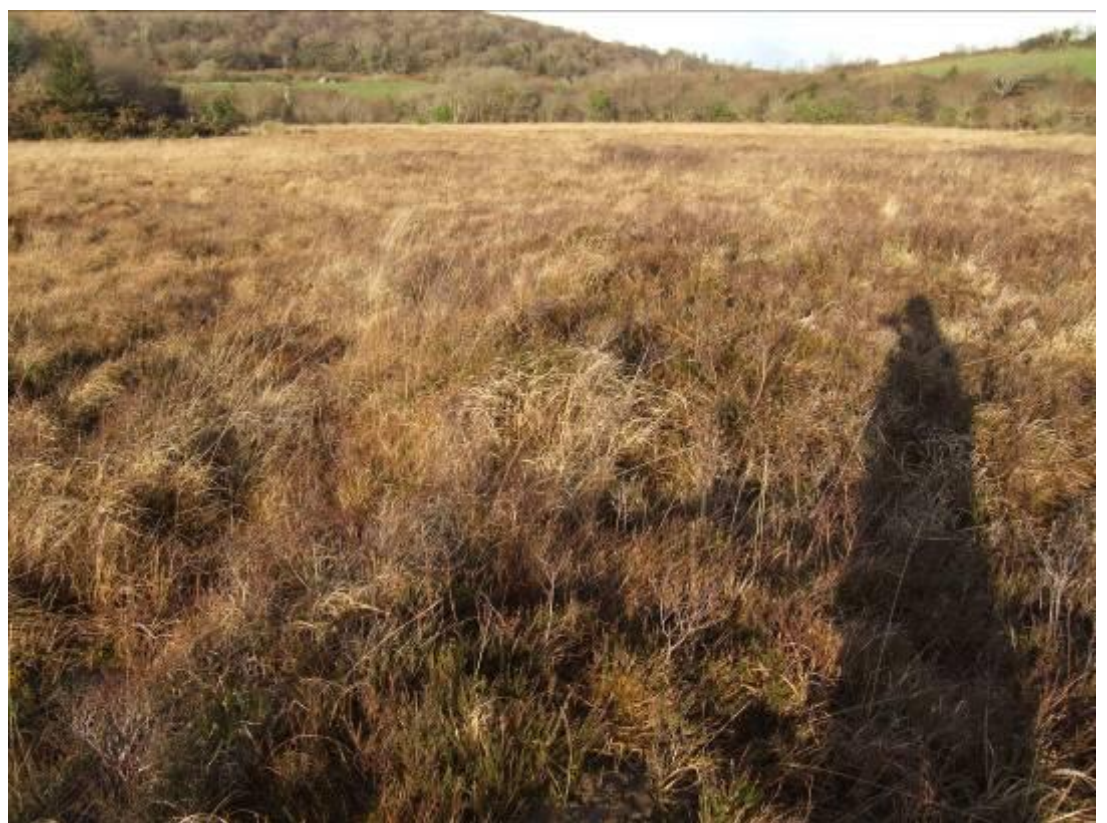
Plate 5

Plate 5. South Substation location, Option 2 – general view of bog/heath vegetation looking NW across site.

There has been no peat cutting on site in recent times and the entire site is well vegetated (apart from some poaching and trails by cattle in vicinity of entrance gate). Generally the vegetation on site is dominated by species characteristic of blanket bog and wet heath (see Plate 5), with ling heather (*Calluna vulgaris*), cross-leaved heath (*Erica tetralix*), deer grass (*Trichophorum cespitosum*), common bog-cotton (*Eriophorum angustifolium*), carnation sedge (*Carex panacea*), purple moor-grass (*Molinia caerulea*), bog asphodel (*Narthecium ossifragum*) and bog myrtle (*Myrica gale*) present. Devil's-bit scabious (*Succissa pratensis*) appears common throughout much of the site. Rushes are dominant in the north-west of the site (a strip c.30 m wide parallel to road), with soft rush (*Juncus effusus*) the main species. This strip, while on peat, is more characteristic of wet grassland (GS4) (see Plate 6).

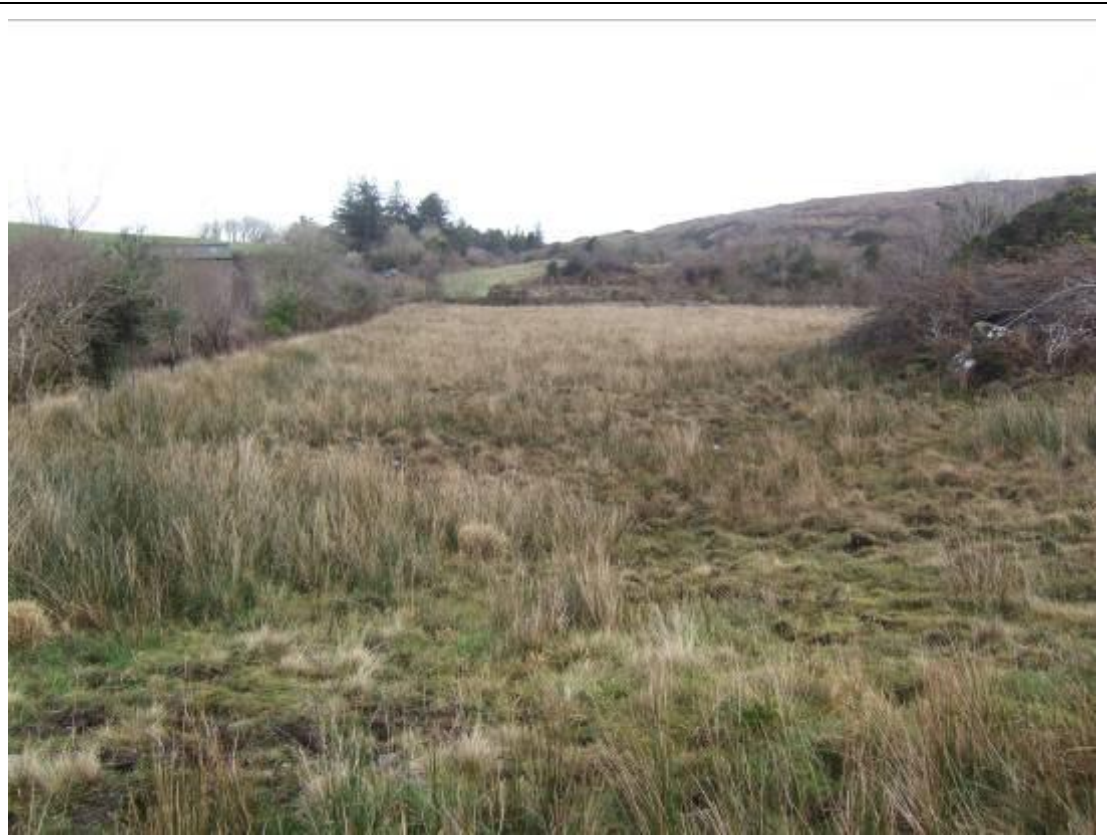
Plate 6

Plate 6. South Substation location, Option 2 – the section of the site alongside the road is dominated by rushes and is classified as wet grassland on peat.

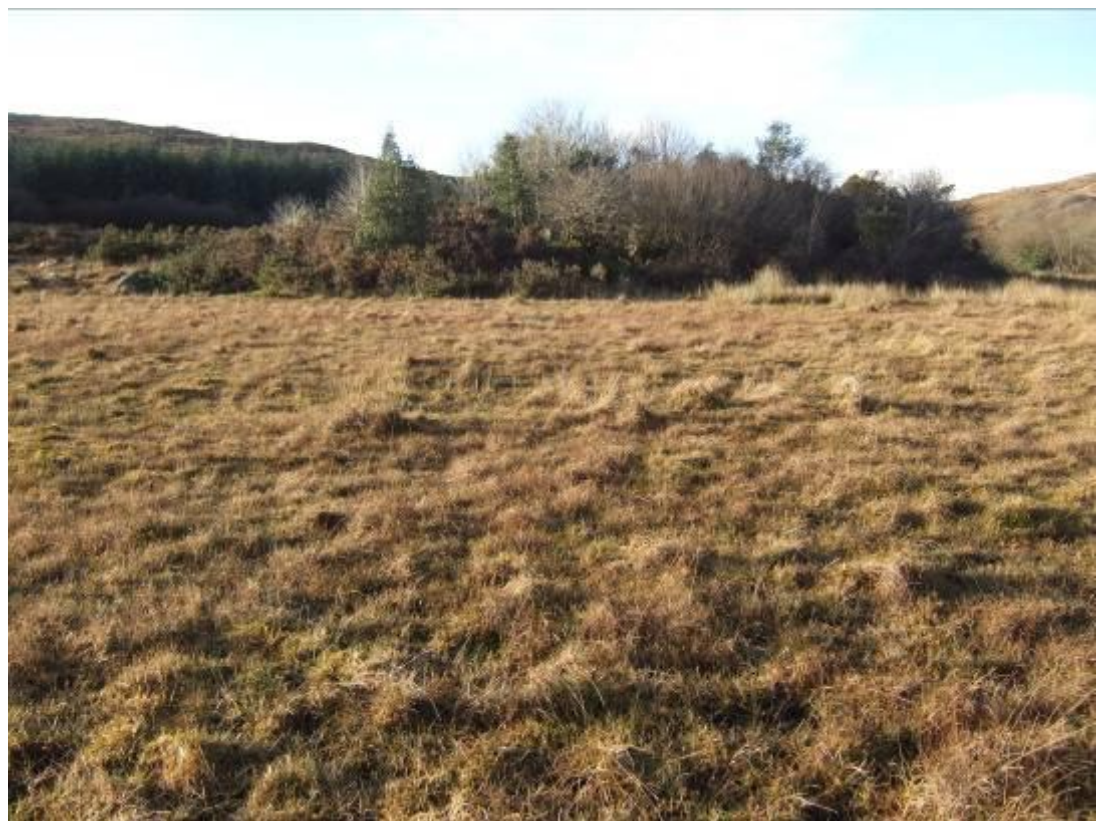
Plate 7

Plate 7. South Substation location, Option 2 – view of area of scrub on rocky knoll within site.

The rocky knoll is dominated by scrub (WS1), with gorse (*Ulex europaeus*), blackthorn (*Prunus spinosa*), hawthorn (*Crataegus monogyna*), holly (*Ilex aquifolium*), willow (*Salix* spp.) and some rowan (*Sorbus aucuparia*) (see Plate 7).

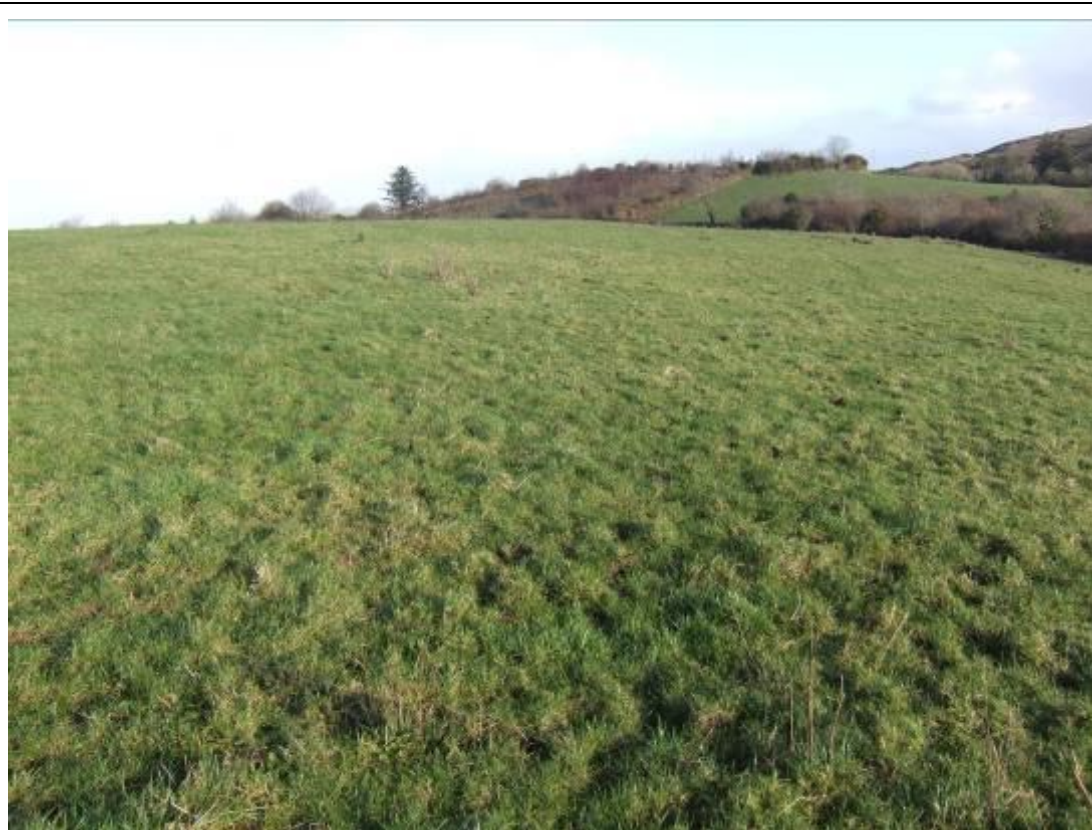
Plate 8

Plate 8. South Substation location, Option 3 – view of improved grassland which dominates the site.

The option 3 site is located on higher ground to the north-west of Option 2 site. This is essentially a large field of improved grassland (GA1) that is intensively managed (i.e. fertilised and reseeded) (see Plate 8). It is surrounded almost entirely by a strip of narrow woodland, with blackthorn, hawthorn, hazel and oak.

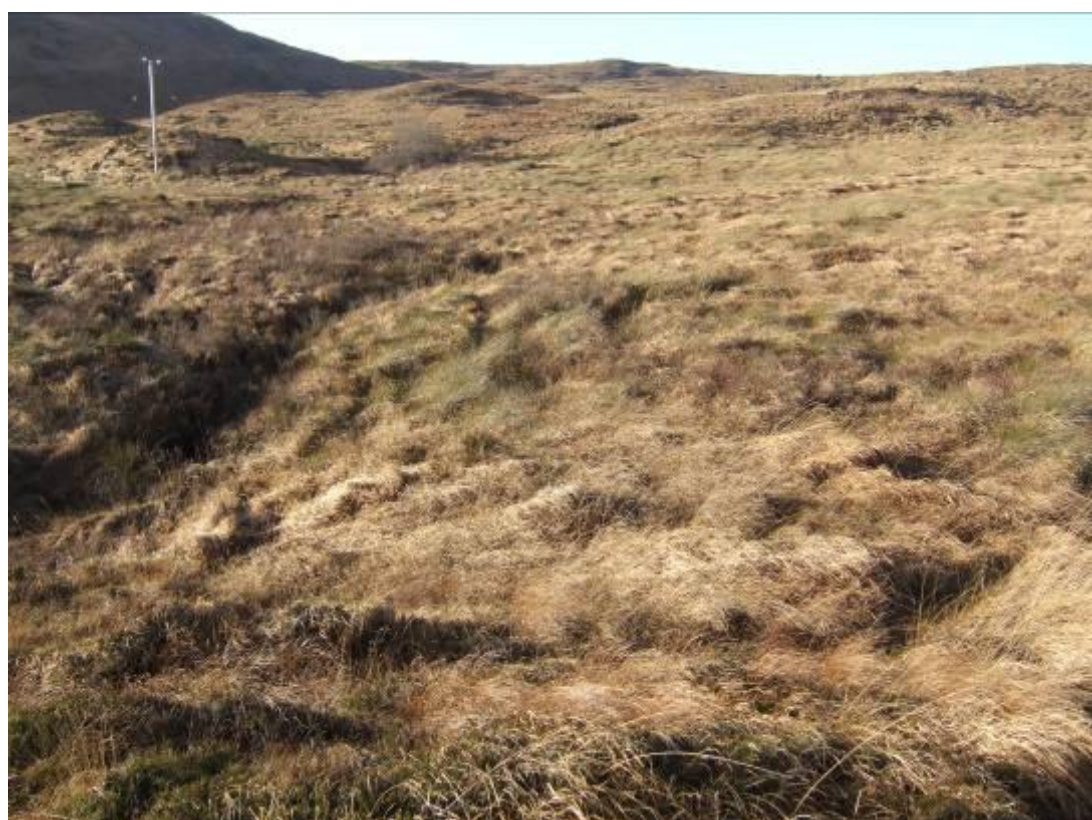
Plate 9

Plate 9. North Substation location – view of blanket bog which dominates the area. A small stream occurs in this area (left hand side of photo).

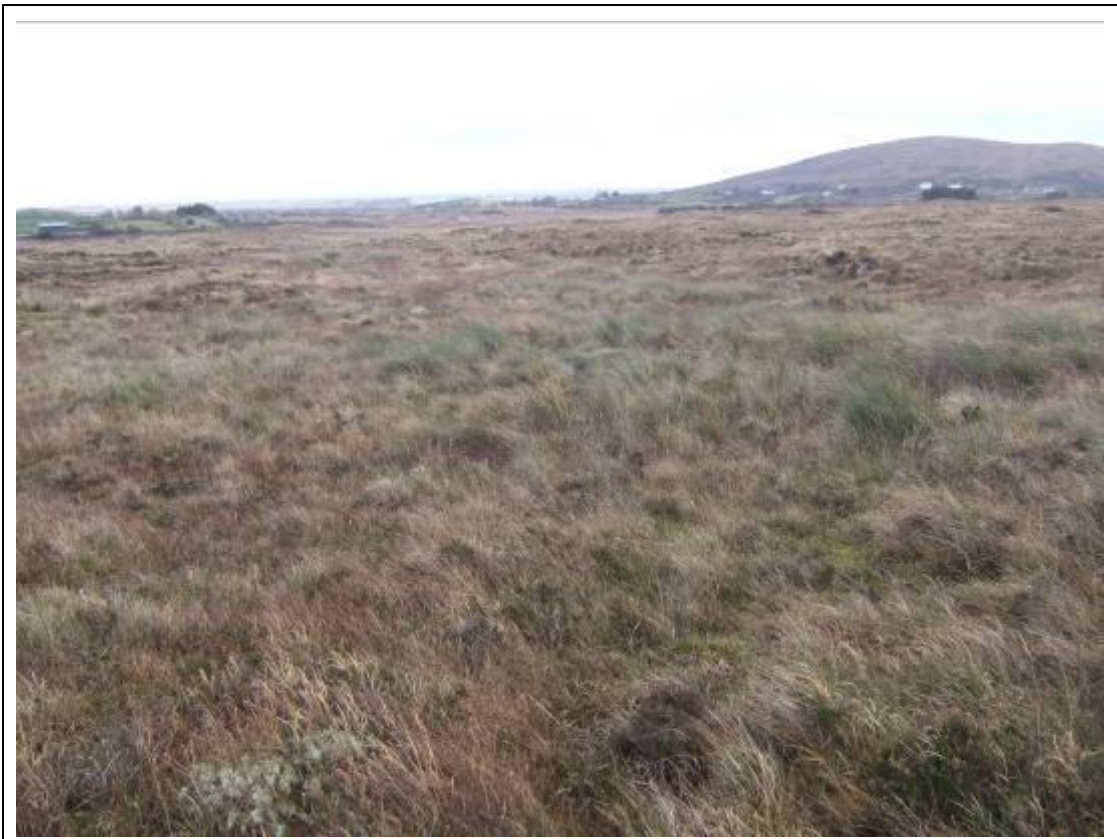
Plate 10

Plate 10. Middle Substation location – view of blanket bog which dominates the area.
