# Agenda

# ELEMENTS of the MOYLE INTERCONNECTOR

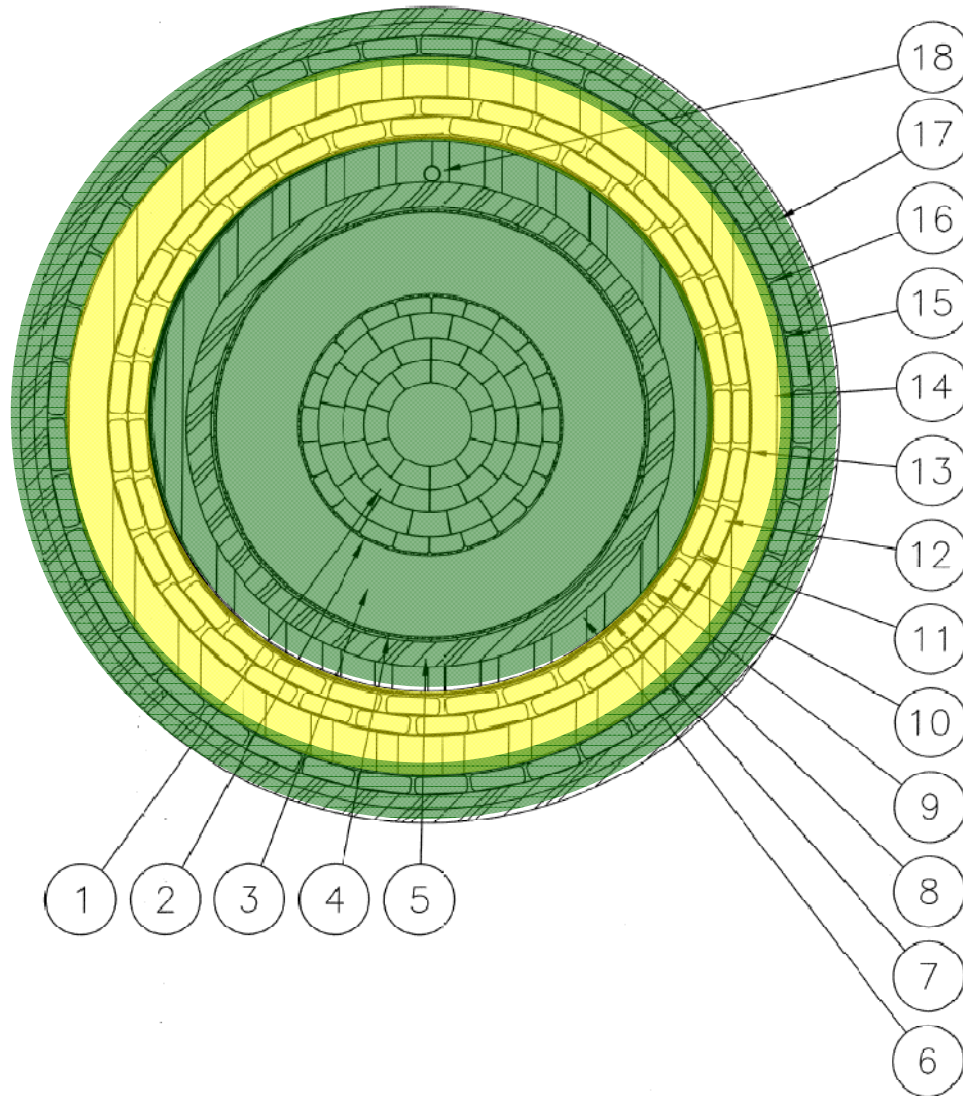
# No Issues with HV Elements of Cable

- There is a low level of confidence in LV part of cable system but there are no reasons to doubt the integrity of the HV elements of the cables
- The longer term strategy to return to full technical capacity at previous high levels of reliability is to replace the two LV conductors by laying two new LV cables
