Power Flow Results

Branch Thermal Ratings

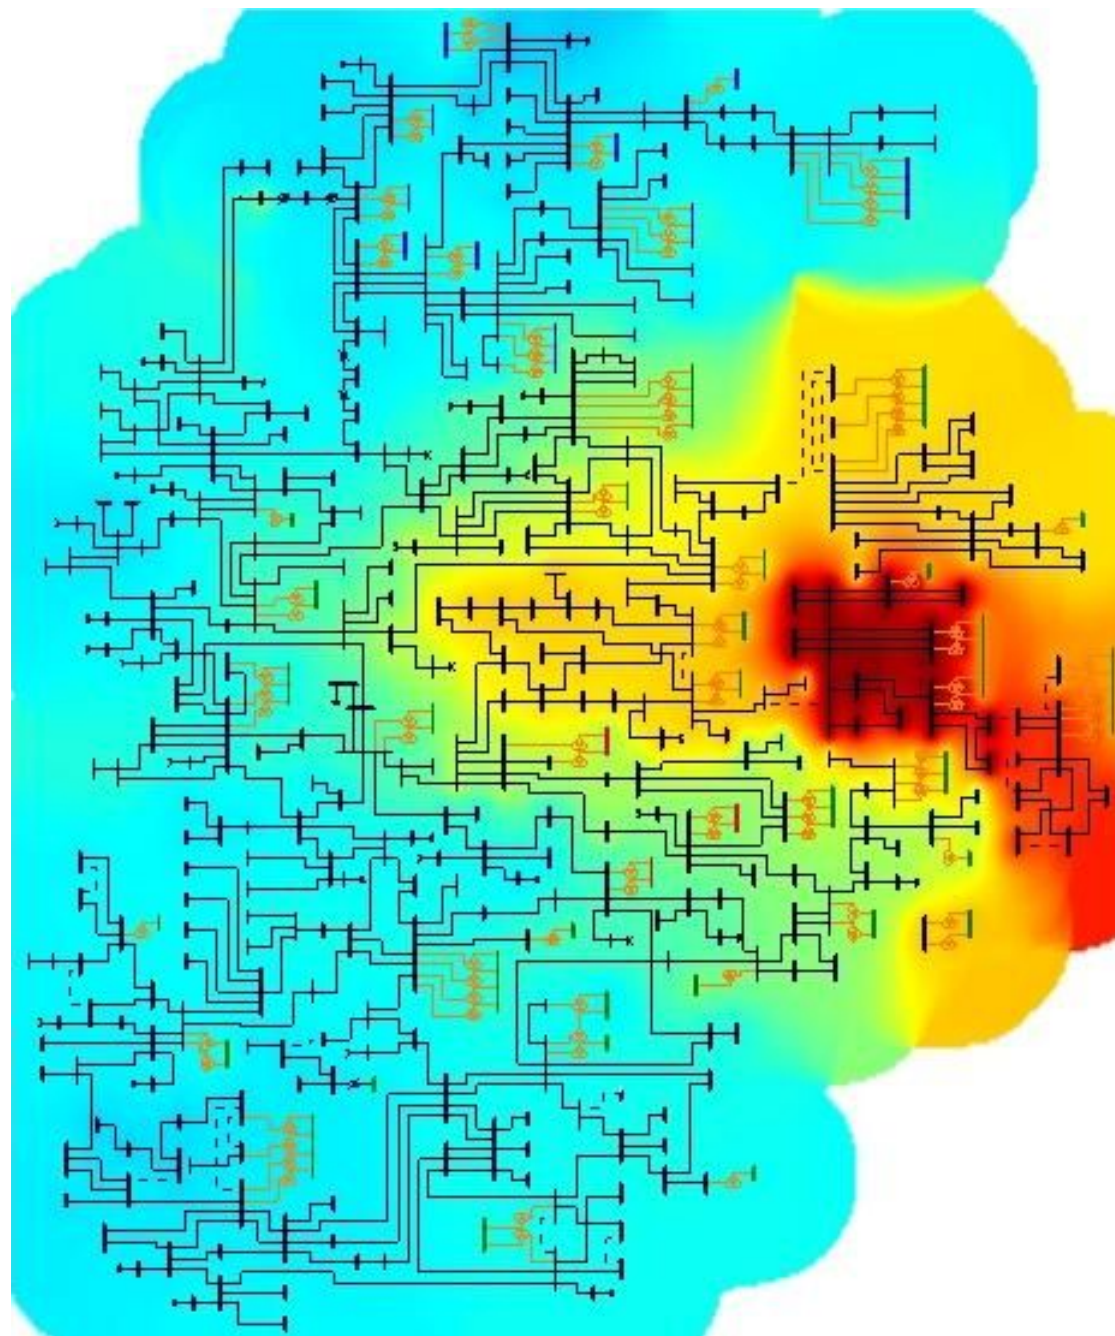
50% Wind

Fault at 2861
(GrangeC)

65/35 Dx/Tx Split, 25%-100%, no import - 110kV
